# FLOOD PLAIN INFORMATION

4-7 JULY 1969 FLOOD

# HURON RIVER

PREPARED BY  
U. S. ARMY ENGINEER DISTRICT, BUFFALO  
MAY 1970

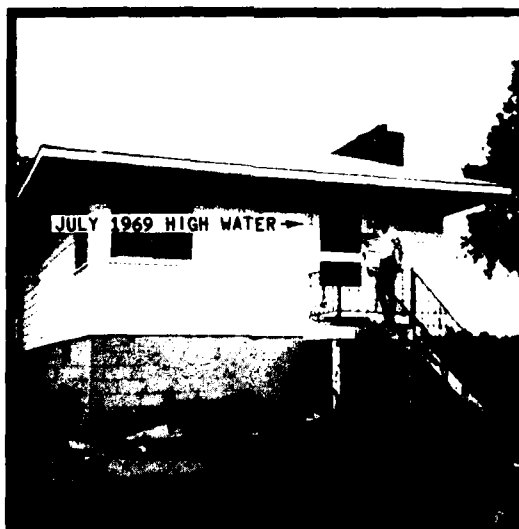
Figure 6 - Franklin Flats between Milan and Huron. Boy is pointing to July 1969 high water mark.

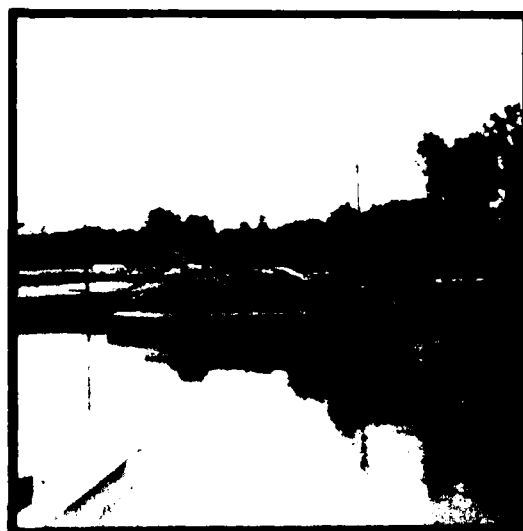
In the city of Milan the river rose so rapidly that campers were forced to flee, leaving cars, boats, trailers and campers to the mercy of the river. In the areas known as Fries Landing, about 100 persons were evacuated by military and civilian personnel and housed in the Sandusky Armory. The Mason Road bridge washed out closing River Road to traffic.

Figure 8 - Looking west along Mason Road at bridge washout. Approximately 2 miles downstream of Milan.

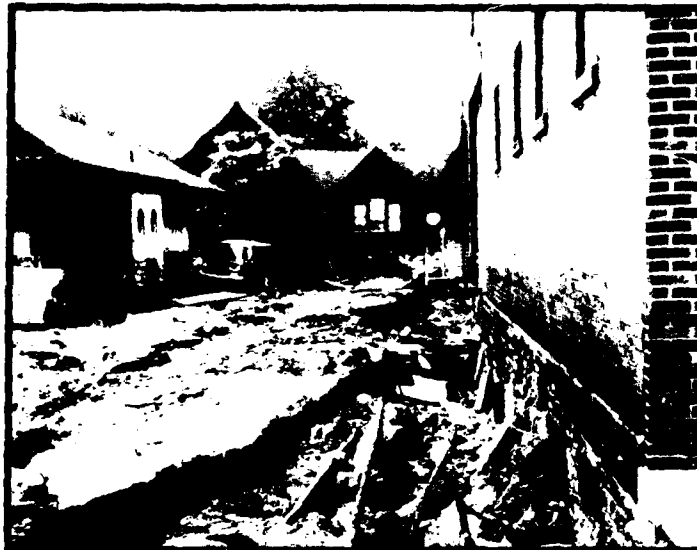
The Elm Street bridge, although cracked, remained in service. Benedict Avenue, Pleasant Street and Old State Road were washed away. Norfolk and Western Railway Company officials reported that due to extensive washouts of railroad embankments, transportation between Brewster and Norwalk was curtailed.

Figure 22 - Washout between railway depot and building on Benedict Avenue.

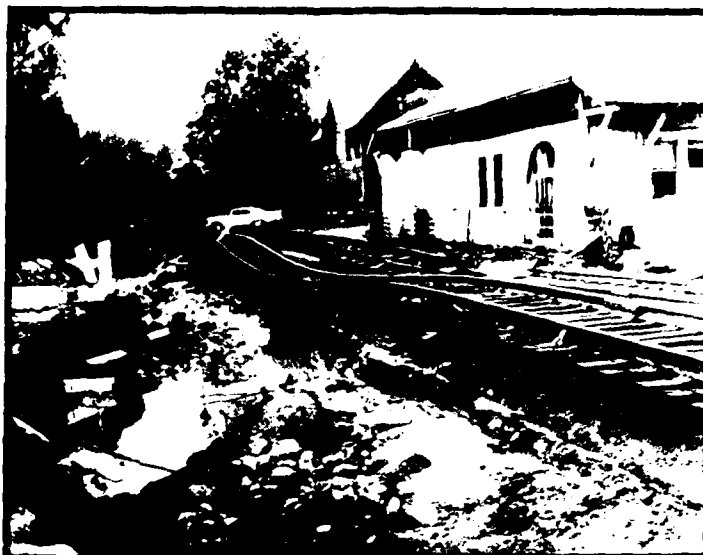
Figure 23 - Looking downstream from Benedict Avenue at railroad washout along the right bank. Photo taken 6 July 1969.

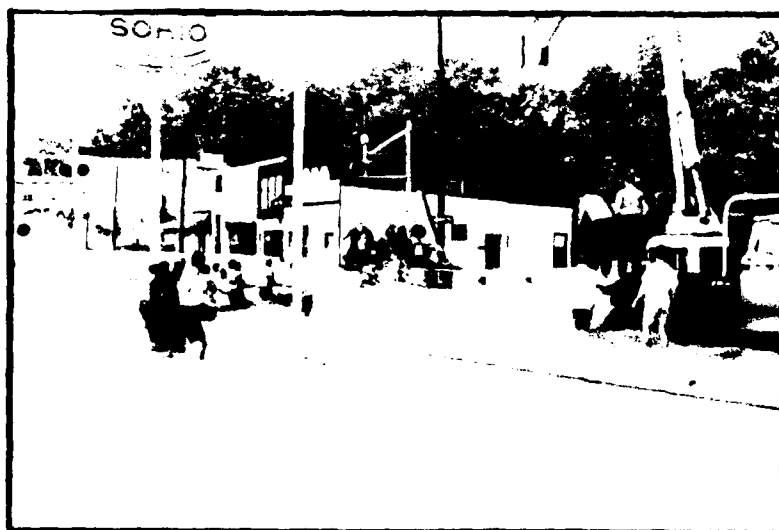
Figure 24 - Looking southerly along Benedict Avenue during rescue operations. The nose of the truck was eventually covered with water. Photo taken 5 July 1969.

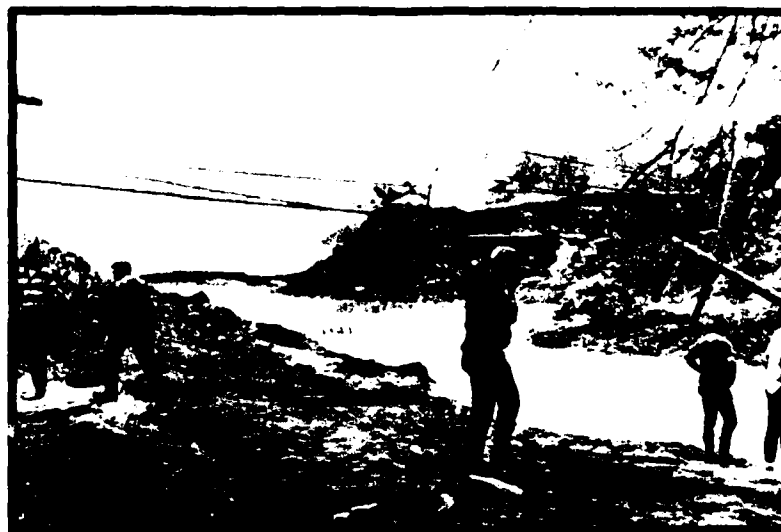
Figure 28 - Looking at break in Lower Reservoir after water escaped. Photo taken 6 July 1969.

Construction crews began repair of the Lower Reservoir in the evening of 5 July. Driving of steel sheet piling began on Sunday and was finished Tuesday. A steel sheet piling wall was driven across the break in the old masonry wall buried beneath the earth fill. The construction crews worked around the clock and minimal water and electrical service was returned by the weekend. Residents were warned by county health officials to boil all drinking water to eliminate any possibility of contamination. The county health department had found some contamination in certain areas of the city. Although water leaving the filtration plant was free of contamination, there were many breaks and leaks in the water lines from the plant to the users.
