# INVESTIGATION OF DETERIORATION OF BRICK IN NAVIGATION LOCK CONTROL HOUSE STRUCTURES, TULSA DISTRICT

Robert H. Denson, G. Sam Wong, and Tony Husbands

September 1980

Prepared for U. S. Army Engineer District, Tulsa  
Tulsa, Okla. 74102

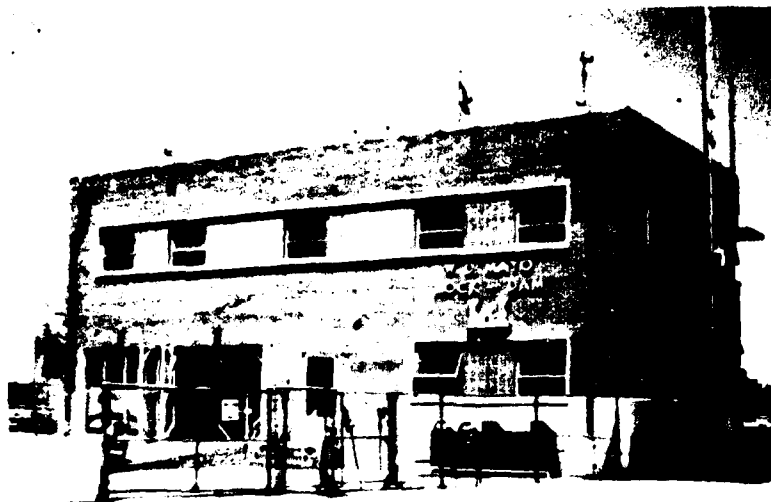
Photo 1. Typical Control House Structure (L&D 14)

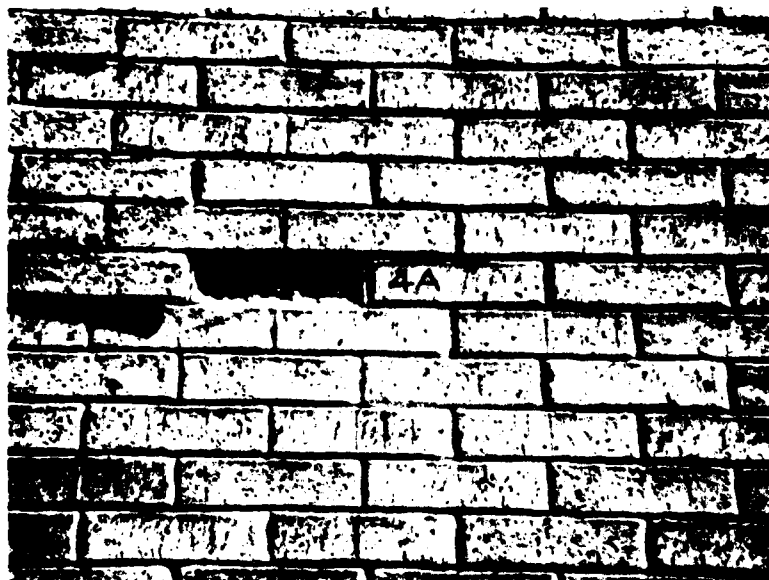
Photo 2. Typical Conditions-nondeteriorated; face popoff; intact face popoff. Control house structure (L&D 15)

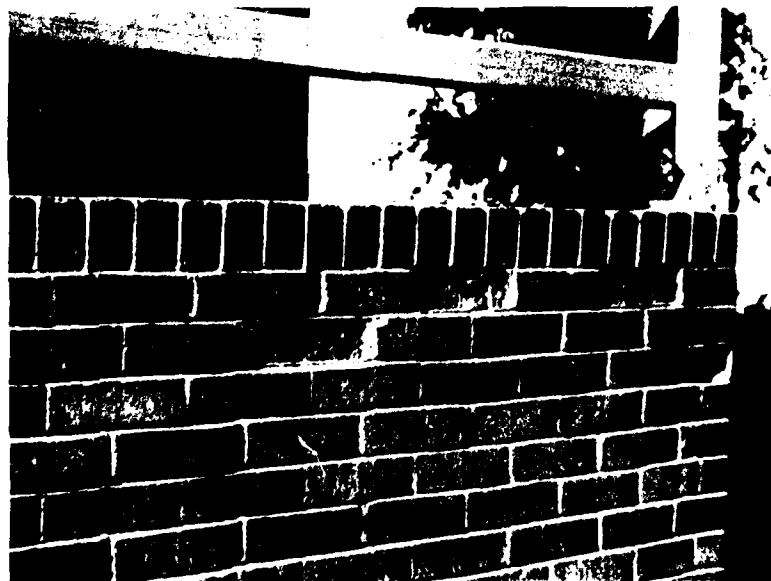
Photo 4. Typical conditions-visitor center (L&D 15)

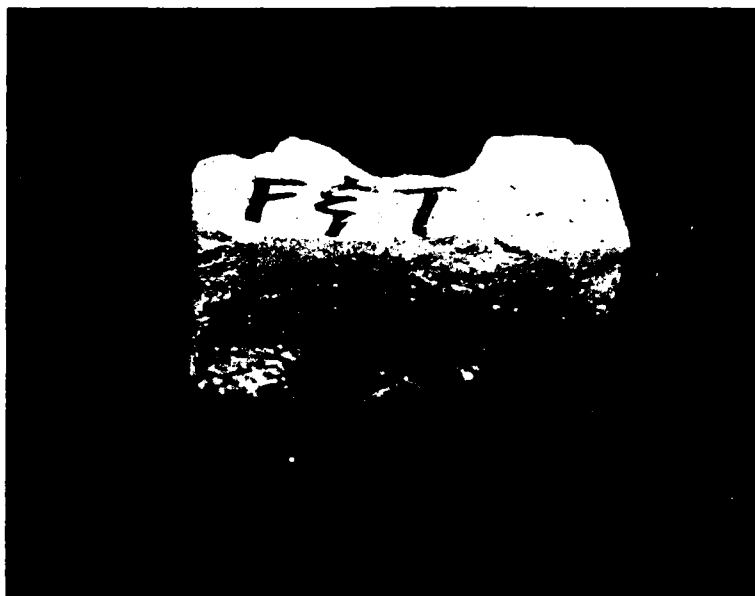
Photo 7. Sample  $2A_2$  - 50 cycles F-T

12. The results show that the F-T test duplicated, in varying degrees, the deterioration taking place in the structures. The only specimens not showing face splitting were 2A<sub>2</sub>, 6A, and 13B<sub>2</sub>. The other specimens all showed cracking or layer separation or both. Specimen 9A<sub>2</sub> suffered a complete separation of a 1/4-in. layer from the face. Several of the others lost portions of the face and nearly all had several layer separations parallel to the face of the specimen. The layers all appear to be approximately 1/8-in. to 5/16-in. thick and will eventually lead to complete disintegration of the brick if some protective mechanism is not implemented.

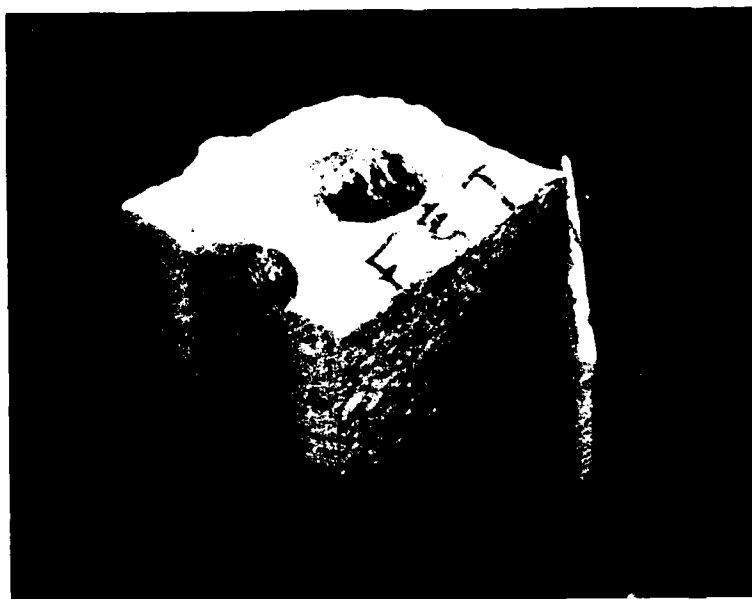
Photo 11. Sample  $9A_2$  - 50 cycles F-T

| Specimen<br>No. | Weight<br>Loss<br>Percent | Remarks |
|---|---|---|
| 9A <sub>2</sub> | 5.70 | Face cracked at Cycle No. 14<br>Face-layering very pronounced at Cycle No. 18 |

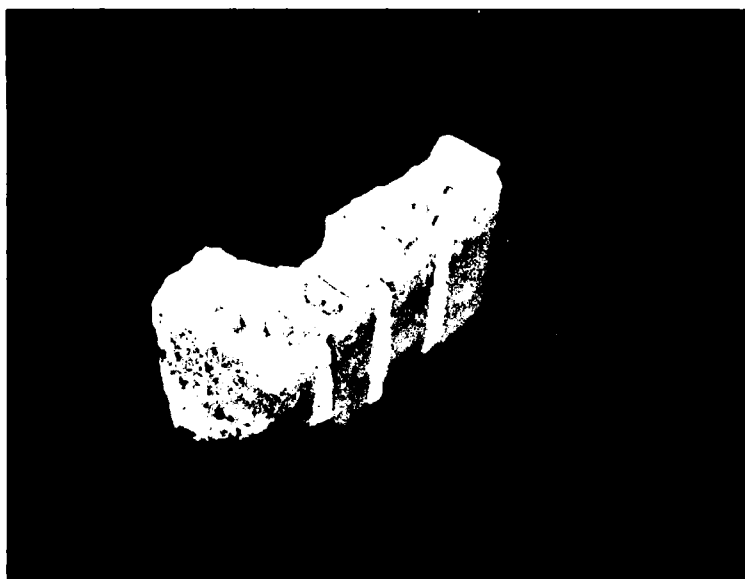
Photo 16. Sample 13B<sub>2</sub> - 50 cycles F-T  
(back face of brick tested)

- (a) See Photos 5-17 for "before" and "after" conditions of each specimen tested.
- (b) Specimen 13B<sub>2</sub>: Back face of brick was used as test face due to destruction of front face in removal.

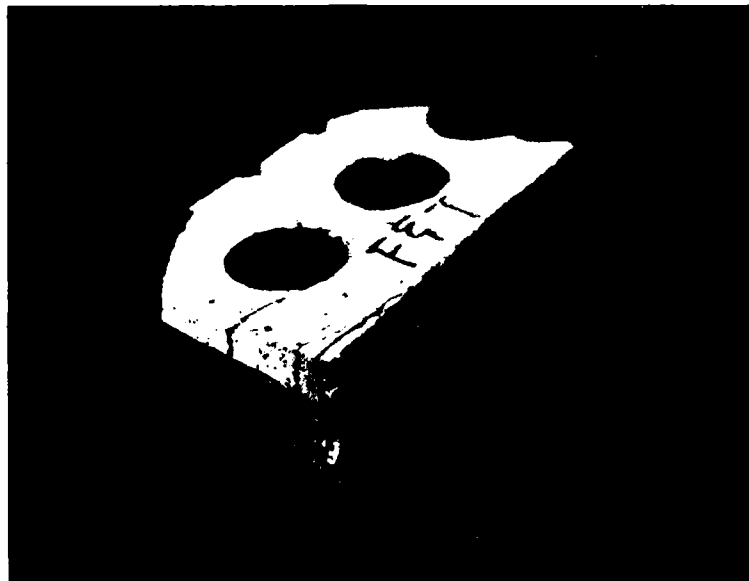
Photo 17. Sample 14A<sub>2</sub> - 50 cycles F-T

| Specimen<br>No. | Weight<br>Loss<br>Percent | Remarks |
|---|---|---|
| 14A <sub>2</sub> | 0.68 | Middle cracked at Cycle No. 10<br>Face-Layering at Cycle No. 23 |

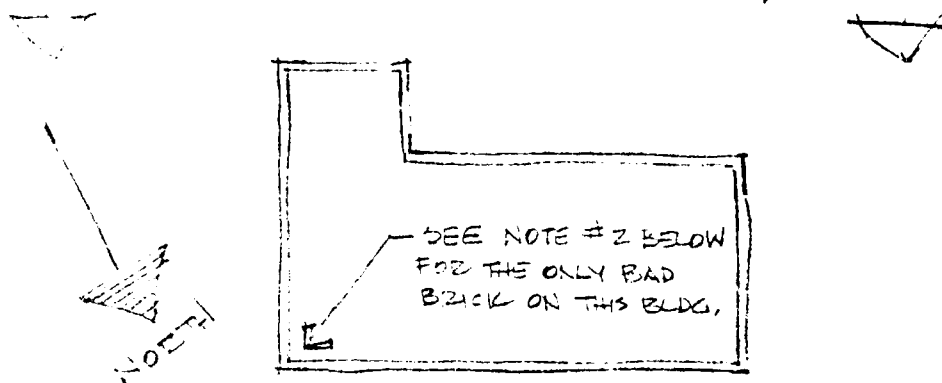
FOUR VIEW OF LOCK CONTROL BLDG.

1. OUTSIDE FACE OF BLDG. APPEARED TO BE SOUND.
2. ABOUT 6 OR 7 BAD BRICK WERE NOTED ON THE INSIDE FACE OF PARAPET AS INDICATED ABOVE.
3. PAINT & OIL BLDG IS O.K.
4. UPSTREAM CONTROL SHELTER (RIVERWALL) IS O.K.

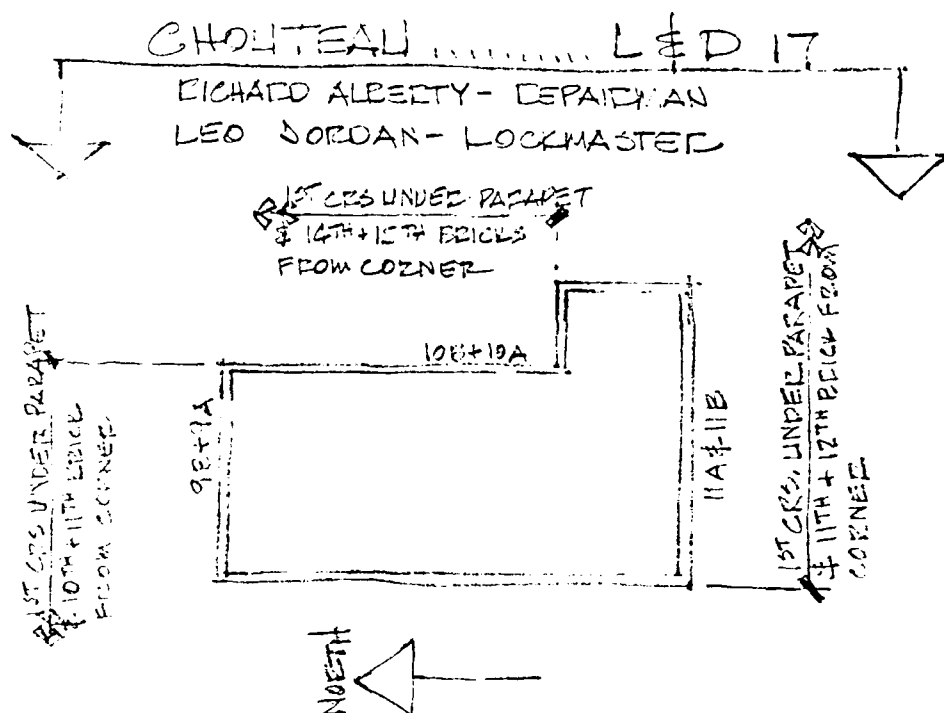
### PLAN VIEW OF LOCK CONTROL BLDG.

1. PAINT & OIL STORAGE BLDG APPEARS OK
2. CONTROL CHESTER (UPSTREAM) APPEARS OK BUT MANY BRICKS ARE DISCOLORED, THIS CLEARLY INDICATES THE PRESENCE OF MOISTURE. THERE IS NO PATTERN TO THE DISCOLORED BRICK. ONE BAD BRICK WAS NOTED AT THE NW CORNER OF BLDG.
3. CONTROL CHESTER (DOWNSTREAM) SHOWS NO BAD BRICK BUT SAME DISCOLORING AS NOTE #2.
