ATLANTIC COASTAL BASIN  
NORTH BRANCH OF FORKED RIVER  
OCEAN COUNTY  
NEW JERSEY

# PARKER STREET DAM

PHASE 1 INSPECTION REPORT  
NATIONAL DAM SAFETY PROGRAM

REPT. NO.: DAEN/NAP-53842/NJ00055-81/05

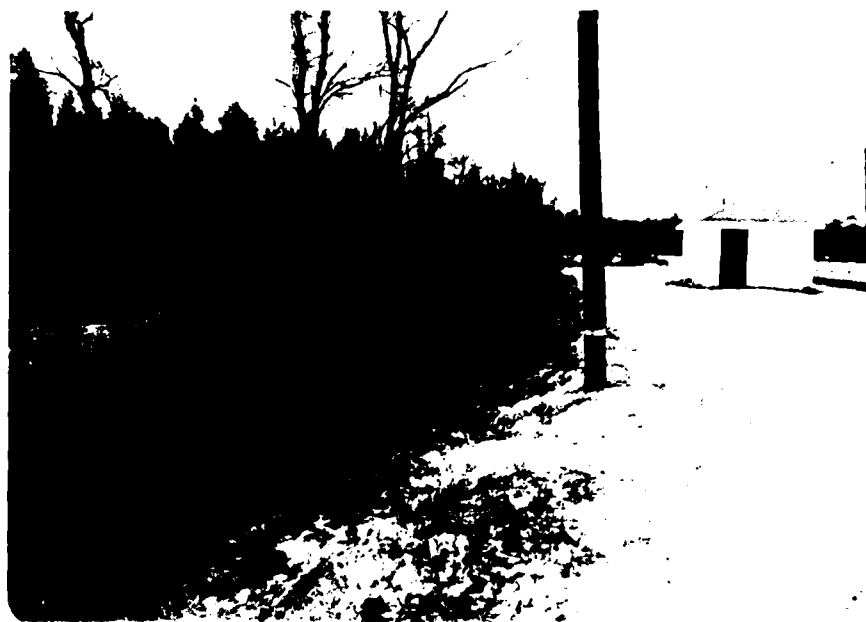
Photo 9 - View of downstream slope at left end of dam.  
(Photo taken January 14, 1981).

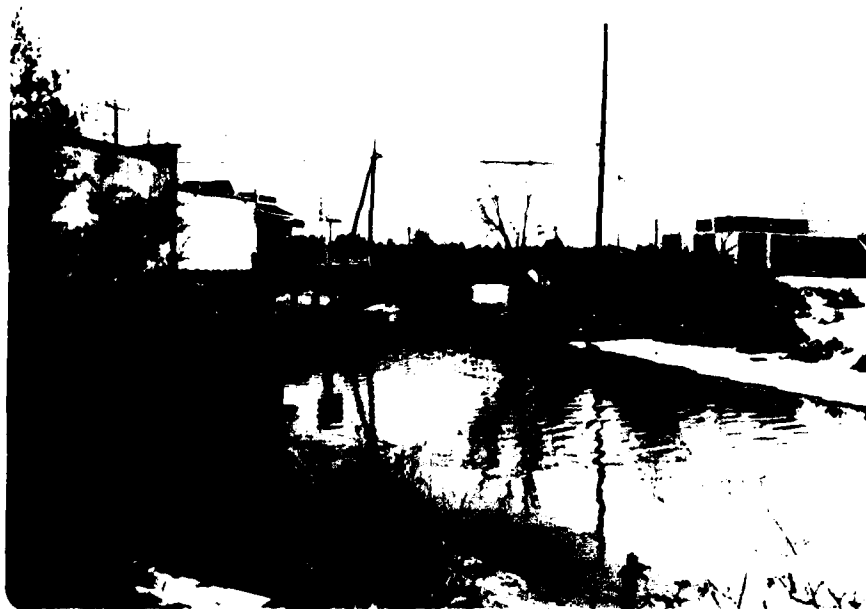
Photo 13 - View of downstream channel at U.S. Route 9 crossing.  
(Photo taken January 14, 1981).

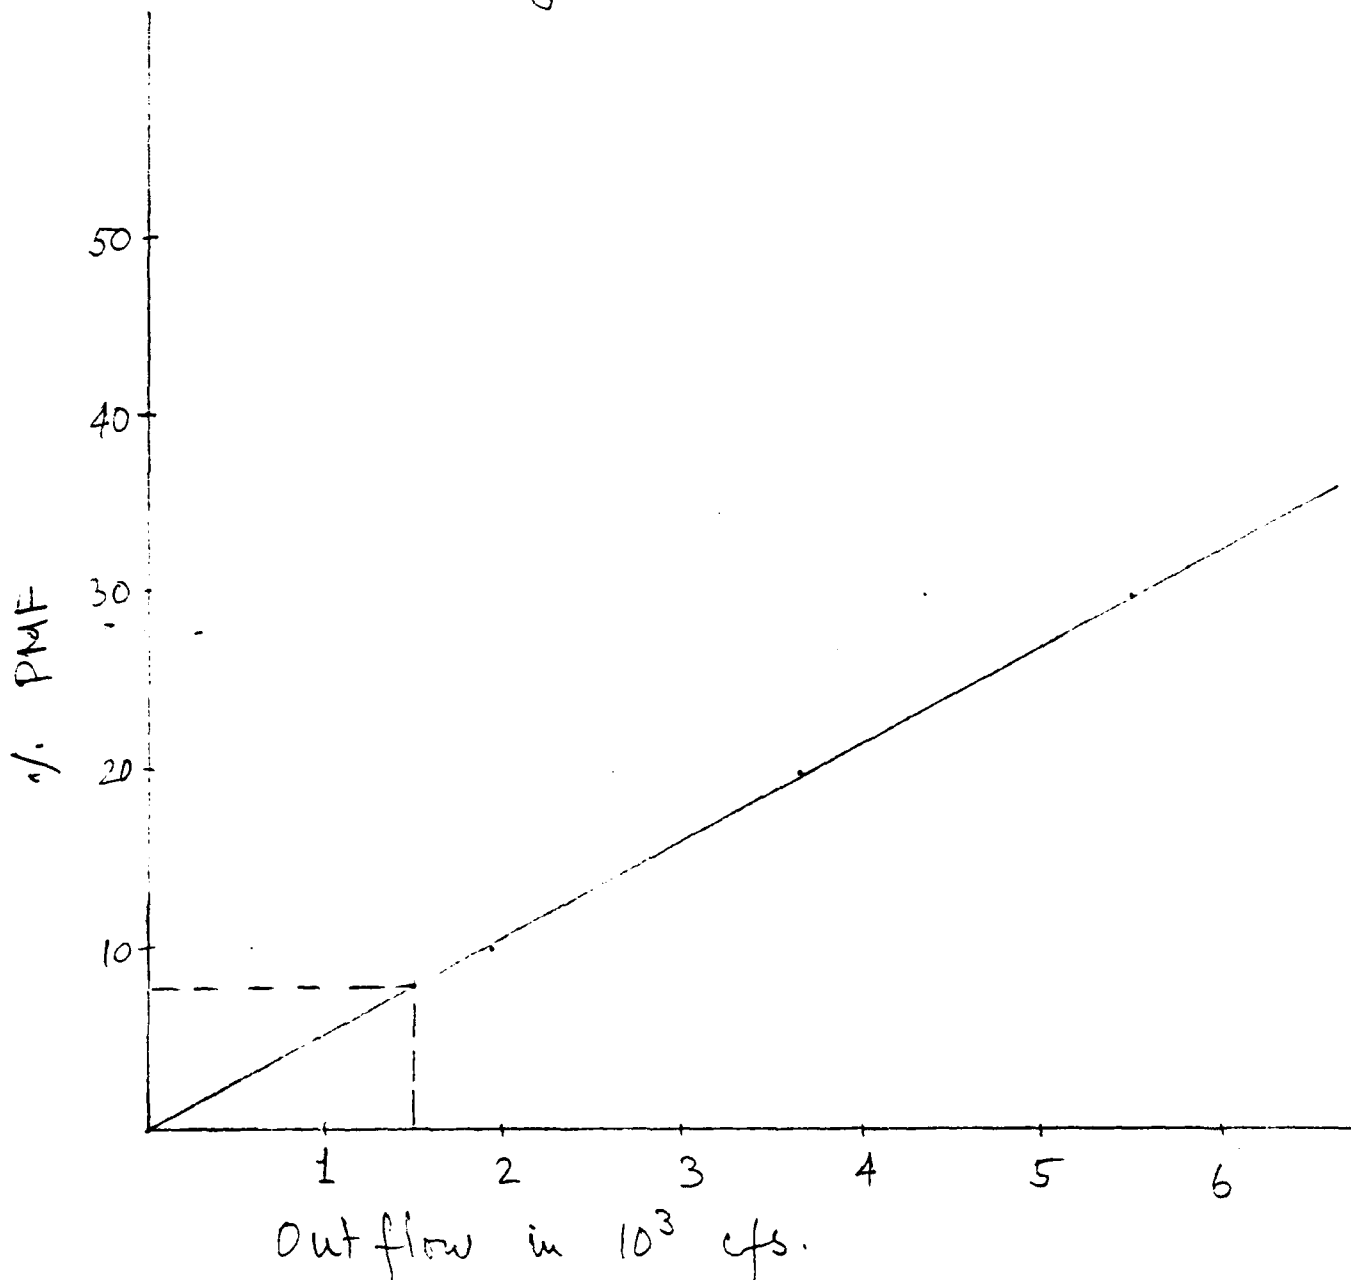
Overtopping of Dam occurs at  $El = 10.00$   
&  $= 1513$  (8 % at PMF)
