# WATCHUNG LAKE DAM

## NJ 00767

PHASE 1 INSPECTION REPORT  
NATIONAL DAM SAFETY PROGRAM  
DAEW61-79-C-0011

JULY 1981

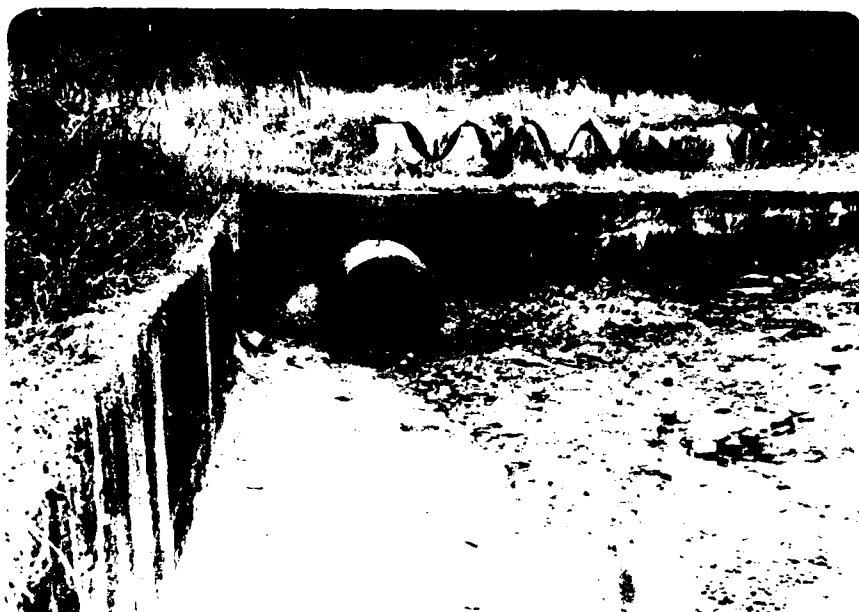
The low-level outlet operating facilities consists of the one manually operated 30-inch gate valve. At the time of inspection, operation of the valve was not demonstrated and it was leaking slightly as there was water running out of the pipe.

Photo 7 - View of 30-inch R.C.P., low-level outlet, and concrete barrier curbs used for slope reinforcing.

(6) Determine if the low-level outlet valve is operable, and if not, make repairs as necessary.
