BLUE GIANT MEADOW DAM

NDI ID No. PA-00564  
DER ID No. 40-80

PHASE I INSPECTION REPORT  
NATIONAL DAM INSPECTION PROGRAM

APRIL 1981

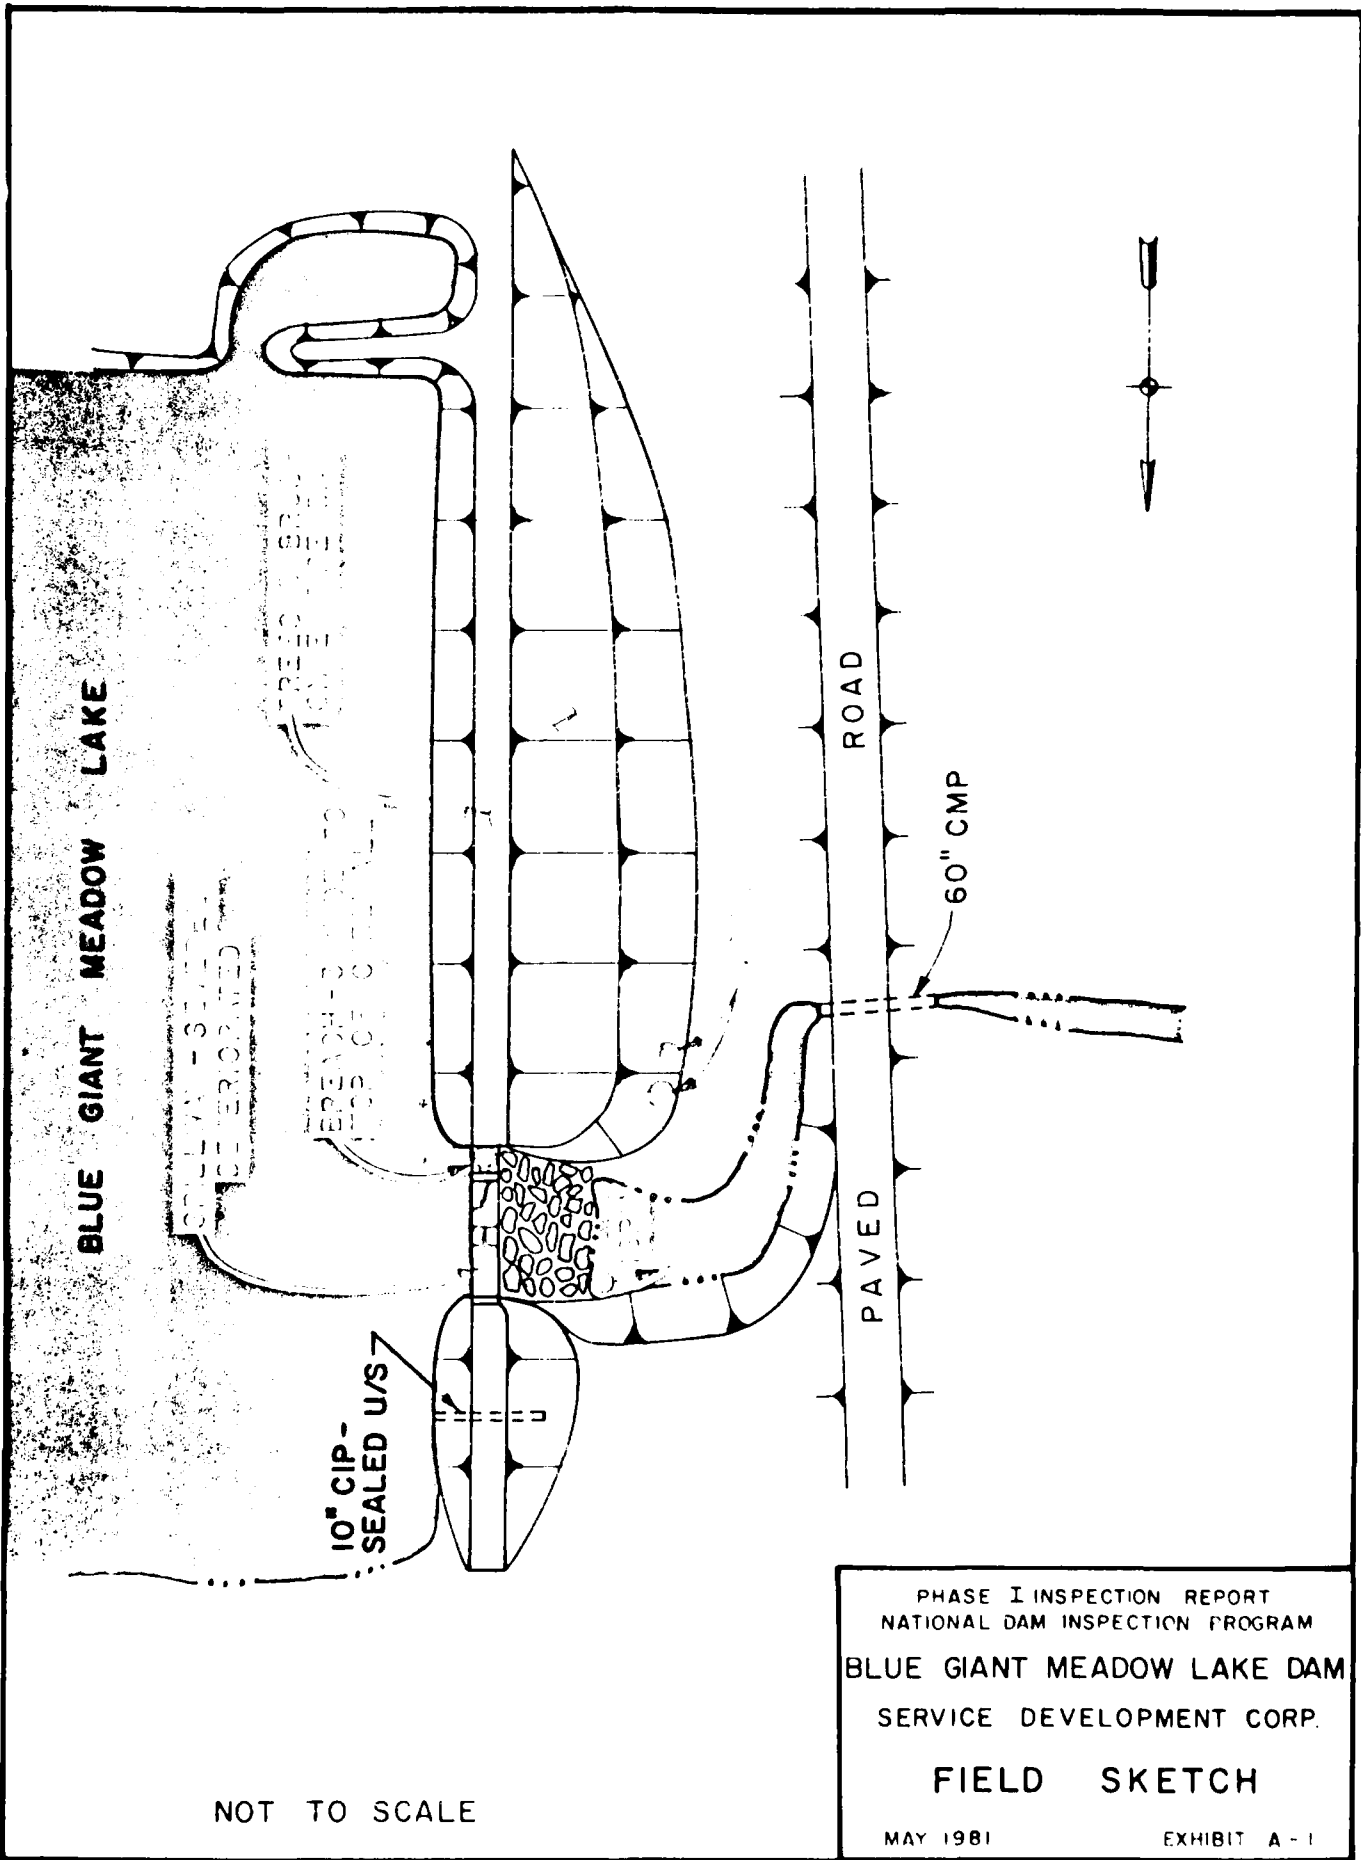
PHASE I INSPECTION REPORT  
 NATIONAL DAM INSPECTION PROGRAM  
 BLUE GIANT MEADOW LAKE DAM  
 SERVICE DEVELOPMENT CORP.  
 FIELD SKETCH  
 MAY 1981 EXHIBIT A-1

VISUAL EXAMINATION OF	OBSERVATIONS
Any noticeable seepage	About 1 gpm near toe of spillway; clear
Junction of Embankment With: Abutments Spillway	Abutment junctions good. Low spots adjacent to spillway walls eroded to top of corewall
Surface Cracks	None observed; excessive vegetation made thorough inspection impossible
Crest Alignment: Vertical Horizontal	Low spot adjacent to left spillway wall. Also low at right wall. Elsewhere rising toward abutments Horizontal - Good
Unusual Movement or Cracking at or Beyond the Toe	None. Variable slope & vegetation made inspection difficult

VISUAL EXAMINATION OF	OBSERVATIONS
Outlet Works	None apparent. Original rock culvert through spillway not found. 10 inch C.I.P plugged u/s.
Spillway Approach Channel	Reservoir; clear
Spillway Crest	Concrete surface deteriorating; top 6" gone in some areas. 2' wide x 4' deep breach through crest; plugged by 8" thick concrete. Walls being undercut and flanked.
Bridge and Piers	None
Discharge Channel	Rock pile on d/s side of crest; then earth lined. No spillway walls d/s of crest.

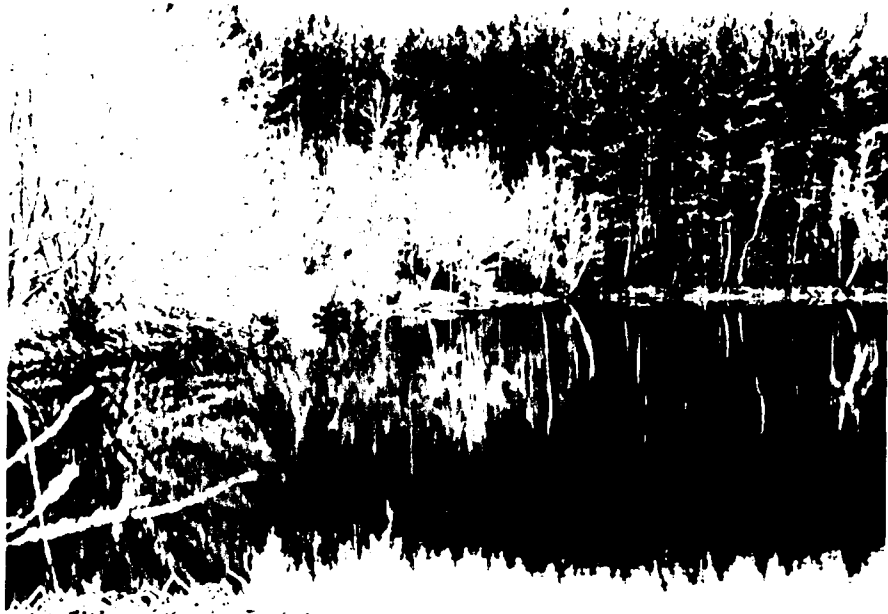
1. Upstream face and right abutment.

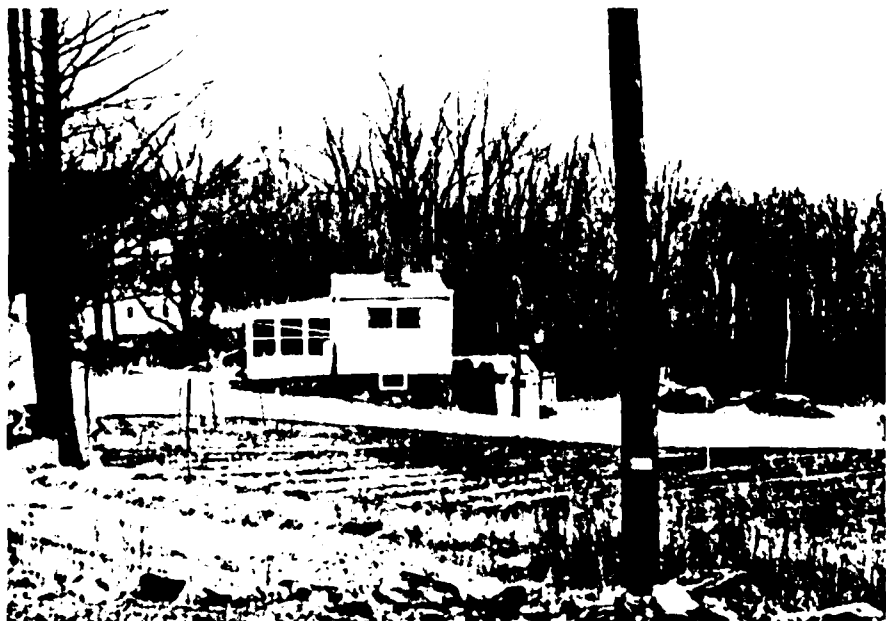
12. Downstream hazard.

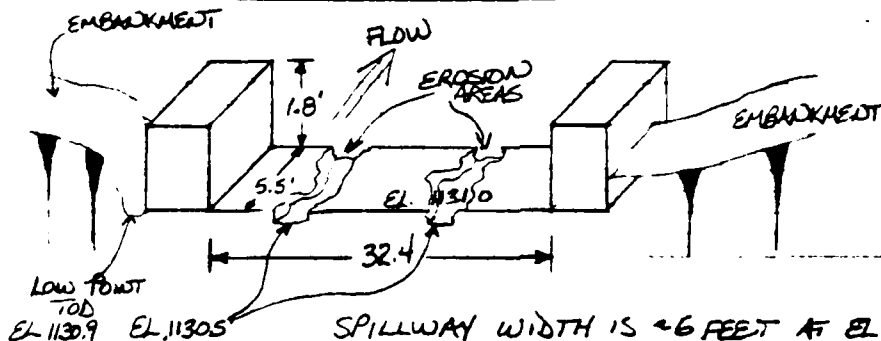
SPILLWAY SKETCH:

SPILLWAY WIDTH IS ~ 6 FEET AT EL. 1130.5 WITH 0.4 FEET FREEBOARD PRIOR TO OVERTOPPING LOW POINT OF EMBANKMENT. AT ELEVATION 1130.9, SPILLWAY WIDTH IS ORIGINAL VALUE OF 32.4 FEET PRIOR TO EROSION IN CONCRETE PAD.

NOTE: SEE PHOTOGRAPHS IN APPENDIX C. THESE EROSION CHANNELS HAVE CREATED A LOW FLOW NOTCH IN THE SPILLWAY.
