National Dam Inspection Program, Pocono
Woodland Lake Dam (NDI I.D. Number
PA-00443, PennDER I.D. Number 52-179),
Delaware River Basin, Branch of Raymond-
skill Creek, Pike County, Pennsylvania.
Phase I Inspection Report,

PHASE I INSPECTION REPORT
NATIONAL DAM INSPECTION PROGRAM

Pocono Woodland Lake Dam: NDI I.D. No. PA-00443

Inspection Date: 12 November 1980

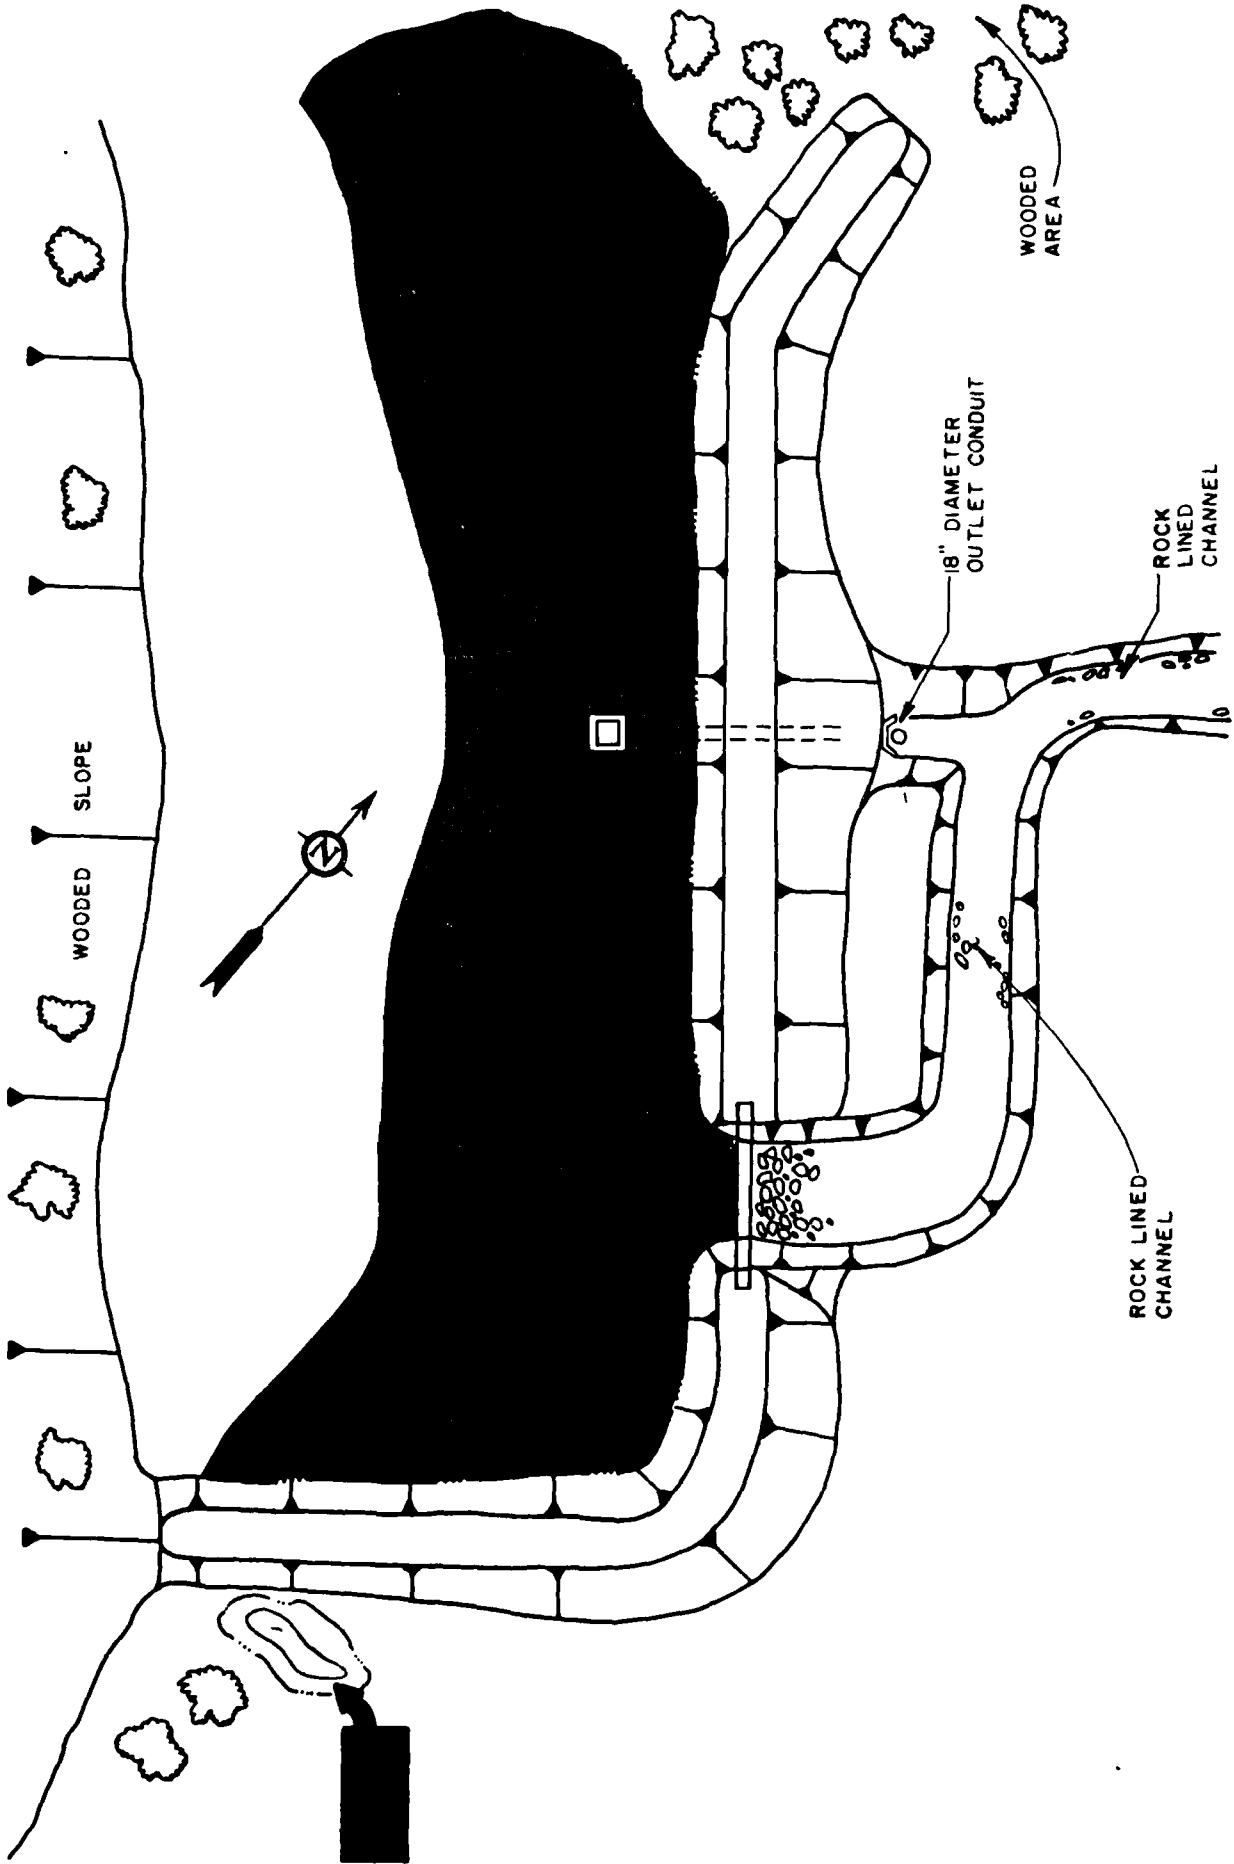
POCONO WOODLAND LAKE DAM
GENERAL PLAN-FIELD INSPECTION NOTES

ITEM	OBSERVATIONS/REMARKS/RECOMMENDATIONS	NDI# PA. 00443
DAMP AREAS IRREGULAR VEGETA- TION (LUSH OR DEAD PLANTS)	Poor drainage of surface water near downstream embankment at south end of dam causing minor ponding. Not significant, but should be reshaped to drain into diversion ditch.	
ANY NOTICEABLE SEEPAGE	None observed.	
STAFF GAGE AND RECORDER	None.	
DRAINS	None observed.
