N.J. NO NAME  
DAM NO. 51  
NJ 00823

PHASE 1 INSPECTION REPORT  
NATIONAL DAM SAFETY PROGRAM

REPT. NO: DAEN/NAP-53842/NJ00823-81/03

MARCH 1981

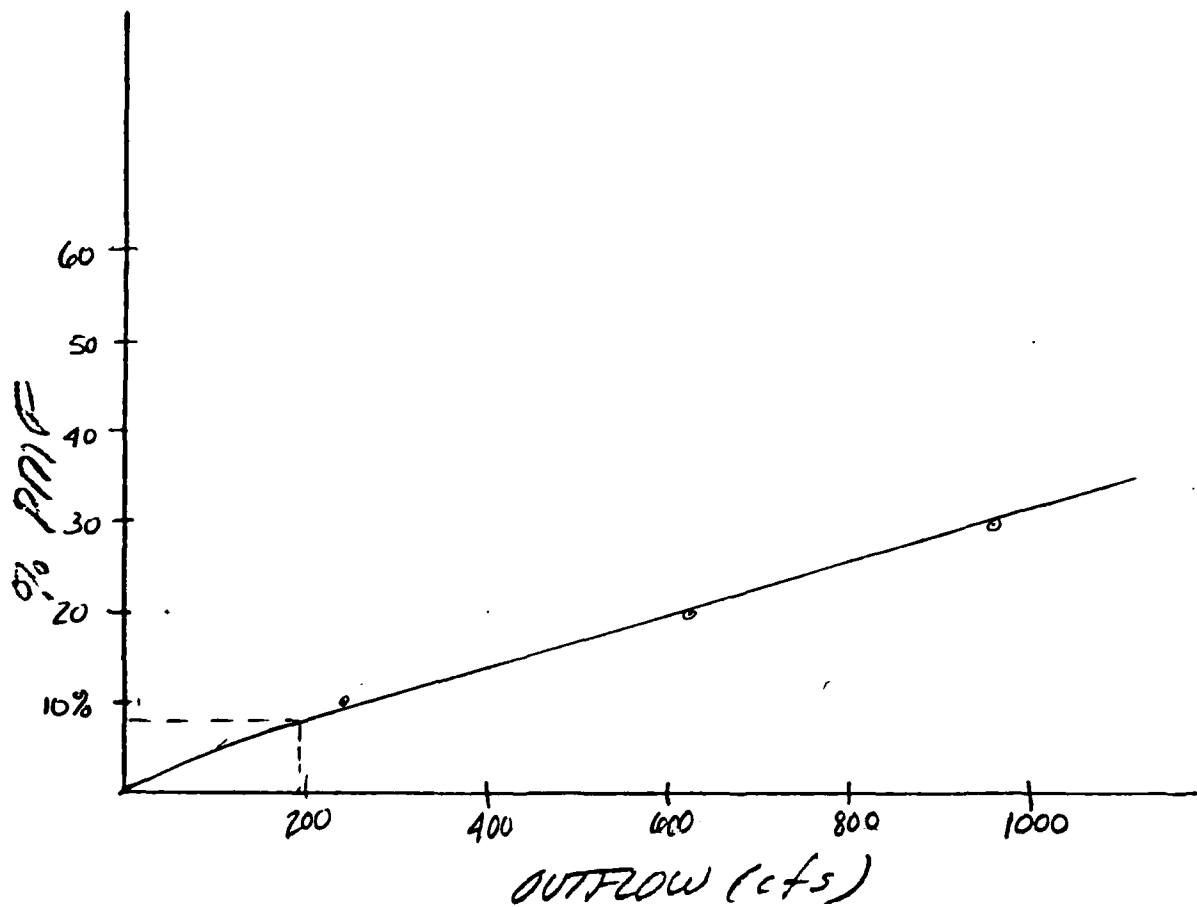
## OVERTOPPING POTENTIAL

- 3) Dam overtops at elevation 100.15 with  $Q = 194$  cfs  $\therefore$  dam can pass approx. 8 % of the PMF
