**SUNSET LAKE  
RACEWAY DAM  
NJ 00764**

**PHASE 1 INSPECTION REPORT  
NATIONAL DAM SAFETY PROGRAM**

Sunset Lake Raceway Dam (NJ00764).  
Delaware River Basin, Cohansey River,  
Cumberland County, New Jersey. Phase  
I Inspection Report.

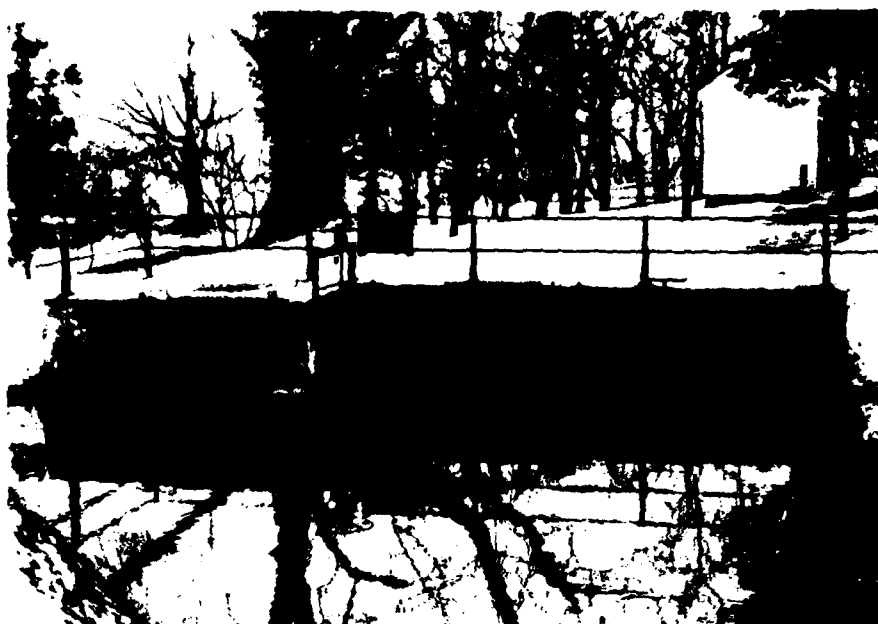
PHOTO 1  
SPILLWAY AT DOWNSTREAM END OF RACEWAY (STA 0+0)

- 2) Spalled and deteriorated surfaces of the spillway structure should be repaired.
- 3) The twin discharge culverts for the spillway should be renovated or replaced.
- 4) The railing along the spillway structure should be extended along the raceway to the road bridge.

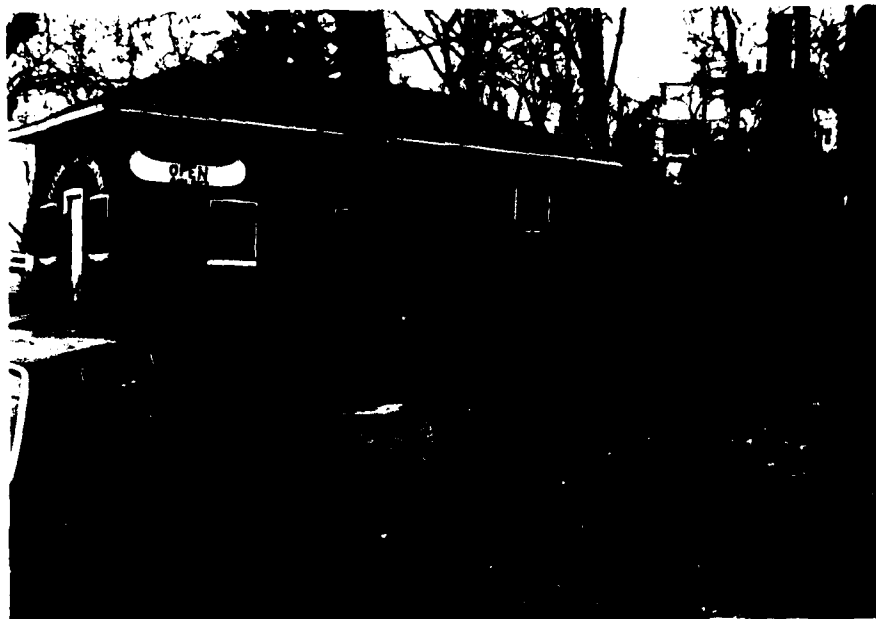
PHOTO 5  
DOWNSTREAM FACE OF EMBANKMENT AT PARK BUILDING  
(APPROX. STA 1+0)

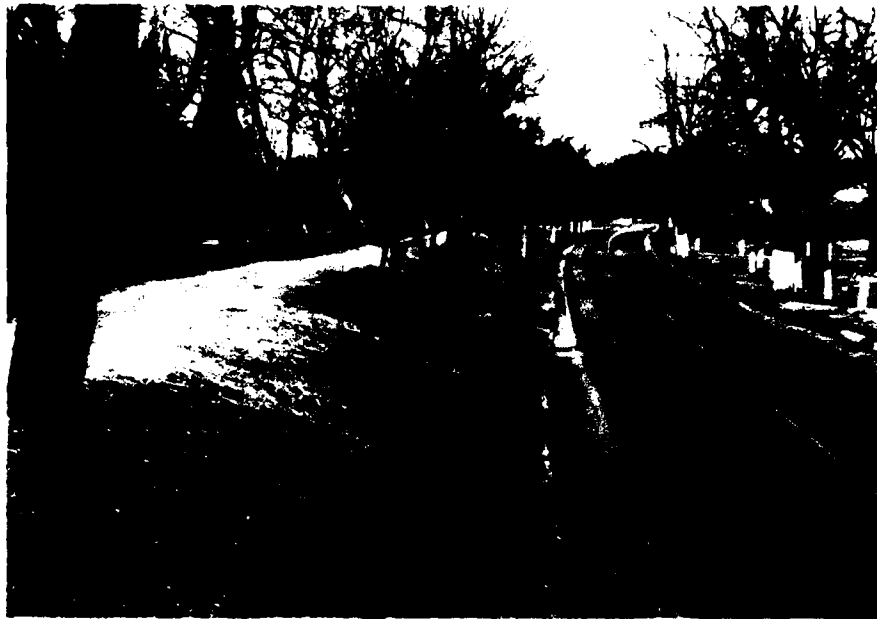
PHOTO 7  
DOWNSTREAM FACE OF EMBANKMENT (APPROX. STA 11+0)

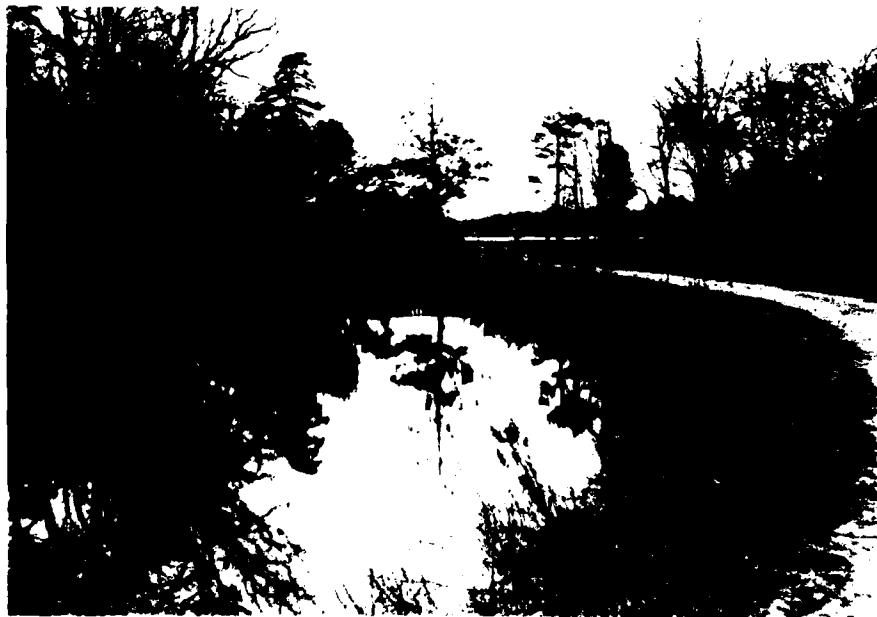
PHOTO 8  
UPSTREAM FACE OF EMBANKMENT IN VICINITY OF ENTRANCE  
FROM SUNSET LAKE
