DELAWARE RIVER BASIN  
WELDON BROOK, MORRIS COUNTY  
NEW JERSEY

**N.J. NO NAME  
NO. 30 DAM  
NJ 00339**

**PHASE 1 INSPECTION REPORT  
NATIONAL DAM SAFETY PROGRAM**

JULY 1981

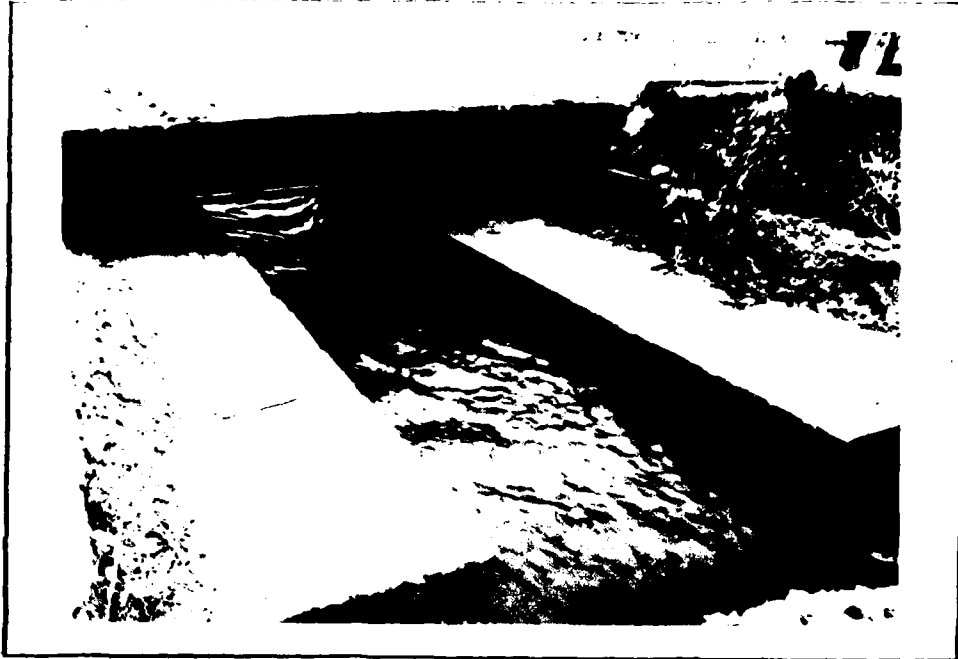
| <u>VISUAL EXAMINATION OF</u> | <u>OBSERVATIONS</u> | <u>REMARKS OR RECOMMENDATIONS</u> |
|---|---|---|
| CONCRETE WEIR | The weir is 10.5 feet wide.<br>Concrete is severely spalled and<br>rebars are exposed. | Concrete should be<br>repaired. |

3. VIEW OF THE SPILLWAY CREST AND ERODED CONCRETE ON THE  
DOWNSTREAM SIDE. (4/24/81)

8. The deteriorated concrete on the spillway should be repaired.
