**CEDAR LAKE DAM**

**NJ 00805**

PHASE 1 INSPECTION REPORT  
NATIONAL DAM SAFETY PROGRAM

REPT. NO. DAEN/NAP-53842/NJ00805-81/05

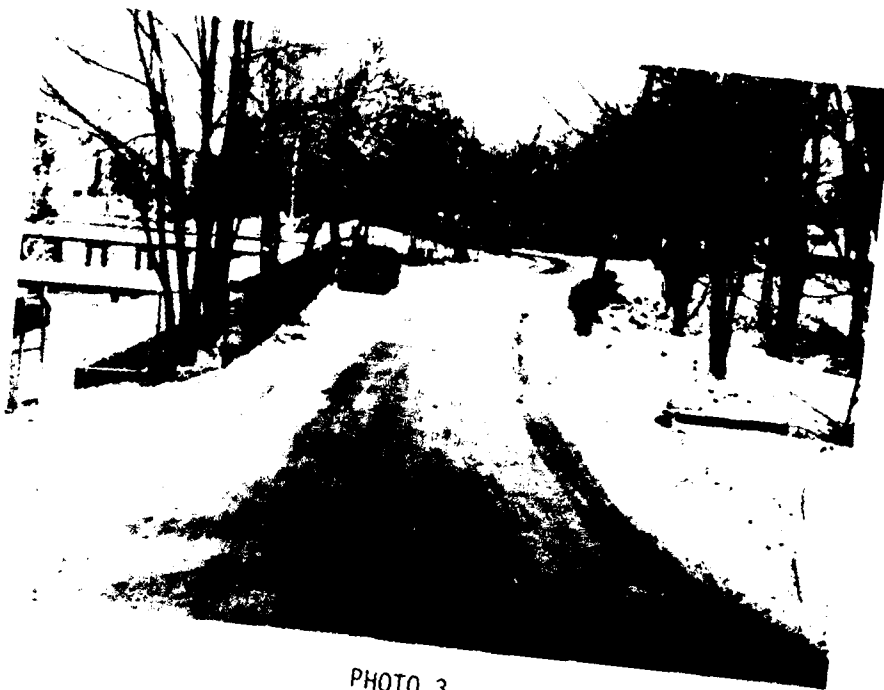
The paved roadway on the crest was in satisfactory condition. The timber docks and boardwalk area were all in good condition. A chain link fence extending along the upstream side of the roadway was in good condition. Immediately upstream from the fence decorative shubbery and a few trees ranging in size from 6 inches to 18 inches were observed.

PHOTO 3  
CREST OF DAM

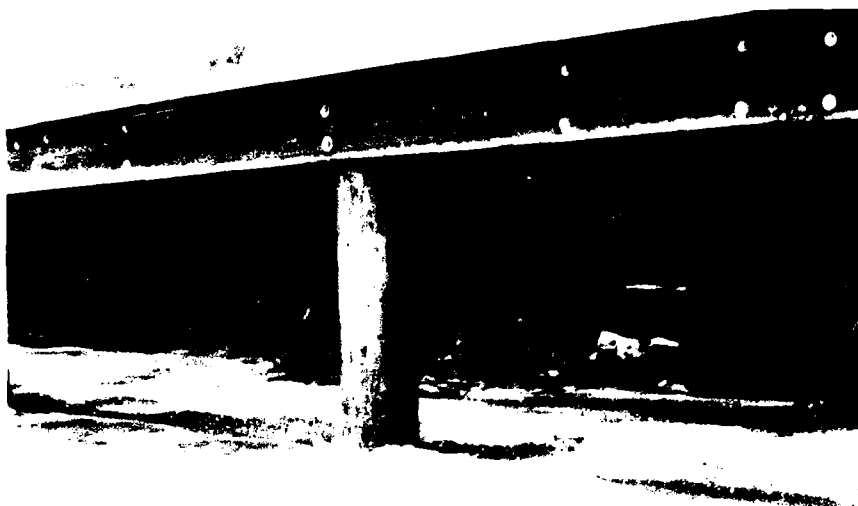
The timber walls forming the upstream side of the dam above the water line were in good condition. The downstream side of the dam was very irregular and consisted of an earth slope with trees, bushes and boulders. Also, fill was observed

PHOTO 5  
TIMBER WALL ON UPSTREAM SIDE OF DAM

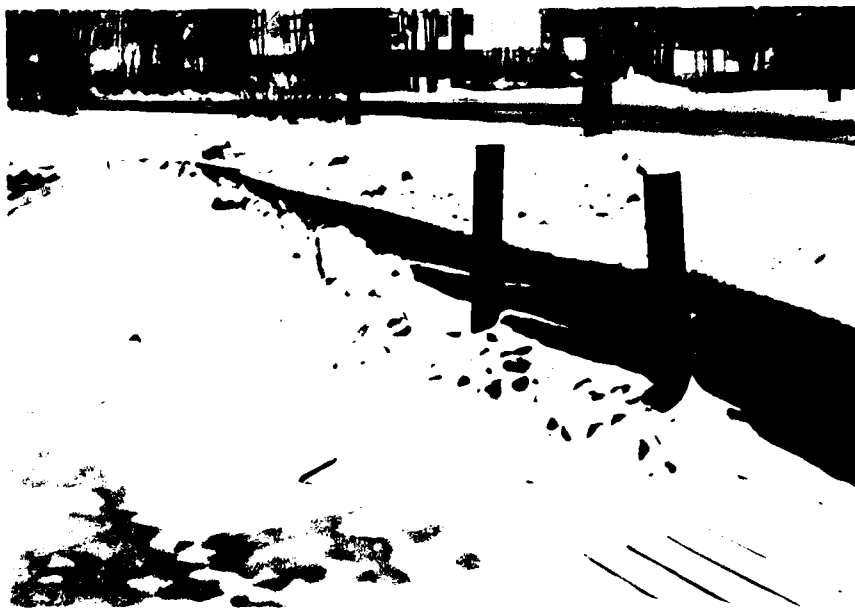
PHOTO 6  
TIMBER WALL AT LEFT END OF DAM
