DELAWARE RIVER BASIN  
MANTUA CREEK, GLOUCESTER COUNTY  
NEW JERSEY

# BETHEL LAKE DAM

## NJ00406

PHASE 1 INSPECTION REPORT  
NATIONAL DAM SAFETY PROGRAM.

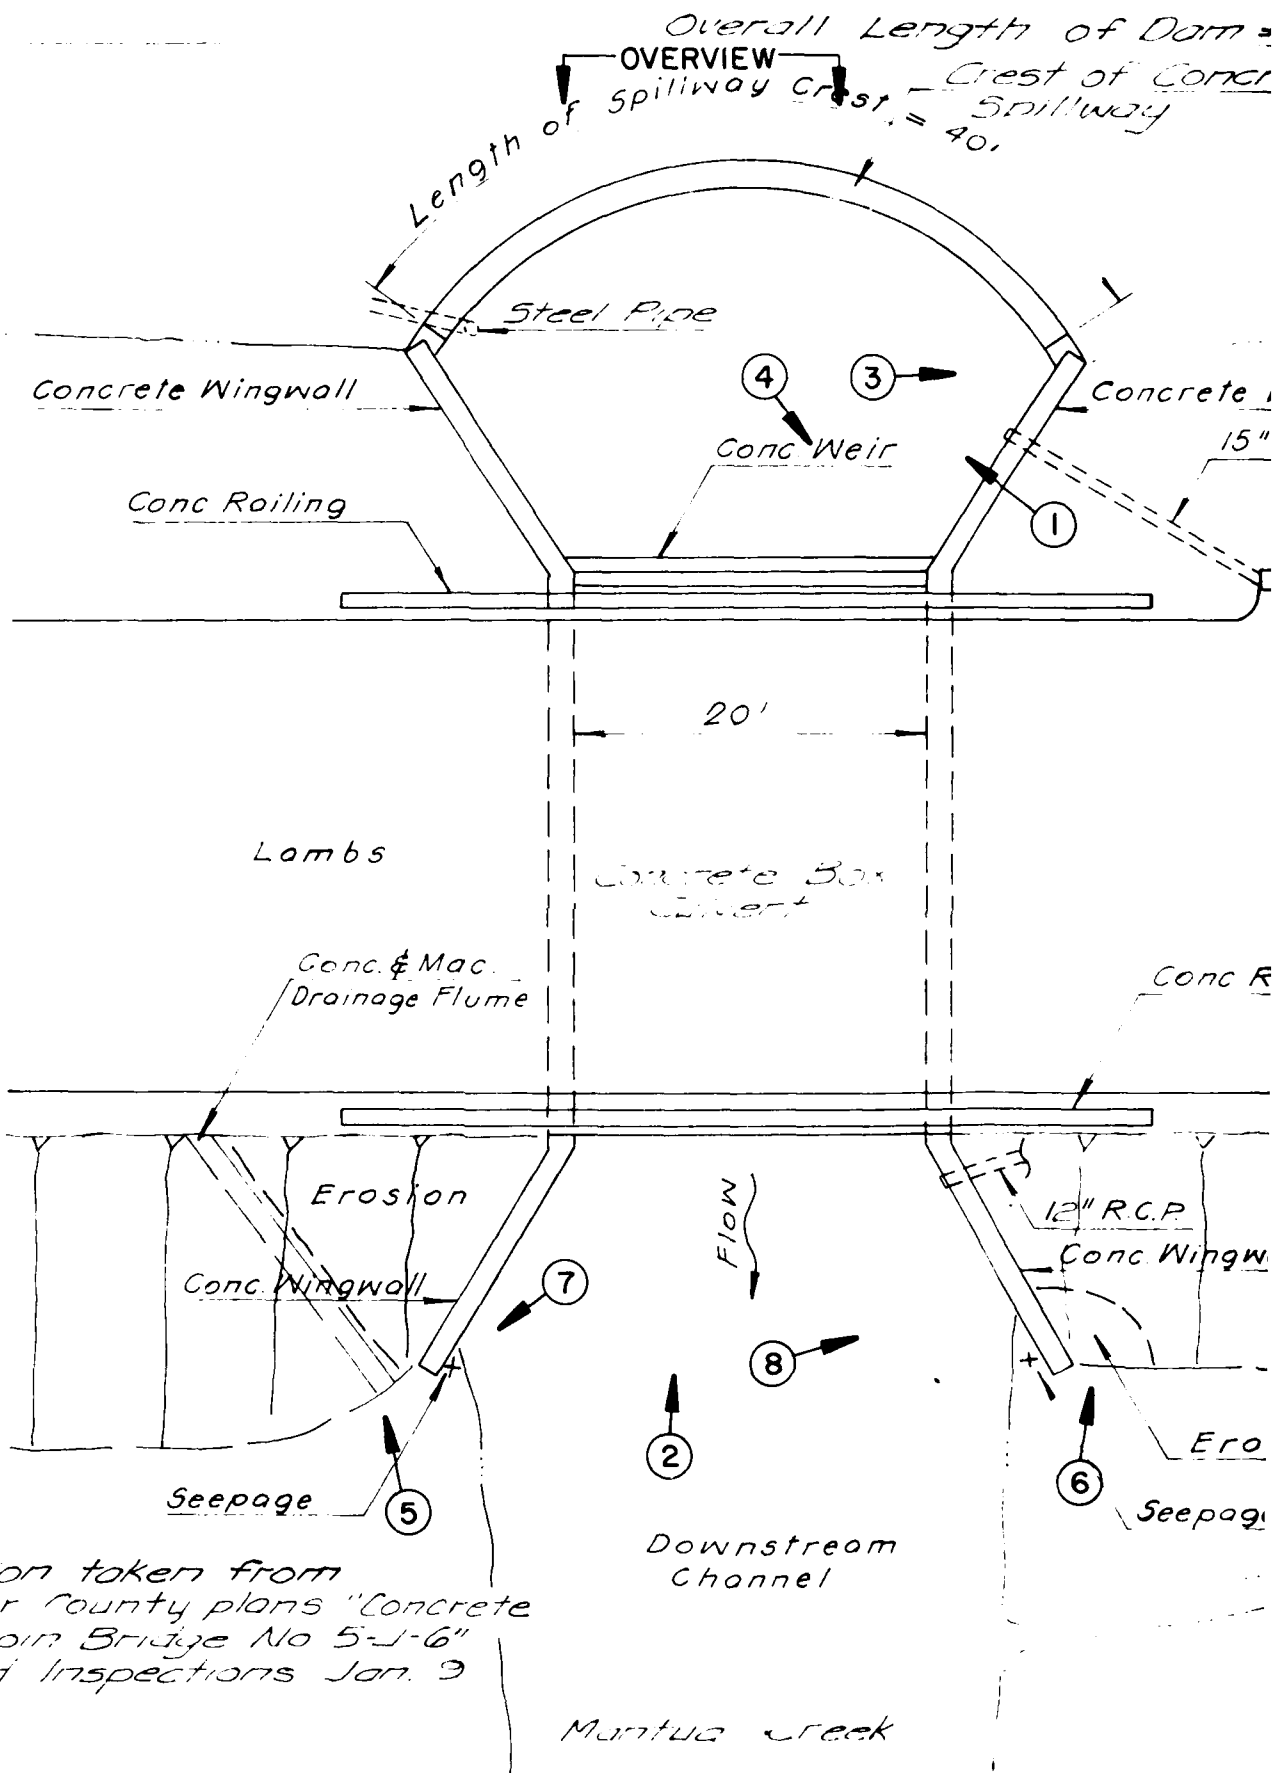
Erosion

Seepage

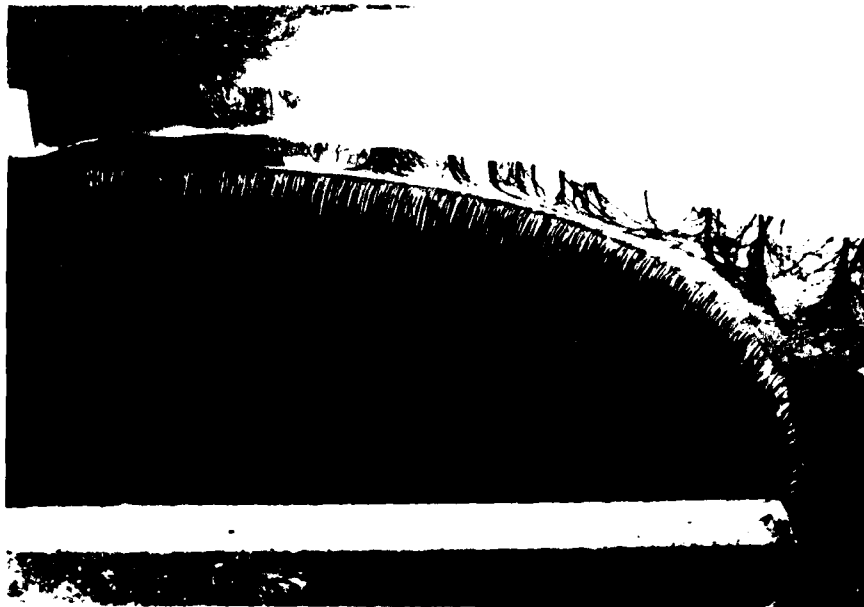
The crest of the horseshoe shaped concrete spillway appeared to be in satisfactory condition. The downstream face of the spillway could not be properly observed because it was obscured by overflow. No outlet works operating mechanism was observed.

| VISUAL EXAMINATION OF | OBSERVATIONS | REMARKS OR RECOMMENDATIONS |
|---|---|---|
| WEIR | Crest of weir appeared to be in satisfactory condition. Weir obscured by overflow. | Spillway structure should be inspected during non-overflow condition. |

PHOTO 1  
SPILLWAY

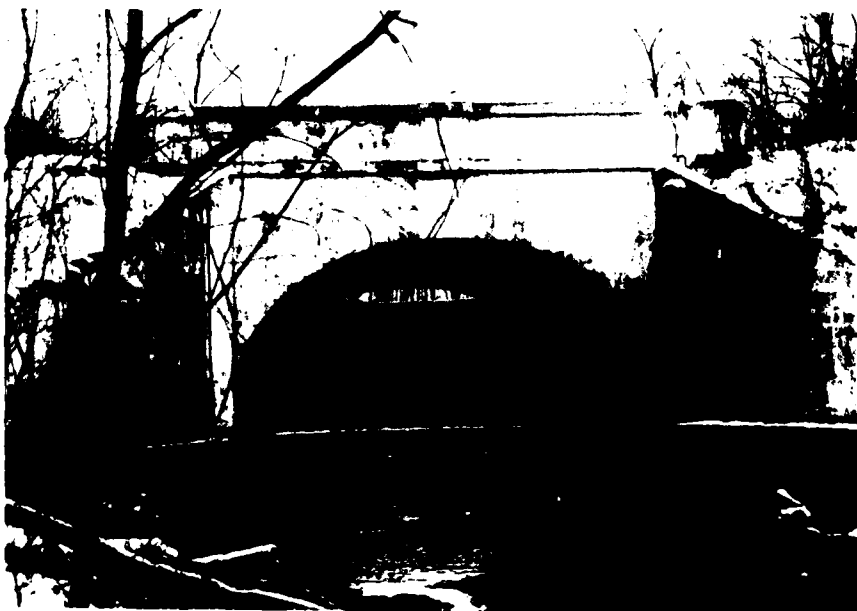
The arch culvert bridge appeared to be structurally sound on the downstream side with no significant cracks observed. The concrete surfaces in general appeared to be in satisfactory condition. Reinforcing steel was observed at the concrete surface within the culvert, apparently resulting from improper placement during construction.

PHOTO 2  
DOWNSTREAM VIEW OF BRIDGE AND SPILLWAY
