PASSAIC RIVER BASIN  
STONE HOUSE BROOK, MORRIS COUNTY  
NEW JERSEY

# LOWER KAKEOUT DAM NJ 00822

## PHASE 1 INSPECTION REPORT NATIONAL DAM SAFETY PROGRAM

REPT NO: DAEN/NAP-53842/NJ00822-81/07

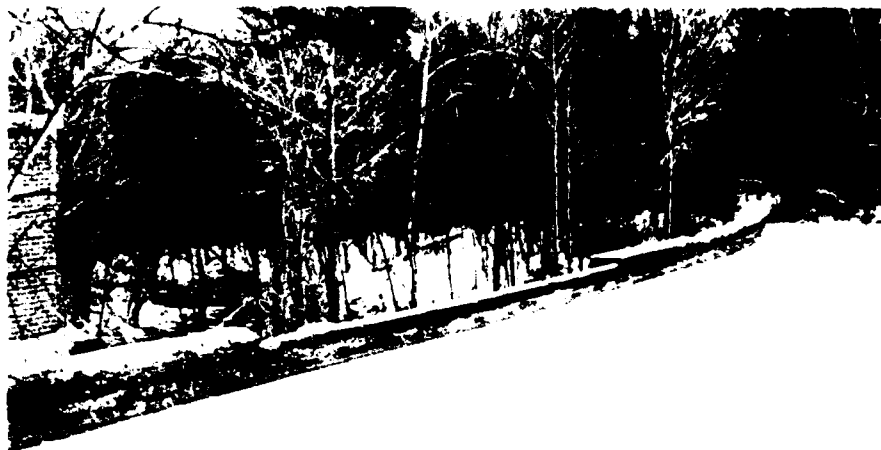
Some spalling could be observed along the upstream face of the dam between the crest and the water level, however, it did not appear to be as severe as the spalling on the downstream side. However, there were some points where it was 3 to 4 inches deep and the spalling tended to run along horizontal lines. There was one location on the downstream face approximately 15 feet to the right of the outlet structure where some ice was emerging from the downstream face. This indicated some very slow leakage. The point where the ice was emerging is a point where there was considerable incrustation and possible exudation.

PHOTO 1  
UPSTREAM SIDE OF DAM
