AFESC/ESL-TR-80-51

**FIELD TEST OF EXPEDIENT  
PAVEMENT REPAIRS  
(TEST ITEMS 16-35)**

**MICHAEL T. McNERNEY  
ENGINEERING RESEARCH DIVISION**

**NOVEMBER 1980**

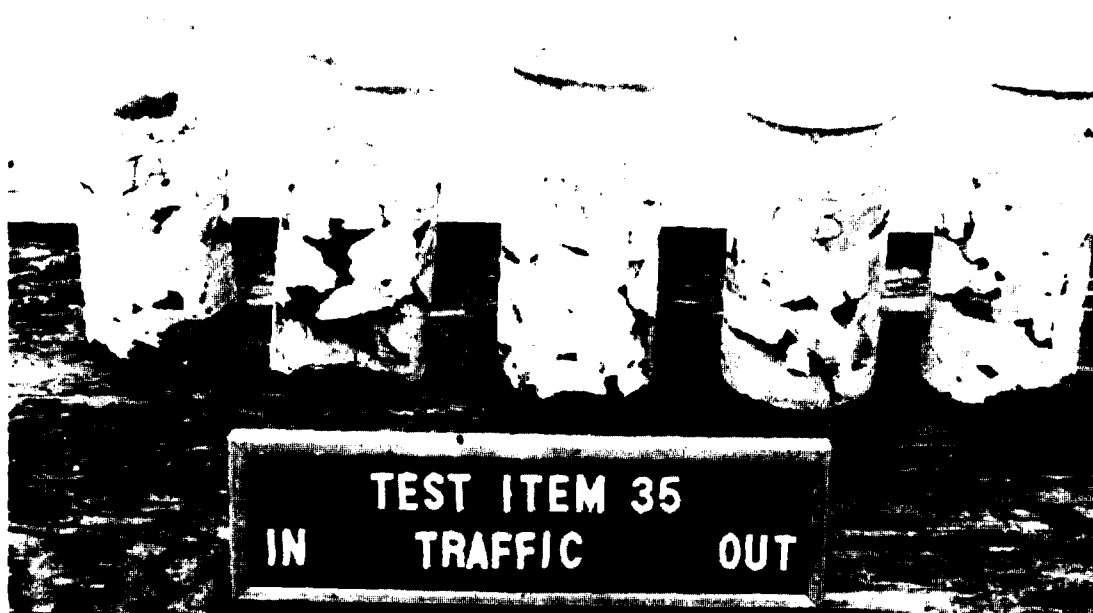
Figure 22. Core Samples

Flexing was severe enough to rule out C-141 traffic over the test pit. Core samples were taken and found to have monomer at the top and bottom with aggregate in between (Figure 22).

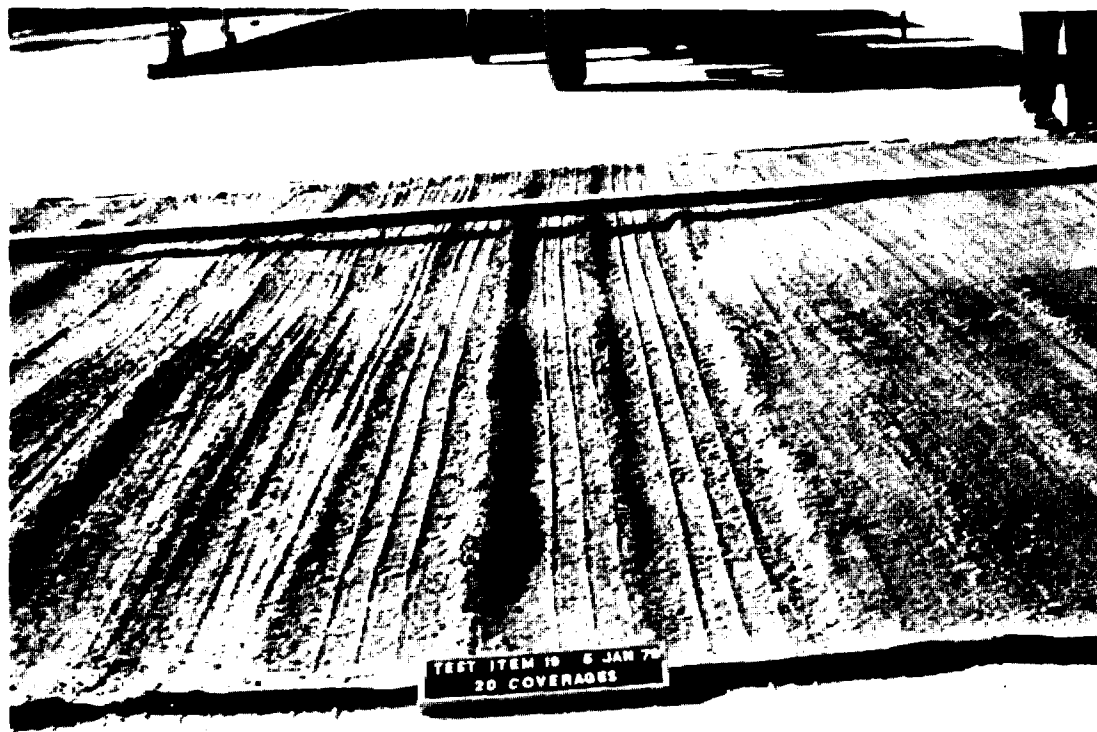
Figure 24. Surface Condition After 20 Coverages of the F-4 Load Cart

(3) Results. During the first coverage of the F-4 load cart, surface flooding was observed and a pumping effect occurred as the load cart passed over the surface. The surface showed ruts of approximately 0.75 inch, and crushed limestone tended to be pushed out of the test pit. After 20 coverages, consolidation of 2.4 inches was measured in the traffic lane (Figure 24). Traffic was halted, and density readings were obtained.

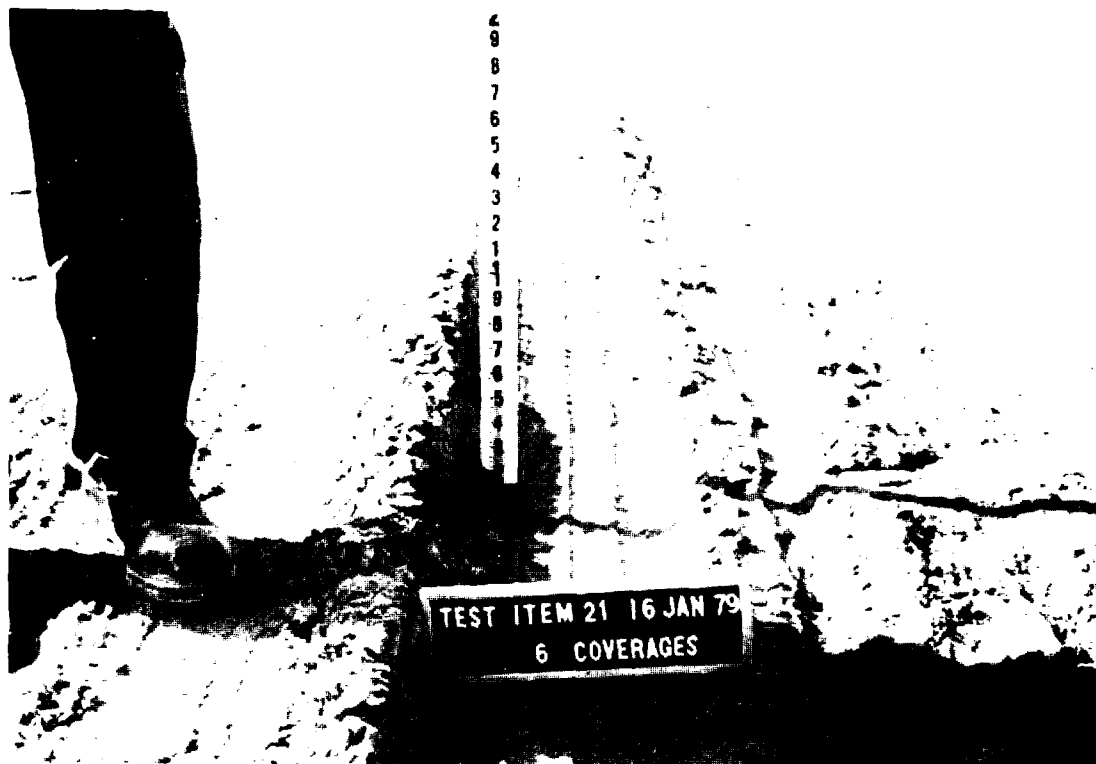
Figure 29. Second Failure After Repairing Test Item 21

Though considered a failure according to Corps of Engineers criteria, the test was continued by adding more crushed stone and compacting with 12 additional coverages. Six coverages of the 1-4 load cart resulted in a second failure of the test item (Figure 29).

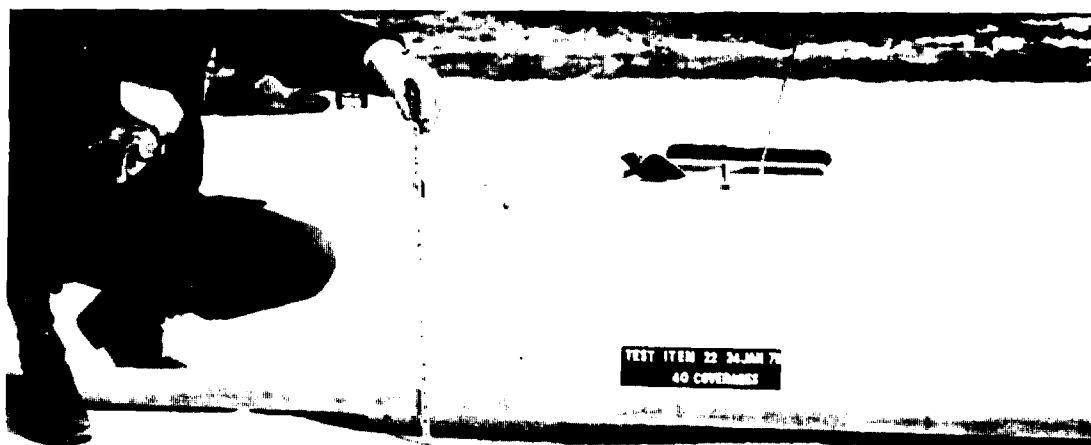
Figure 31. Consolidation of Surface After 40 Coverages, Test Item 22

(3) Results. After 40 coverages with the F-4 load cart, repairs became necessary when the load cart encountered difficulty entering and exiting the pit due to consolidation of 2.25 inches in the traffic lane (Figure 31).

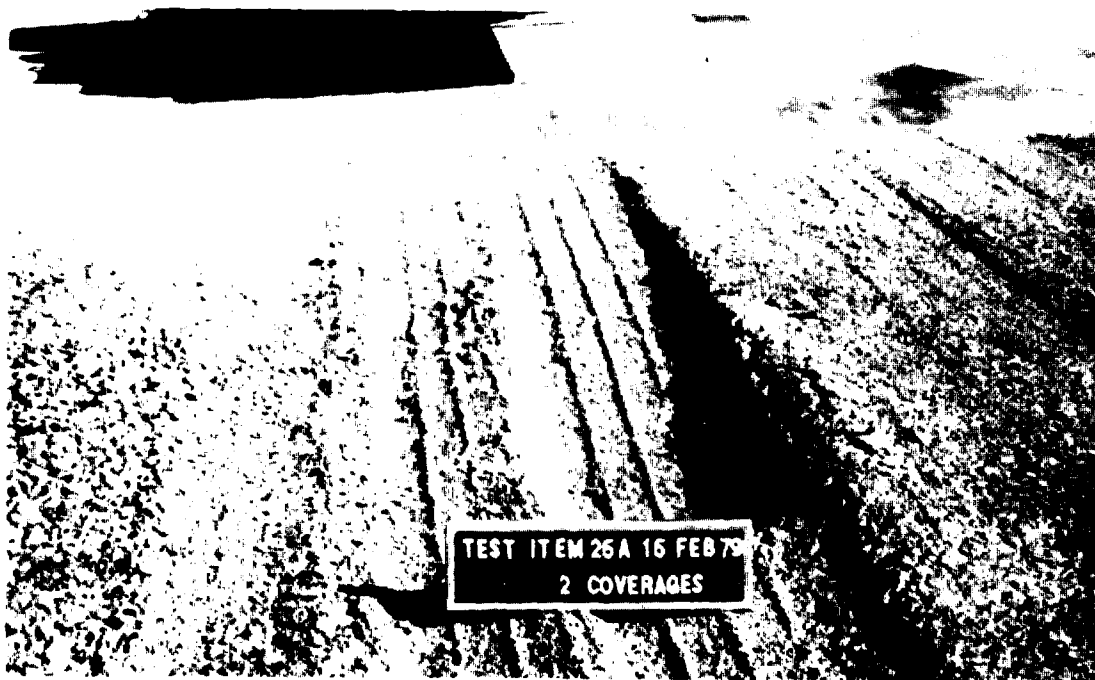
Figure 37. Rutting of Base Course After Two Coverages, Test Item 25

(3) Results. After compaction, prior to initiation of F-4 load cart traffic, water was seen standing in the low spots of the base course. After two F-4 load cart coverages, rutting started and a soft spot was detected near the center of the test pit (Figure 37).

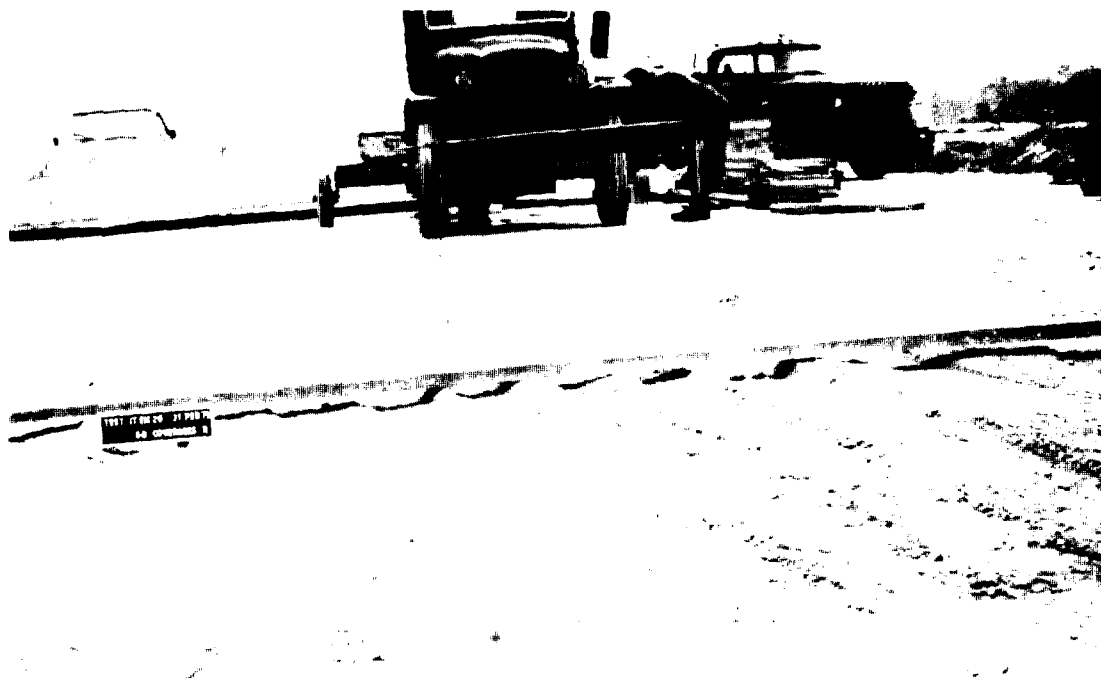
Figure 41. Surface Deformations After 60 Coverages, Test Item 26

(2) Results. After compaction, the limestone showed a moisture content of 2.8 percent and a dry density of 141.7 pcf. Twenty coverages of the F-4 load cart produced deformations of approximately 2 inches; deformations had increased to 3 inches after 40 coverages when it became necessary to add limestone and repair the surface. Figure 40 provides profile data prior to repairs. After 60 coverages, the surface deformation was as shown below (Figure 41).

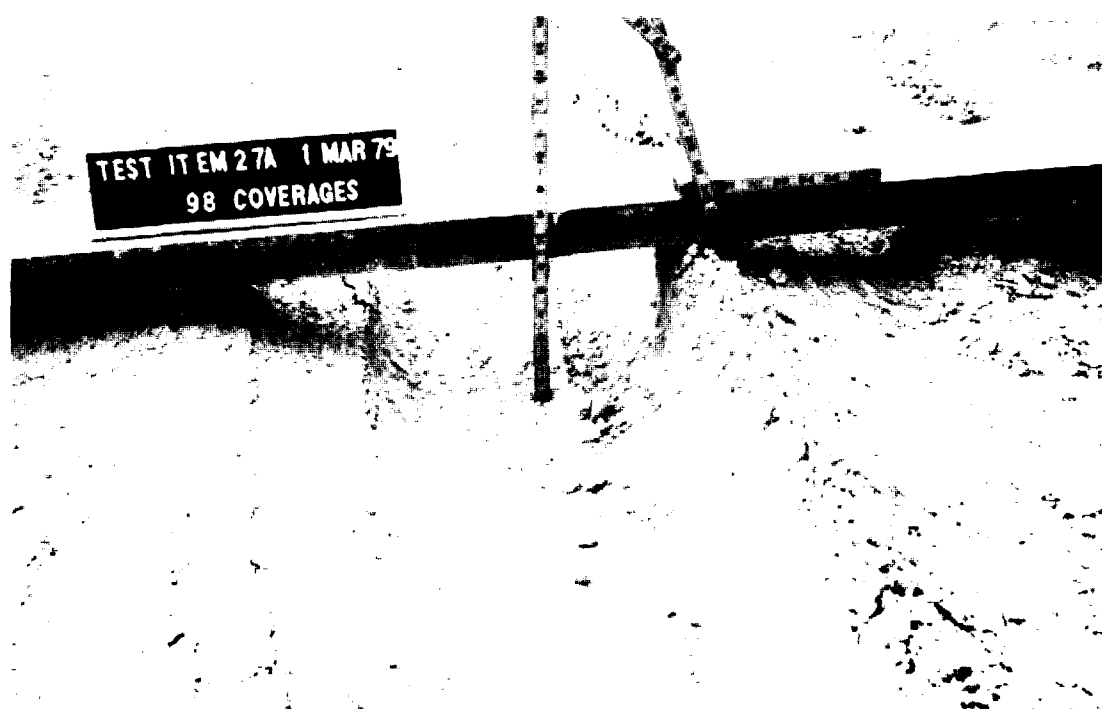
Figure 44. Failure of Test Item 27 (RayGo 510A)  
After 98 Load Cart Coverages

continue the evaluation in order to obtain additional data. Limestone was then added to item 28 and compacted with eight coverages of the RayGo 510A. Although no standing water was visible after compaction, item 28 was characterized as spongy and unstable. Two passes of the F-4 load cart confirmed the suspicion that the repaired test item possesses very little strength. Additional trafficking resulted in progressive deterioration of the surface until further testing of item 28 was abandoned after 24 coverages. After four coverages, test item 27 had encountered much less of a problem, showing deflections of less than 1 inch. Test item 27 sustained 48 coverages before a hump developed in the center of the pit, causing a near-failure. Repairs were made at this point and trafficking continued. Two more repairs were necessary before the failure criteria was exceeded during the 98th coverage (Figure 44).
