MISCELLANEOUS PAPER SL-81-16

# STRUCTURAL STABILITY EVALUATION GULL LAKE DAM

June 1981

Prepared for U. S. Army Engineer District, St. Paul  
St. Paul, Minn. 55101

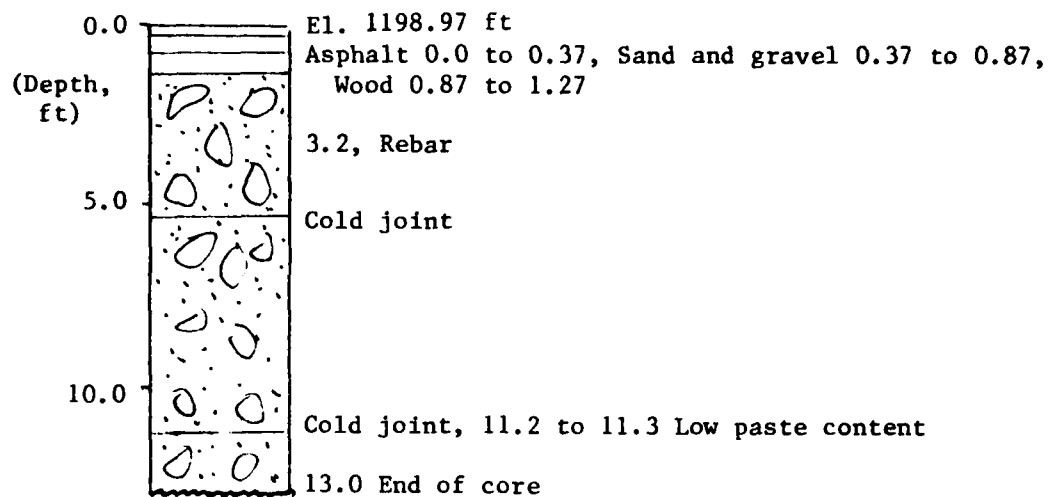
Figure 7. Core log, hole G-P2, Gull Lake Dam

22. Ettringite was commonly found partially filling voids in the concrete. Small amounts of white alkali-silica reaction gel were found on a few aggregate surfaces. While this occurrence was noted more often on the dark particles, it was also found on some of the light-colored particles. A powder immersion mount of this gel showed it to have a refractive index below 1.498. The presence of this gel indicated that some alkali-silica reaction had occurred; the lack of cracking indicated that this reaction had not damaged the concrete that was examined.

2-in. maximum size  
 crushed aggregate com-  
 posed of granite,  
 granite gneiss, and  
 dark, fine-grained  
 igneous rock particles.

Some alkali-silica  
 reaction gel was found  
 coating aggregate  
 surfaces.

Ettringite needles found  
 in voids and coating  
 aggregate surfaces.

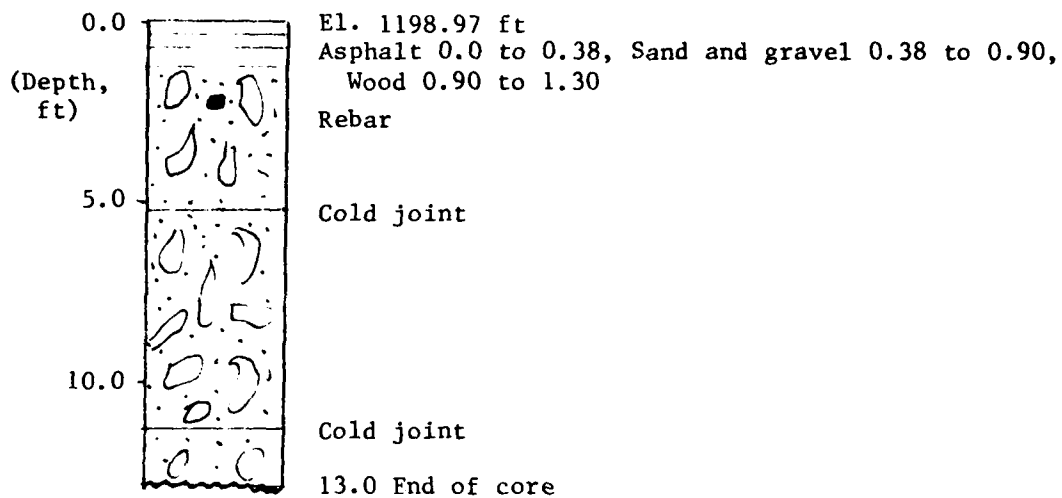
Figure 8. Core log, hole G-P4, Gull Lake Dam

2-in. maximum size  
crushed aggregate  
composed of granite,  
granite gneiss, and  
dark, fine-grained  
igneous rock particles.  
Some alkali-silica  
reaction gel was found  
coating aggregate  
surfaces.  
Ettringite needles found  
in voids and coating  
aggregate surfaces.  
Fine aggregate was  
natural sand.  
Non air-entrained  
concrete.

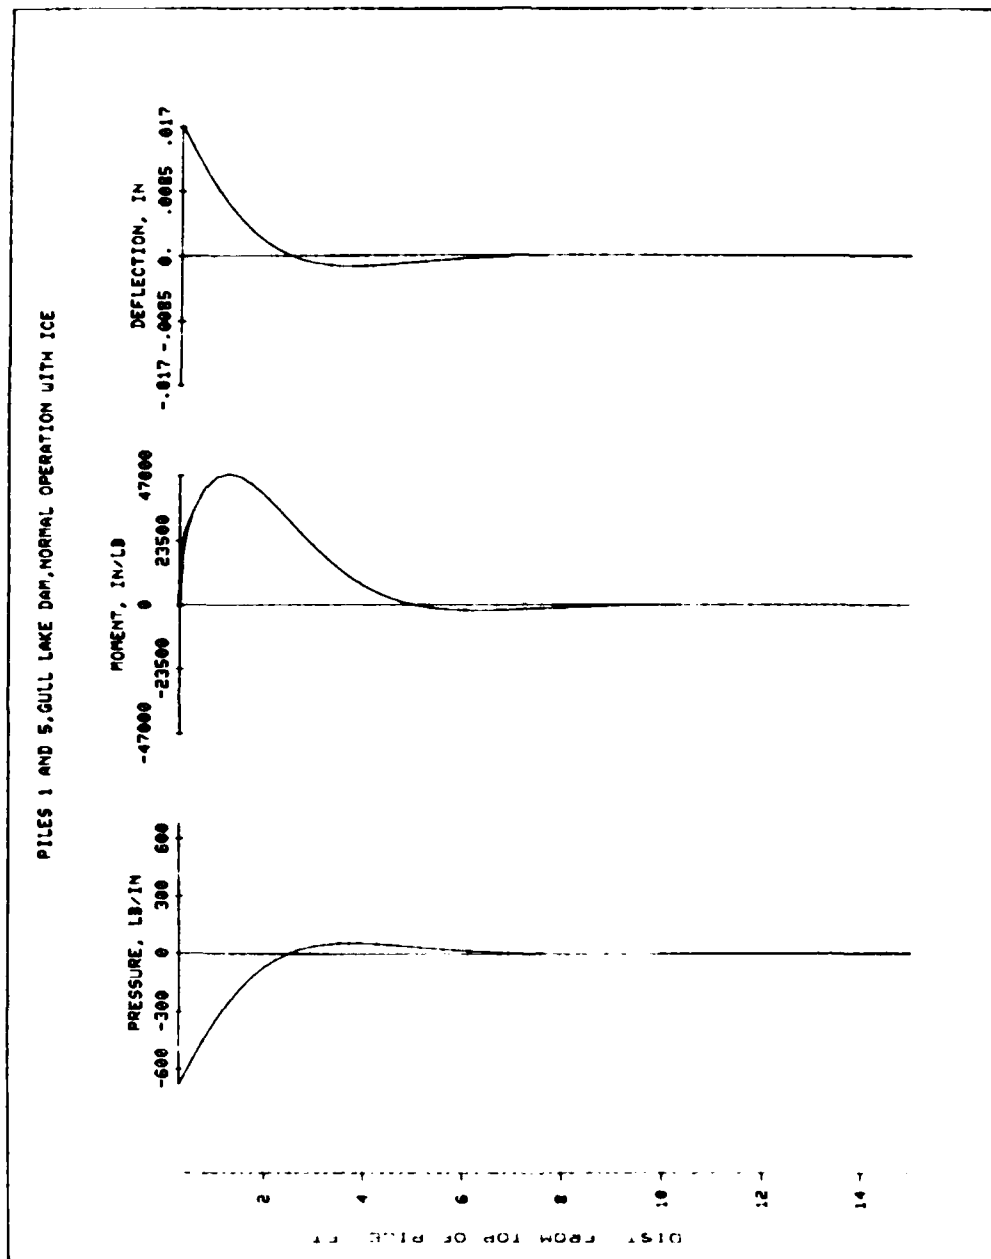
Figure 32. Pressures, moments, and deflections along length of pile for most case loading (normal operations plus ice).

57. The results of the three-dimensional pile foundation analysis are presented in Table 9. The pressures, moments, and deflections along the length of the pile for the most critical load case (normal operation with ice) are presented in Figure 32. The stresses and shears were below the allowables for the piling. The stresses compare to the allowables as follows:

58. The deflections of the piling were less than one quarter inch for all load cases and were acceptable. Since there are no noticeable vertical deflections of the structure and due to the adequacy of the foundation, it is not expected that vertical deflections will cause any loss of reservoir pool in the future. The vertical deflections were computed only as axial deflections of the piles ( $\frac{PL}{AE}$ ) to save time and expense. The pile foundation at Gull Lake Dam is adequate in stability.
