ALTERNATE T-38 TRANSPARENCY DEVELOPMENT
Part II: Baseline Birdstrike Testing

Blaine S. West

Final Technical Report for Period June 1979 - October 1980

December 1980

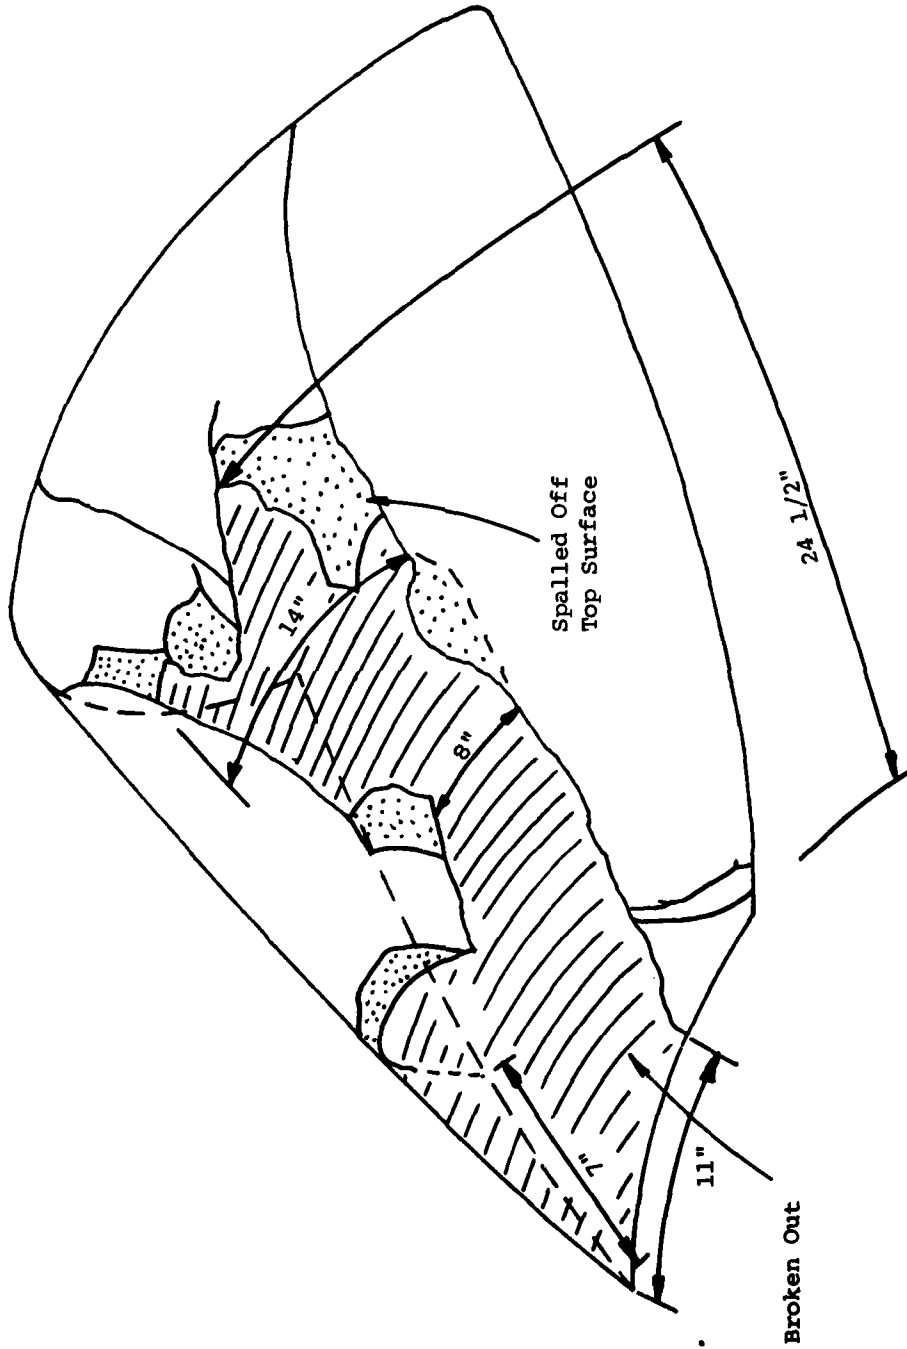
was 236 knots. All components were the same as in Test No. 632. The transparency failed catastrophically with approximately 30 to 40 percent of the bird penetrating the cockpit. The bird orientation prior to impact looked good and impact was at the desired location. Analysis of the films showed little, if any, apparent motion in the forward fuselage. Visual observation revealed no apparent damage to the windshield support structure or mounting hardware. The transparency had cracked through to its leading edge at the front bulkhead center screw location. This was discovered when the transparency was removed from the frame. The windshield arch-canopy frame gap measurements are shown in Table 2. The test established that the catastrophic failure velocity for impact location 1 is equal to or less than 236 knots. The characteristics of the failure are shown in Figures B-1, B-2, and B-3.

1. Catastrophic failure (see sketch and photograph, Figures B-1 and B-2).
2. 30-40% of bird penetrated.
3. No visible damage to support structure or mounting hardware.
4. Bird location and orientation looked good.
5. Appears to be little, if any, motion in forward fuselage.
6. Measured gap change between windshield frame and canopy frame (see Table 2).
7. Transparency was cracked through to edge at front bulkhead center screw location.

Figure B-1. Sketch of T-38 Forward Windshield After Test No. 633.

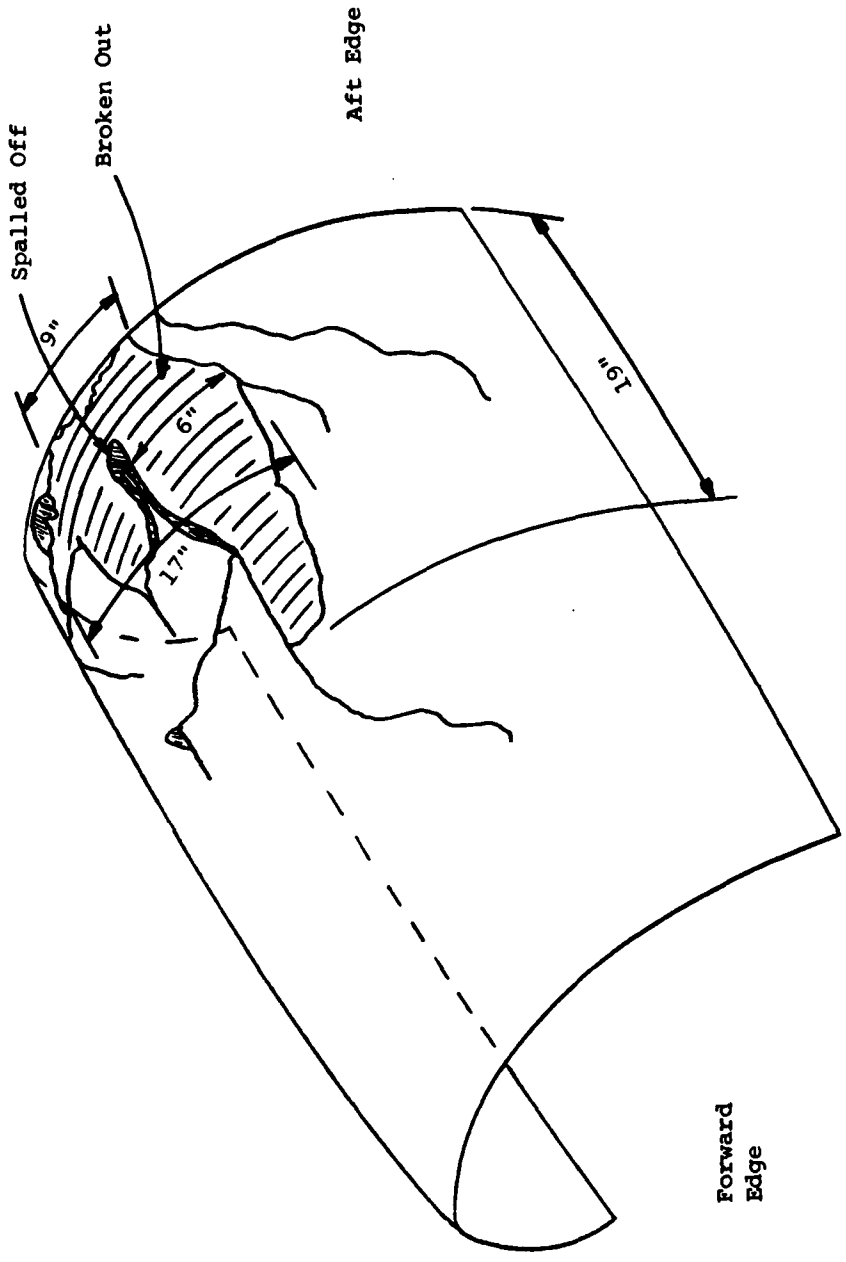
attachment screws. The canopy failed catastrophically at the aft bow frame without any bird penetration of the cockpit area. One large piece of acrylic (10"x5"), two smaller pieces (2"x4") and several 1"x1" pieces were found inside the cockpit. The bird was not completely pulverized as several large pieces were found intact behind the test fixture. Review of the motion pictures revealed that a stress wave formed following impact and traveled aft reaching the aft arch of the forward canopy at approximately the same time that the bird carcass passed over. A reflection wave of significant magnitude traveled forward over the pilot's head position as the transparency failure occurred. The bird orientation at impact looked good. The characteristics of the failure are documented in Figures B-4 and B-5.

1. Canopy failed at aft bow-frame (see photograph and sketch, Figures B-4 and B-5).
2. Zero bird penetration.
3. One large piece acrylic inside (10" x 15") in front floor area plus two intermediate 2" x 4" pieces (one in floor, one in front of instructor's windshield). Several smaller particles 1" x 1" or less inside.
4. Bird not completely pulverized, some fairly large pieces intact.

Figure B-4. Sketch of T-38 Forward Canopy After Test No. 635.

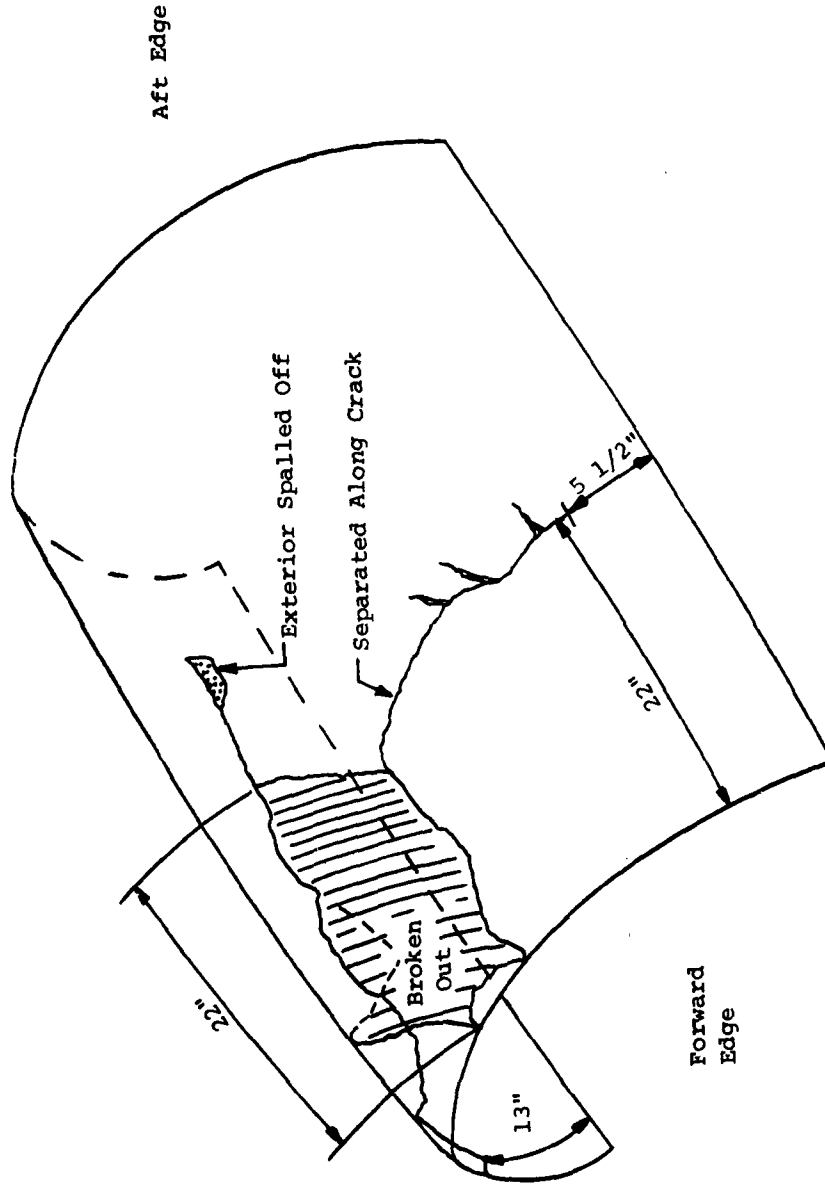
Test No. 640 was the fifth shot at impact location 4 and achieved an actual velocity of 178 knots versus the 180 knots desired. All test hardware had been previously utilized in tests 636, 637, 638, and 639. There was little deflection of the canopy prior to failure in the impact area. The initial impact was at the forward canopy frame causing some flattening of the forward former in the centerline area. Cracks in the acrylic appear to originate in the leading edge of the transparency propagating outboard and aft prior to complete failure of the acrylic. The majority of the bird penetrated the canopy and impacted with enough force on the plexiglass shield directly in front of the instructor's windshield to break the instructor's windshield. Since the 0.5 inch plexiglass was not in direct contact with the instructor's windshield, it must have flexed under the impact forces and impacted with sufficient force to crack the instructor's windshield. Beside the bird, there was a large amount of acrylic in the forward cockpit that would have presented a hazard to the crew member, including one piece approximately 4 square inches in size. The change in gap between the windshield frame and forward canopy bow was sufficient to be visibly noticeable. The characteristics of the failure are shown in Figures B-6 and B-7.

1. Canopy broke out at forward former (see sketch and photograph, Figures B-6 and B-7).
2. Noticeable change in windshield - canopy frame gap (see Table 2).
3. Broke instructor's windshield and 0.5 inch plexiglass protective plate in front of it.
4. Slight flattening of forward former at the centerline and looks like rear frame of windshield flattened slightly.
5. Majority of bird in cockpit.
6. Appears mirror mounts might have touched canopy but no damage apparent above either one.
7. No readily visible change in seam along forward retainer and transparency does not appear to have pulled loose significantly if at all from the forward retainer.

Figure B-6. Sketch of T-38 Forward Canopy After Test No. 640.

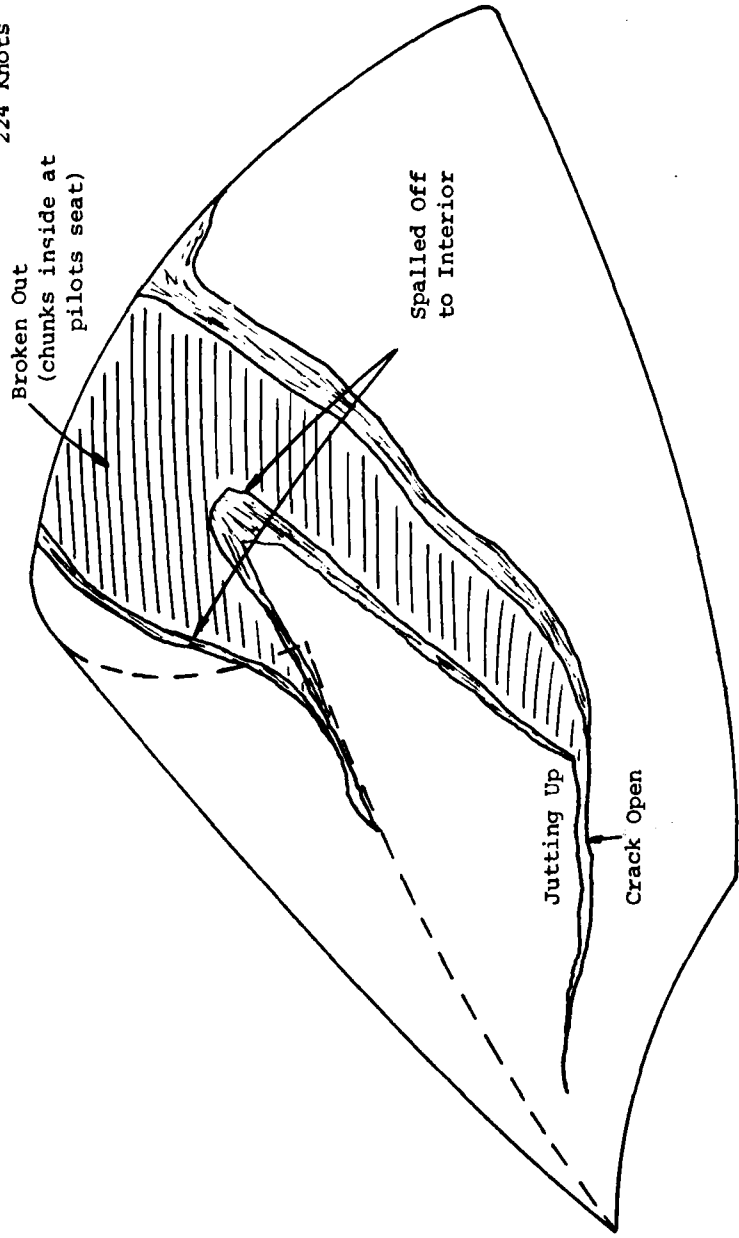
Test No. 642 was the second shot at impact location No. 2 on the forward windshield. All test hardware was the same as was used for Test No. 641. The planned impact velocity was 230 knots and the actual impact velocity was 224 knots. The windshield failed catastrophically with failure initiating under the point of impact and propagating aft to the arch frame and forward towards the front bulkhead. Several pieces of the acrylic windshield, including some large pieces, entered the cockpit and would have impacted the pilot. Approximately 50 percent of the bird mass entered the cockpit and would have impacted the pilot. This test established the threshold of failure at this location at less than 224 knots. The characteristics of the failure are shown in Figures B-8, B-9, and B-10.

1. Windshield failed catastrophically with several pieces of plexiglass entering cockpit and breaking interior light (Reference Figures B-8, B-9, and B-10).
2. Bird debris sprayed on rear of student cockpit where seat would be and some even entered instructor's cockpit along sides of bulkhead.
3. Large piece of plexiglass on cockpit floor at approximate location of pilot's lap.
4. No Δ in gap between aft edge on forward canopy and leading edge of instructor's canopy but approximately 1/8" Δ in total canopy length.
5. Strain gauges at centerline pulled loose.
6. Magnetic compass mount bent aft and up slightly but compass not pulled loose.

Figure B-8. Sketch of T-38 Forward Windshield After Test No. 642.

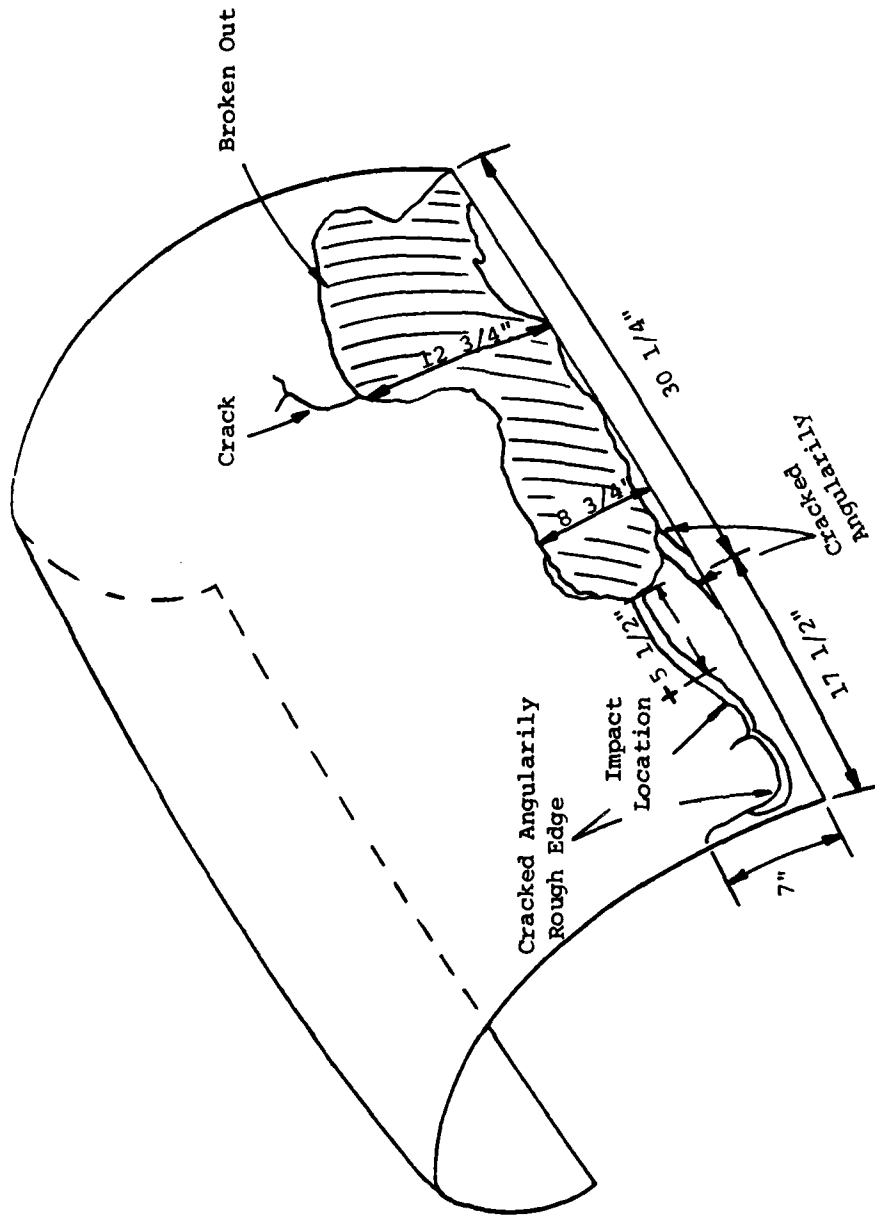
Test No. 644 was the second shot at impact location No. 6 on the forward canopy. All test hardware was the same as was used for shot No. 643. The planned impact velocity was 145 knots and the actual impact velocity was 141 knots. The bird was partially out of the bag and appendages were flailing at impact. However, the center of gravity of the bird was on target. The canopy failed by fracture. Failure appeared to initiate at the frame and propagated rapidly with large pieces of acrylic breaking out under the bird. Considerable deflection along the hinge line was observed as the bird traveled aft. A majority of the bird and much of the plexiglass remained outside the cockpit (for this condition of no aerodynamic flow). Approximately 20 to 25 percent of the broken acrylic was found inside the cockpit including two pieces 3x4 inches in the front cockpit and several pieces 2x4 inches in the rear cockpit. About 20 percent of the bird mass was either inside the cockpit or trapped in the framework. There was no apparent damage to the hinge pin or nodes. The fiberglass material was torn from a point where the clear area of the panel starts to a point just forward of the 25th node. Cracking of the acrylic occurred under the fiberglass material. This test established the upper limit on the failure velocity for this condition at 141 knots. The characteristics of the failure are shown in Figures B-11, B-12, B-13, and B-14.

Figure B-11. Sketch of T-38 Forward Canopy After Test No. 644.

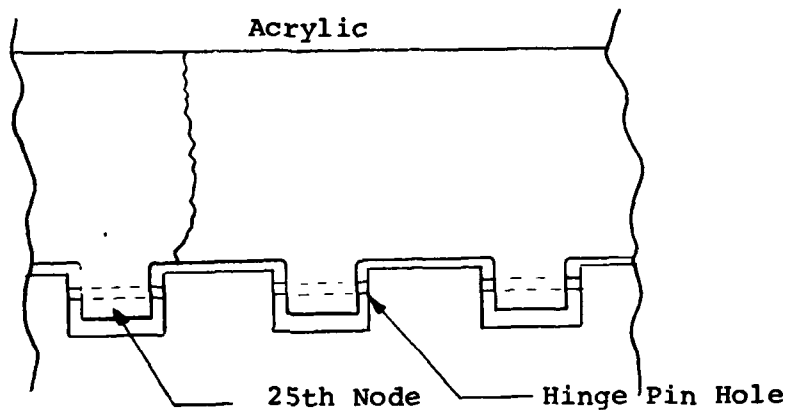
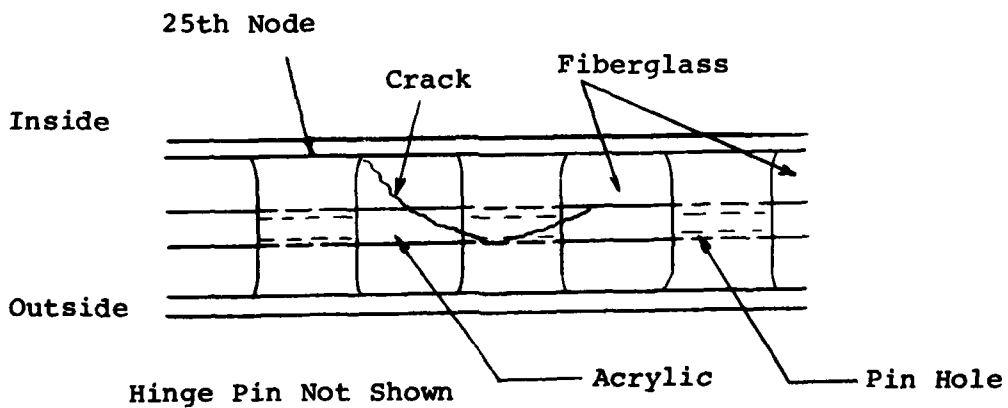
Figure B-12. T-38 Canopy Edge Failure Resulting from Test No. 644.

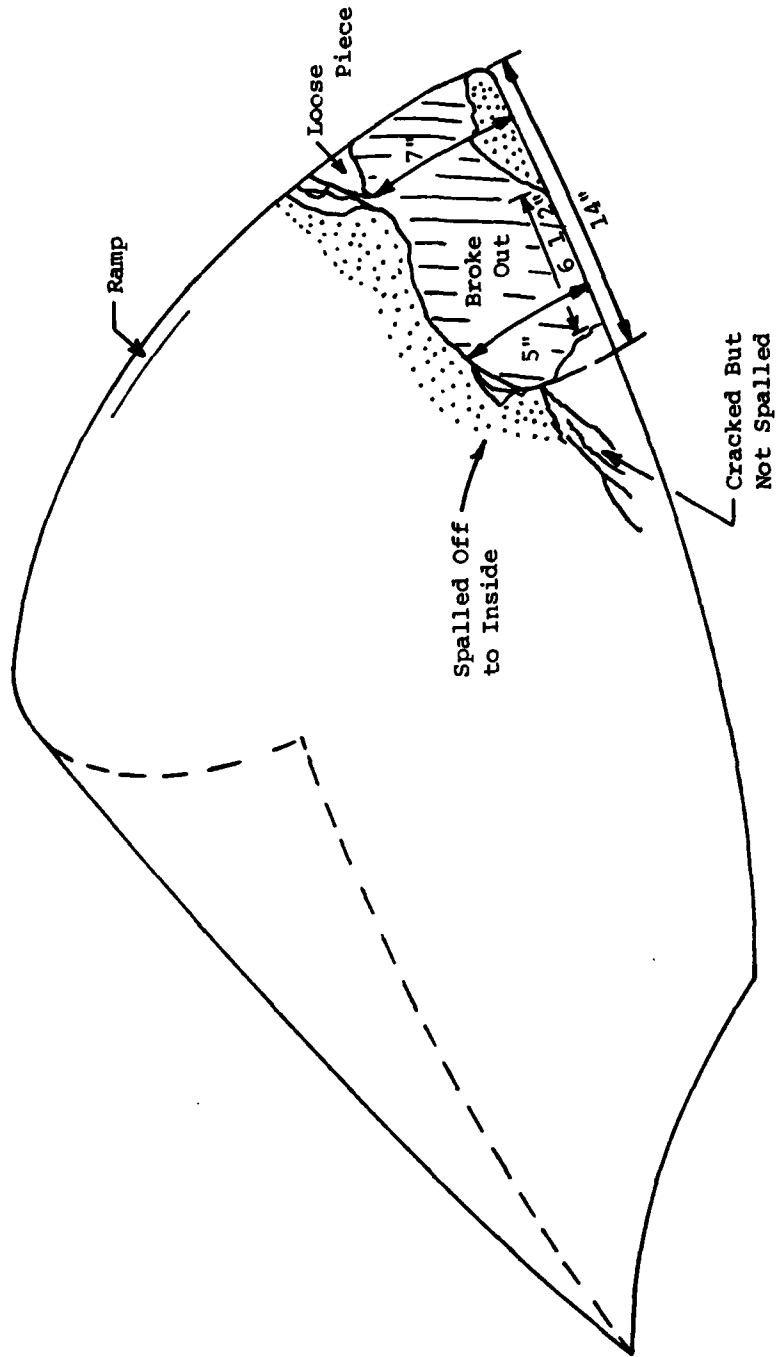
Test No. 646 was the second shot at impact location No. 3 on the forward windshield. All test hardware was the same as was used for shot No. 645. The planned impact velocity was 250 knots and the actual impact velocity was 247 knots. A section of the windshield approximately 6x14 inches was broken out at the aft rear corner. It appeared that all of the broken acrylic entered the cockpit as did 20 to 30 percent of the bird mass. Some spalling of the inside surface of the acrylic around the fracture occurred. The fiberglass edge was broken out around the boundary of the fracture area as was the outer surface ramp along the aft arch area. This test established the upper limit of the capability at less than 247 knots for this impact condition. Characteristics of the failure are documented in Figures B-15, B-16, and B-17.

Figure B-15. Sketch of T-38 Forward Windshield After Test No. 646.
