EVALUATION OF POWDER PROCESSED TURBINE ENGINE BALL BEARINGS. (U)  
JUN 81 P F BROWN, G A BOGARDUS, J R MINER F33615-75-C-2000

AFWAL-TR-80-2110

## EVALUATION OF POWDER PROCESSED TURBINE ENGINE BALL BEARINGS

United Technologies Corporation  
Pratt & Whitney Aircraft Group  
Government Products Division  
P.O. Box 2691  
West Palm Beach, Florida 33402

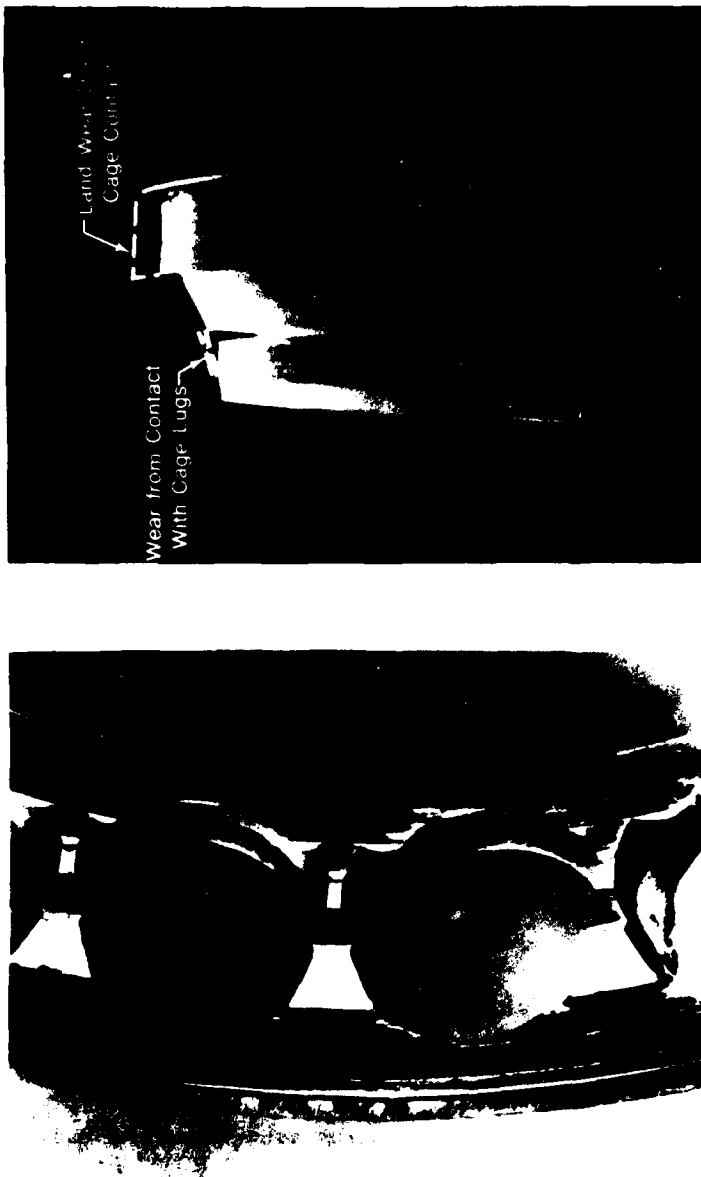
A visual examination was conducted with binocular assistance on the eight bearings run in the initial test. This revealed various degrees of wear on the inner ring lands and the mating cage bore surfaces. The inner ring land surfaces were worn uniformly in depth, axially, radially and circumferentially. One bearing with the greatest ring/cage clearance, see Figure 12, was measured and found to have the ring lands worn to a depth of approximately 0.070 inch. In addition, the inner race ball groove surface was worn due to contact with the cage ball-retention lugs. See Table 12 for a tabulated summary of post-test visual observations made on the test bearings.

The nature of the wear observed on the program bearings had the appearance of the abrasive type that can be generated by hard particles bridging any oil film between the OD land surface and the inner ring and the bore surface of the cage. This type of wear has been seen before on service engine bearings and in most instances has been attributed to dirt particles suspended in the oil. However, as described earlier, after a complete oil system cleanup and the successful running of P/M M-50 alloy bearings, a P/M CRB-7 alloy bearing that was run next still experienced the same type of distress as observed in the first test. It was then concluded that the problem was not due to dirt in the oil system from sources outside the test bearing itself.

Figure 12. Powder Metal Processed CRB-7 Alloy Bearing Wear. (left) Pitting Shown on This Cage Bore Surface is The Worst Case, But Similar in Appearance to All Other CRB-7 Bearing Cages Tested. (Right) Inner Ring Wear Was Extensive, And This Was the Worst Case; 0.070 in. of Material Was Worn From The Land.

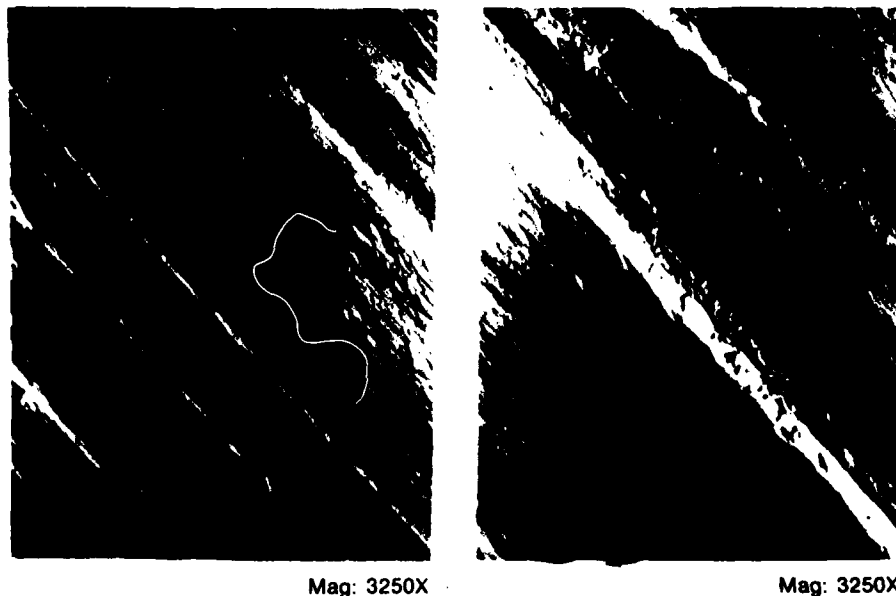
Figure 20. Unrubbed CRB-7 Ring Land Surface. Absence of Desirable "Moonscape" Textured Surface Was Apparent in Both Micrographs of an Unrubbed Ring Land Surface.

As a result of this production bearing experience it was considered desirable at this juncture in the P/M CRB-7 program to develop an acid etch based procedure that would produce a land texture similar to that of the M-50 museum piece. The nital acid etch, which uses an etchant solution composed of 4% by volume of nitric acid and 96% by volume of alcohol, when applied to the CRB-7 rings was found not to produce any visible change in the surface appearance or its texture. Thus, CRB-7 being a more highly alloyed material than M-50, was determined to require the development of a new more erosive etchant that would provide a surface texture that would have a visual appearance similar to that shown in Figure 21. Toward this end a series of candidate etchants were compiled as shown in Table 13.

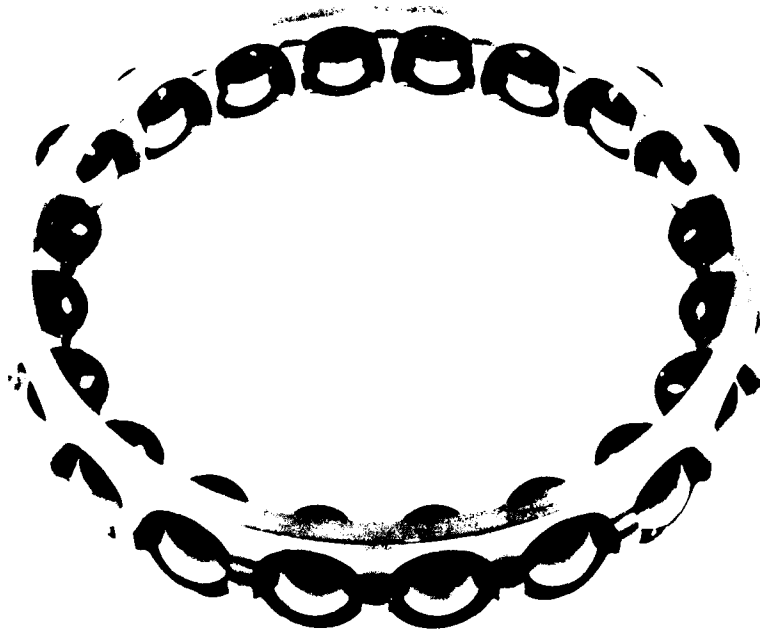
Figure 25. Replated Cage after 7 Test Hours.  
No Evidence of Cage Distress by Contact With  
Nickel Plated Inner Rings Was Observed.

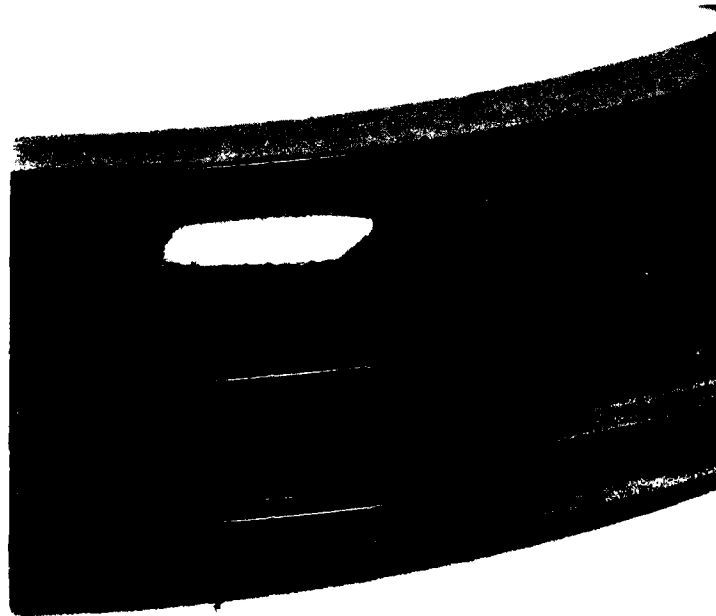
After five hours of testing the CRB-7 P/M bearing that had nickel plated inner ring lands and a resilvered cage, only minimal distress was observed during post test inspection. The testing of this combination of alternate surface material was successfully extended to 25 hours at the same test conditions. Using a surface analyzer, an axial stylus trace across the inner ring lands indicated the wear to be less than 0.00085 inch. The condition of the cage after seven hours of this testing can be seen in the photograph in Figure 25. The condition of the inner ring lands after 25 hours of testing can be seen in the photograph in Figure 26.

Figure 26. Nickel Plated Inner Ring After 25 Test Hours.  
Minimal Distress Was Seen Upon Bearing Inspection.

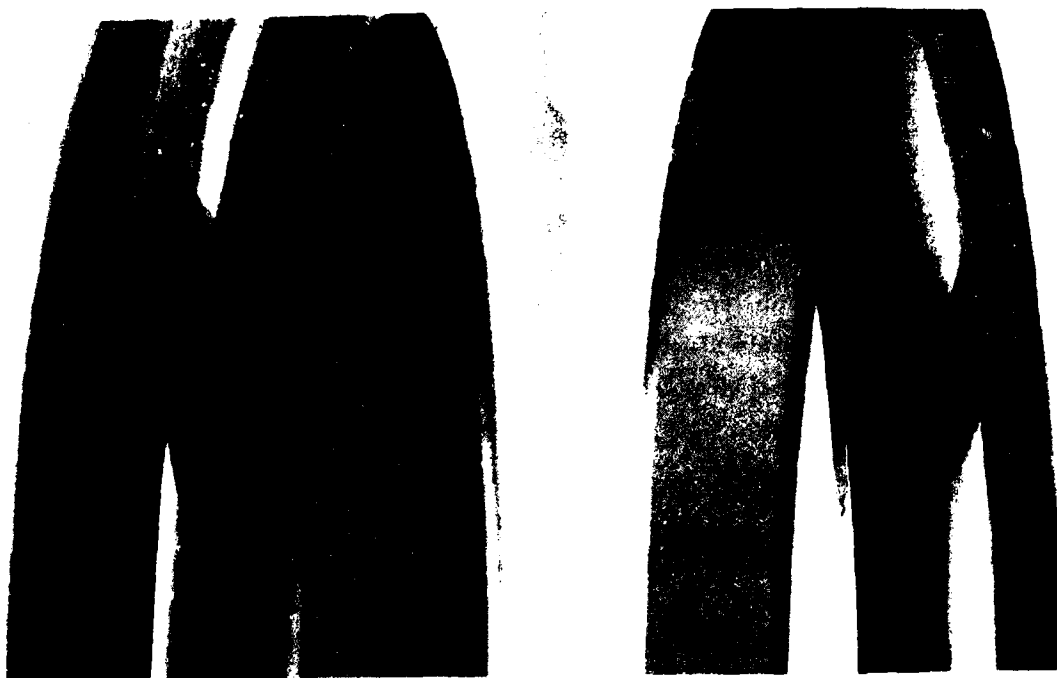
Figure 28. Ball Tracking at Bottom of the Inner Race Groove.  
This Bearing, S/N R13, Apparently Operated at a Low Thrust  
Load Resulting in Bearing Skid Distress.

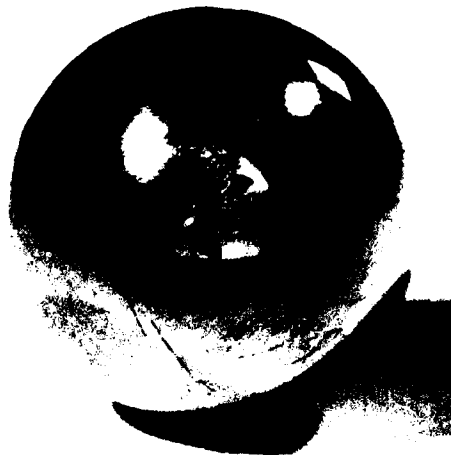
Figure 30. Ball Spall after 157.4 Test Hours, Bearing S/N R11.  
Spall Was Located Adjacent to The Equator Established During  
Ball Fabrication Forging.

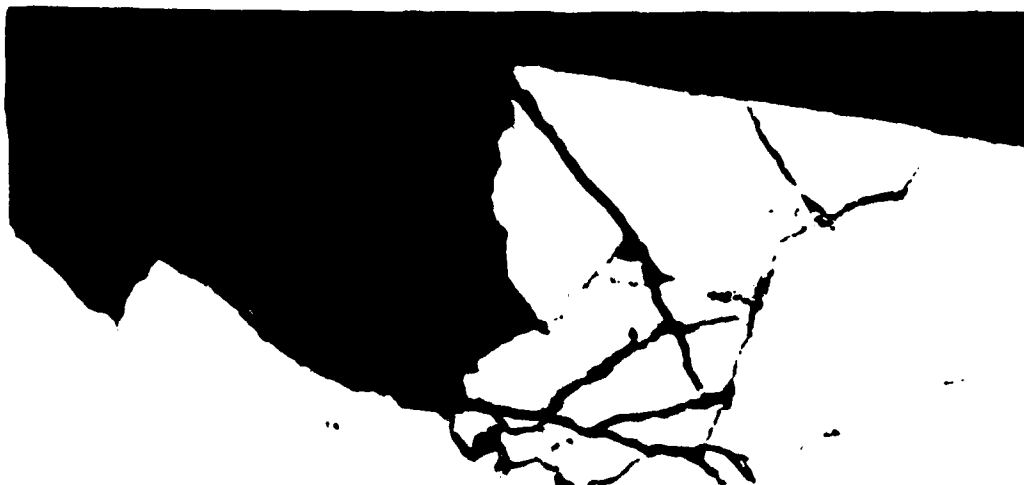
Figure 31. Photomicrograph of Ball Section Through Spall.  
Numerous Transgranular Cracks Emanated From Apparent Spall Origin.
