FAA-AM-81-10

IMPROVING THE CRASHWORTHINESS OF GENERAL  
AVIATION AIRCRAFT BY CRASH INJURY INVESTIGATIONS

MAY 1981

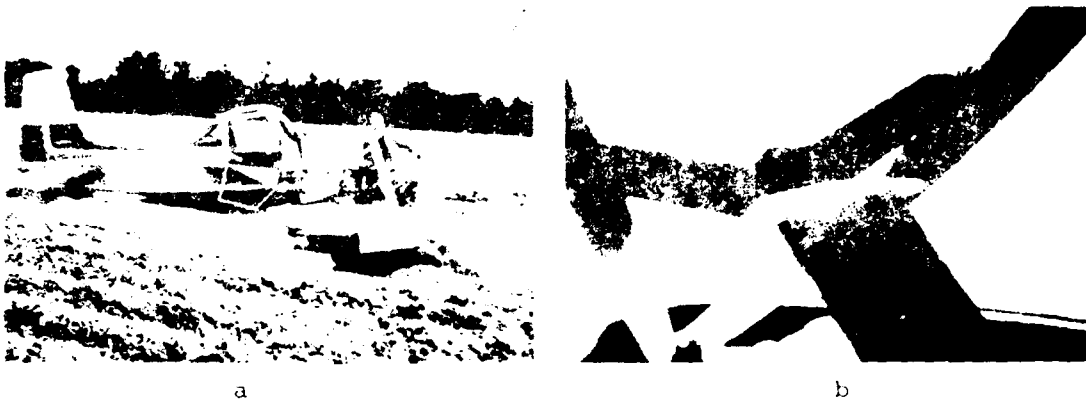
Many aerial application aircraft have been built with a strong crashworthy cockpit frame. Pilots are provided a seat, lapbelt, a shoulder harness, and in many aircraft a large metallic roll on the panel to distribute impact forces over the pilot's body should he strike it in an accident. Further, the pilot usually wears a helmet. The crashworthiness of an aerial application aircraft was illustrated when, on fuel exhaustion, the aircraft stalled and struck the ground in a 45° nosedown attitude. As illustrated in Figure 1a there was moderately severe damage to the engine and hopper. The pilot, who was wearing a lapbelt and shoulder harness, received lacerations above the right eye and a fractured left arm and left knee. He had conspicuous shoulder harness and lapbelt abrasions and contusions. A notable finding was the forward bending of the shoulder harness attachment bracket and cracking of the bond where the bracket had been welded to the cockpit structural bars (Figure 1b). During deceleration the force of the pilot's body against the shoulder harness apparently caused this deformation. Fracturing of the seat pedestal and detachment of the seat from the seat track probably increased the freedom of the pilot's body, allowing it to come forward and strike the instrument panel. The intact upper torso restraint probably prevented the pilot from receiving lethal injuries.

Figure I. In this accident damage was limited and cockpit was intact (a). However, shoulder harness attachment brace showed v-shaped deformation (b) due to force of pilot's body against restraint during crash.

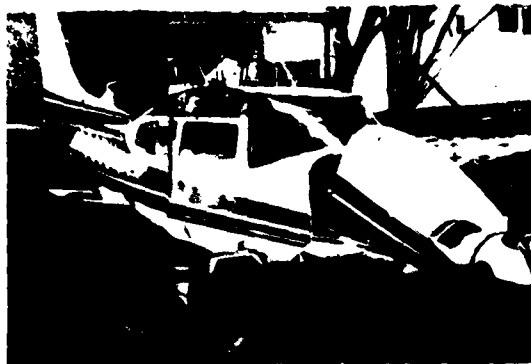
A number of general aviation aircraft are equipped with seat frames, legs, and pedestals cast of magnesium-aluminum alloy. It has been observed in accidents that the legs and the pedestals of such seats are frequently fractured. Indeed, in a review of accidents of one aerial application aircraft employing this type seat (2), it was found that in 14 of the 18 accidents investigated, the seats left their tracks and in 14 of the 18 accidents one or more seat legs or pedestals were fractured. The cited report reviewed findings in an aerial application aircraft because this type of aircraft was specifically designed to be crashworthy. However, the problem extends beyond the aerial

application aircraft as illustrated in Figure XII. The six people in this aircraft all received moderate to severe injuries. The pilot and person in the copilot position had facial injuries and spine fractures. The forward four seats were partially or completely separated from the seat tracks and the pilot's and copilot's seats had fractured seat pedestals as shown in the figure. Cast seat legs and parts are strong and meet all FAA requirements but in accidents when the failure point is reached they appear to break exposing the occupant to possible high peak decelerative forces in secondary impacts rather than deforming under the occupant and attenuating the energy of impact. At present we do not know how pervasive failures of seats are in general aviation aircraft or how such failures add to the severity of injuries. This is a matter of continuing crashworthiness investigations.

Figure XII. On impact, the occupants of this aircraft received serious injuries. Cast alloy seat pedestals were found to be fractured as can be seen in photograph.
