# ENGLISHTOWN LAKE DAM

**NJ 00619**

## PHASE 1 INSPECTION REPORT NATIONAL DAM SAFETY PROGRAM

JULY 1981

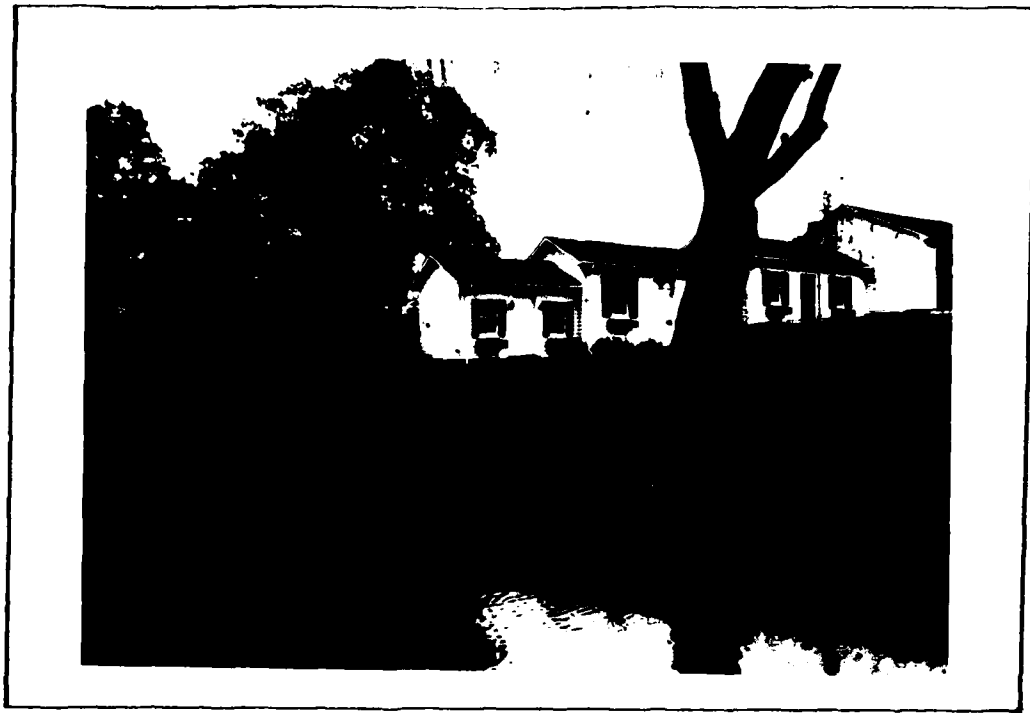
11. POTENTIAL DAMAGE AREA ABOUT 200 FEET DOWNSTREAM OF THE DAM.  
(4/30/81)
