# LAKE PANORAMA DAM &

# LAKE PANORAMA DIKE NJ 00816 & NJ 00828

PHASE 1 INSPECTION REPORT  
NATIONAL DAM SAFETY PROGRAM

MAY 1981

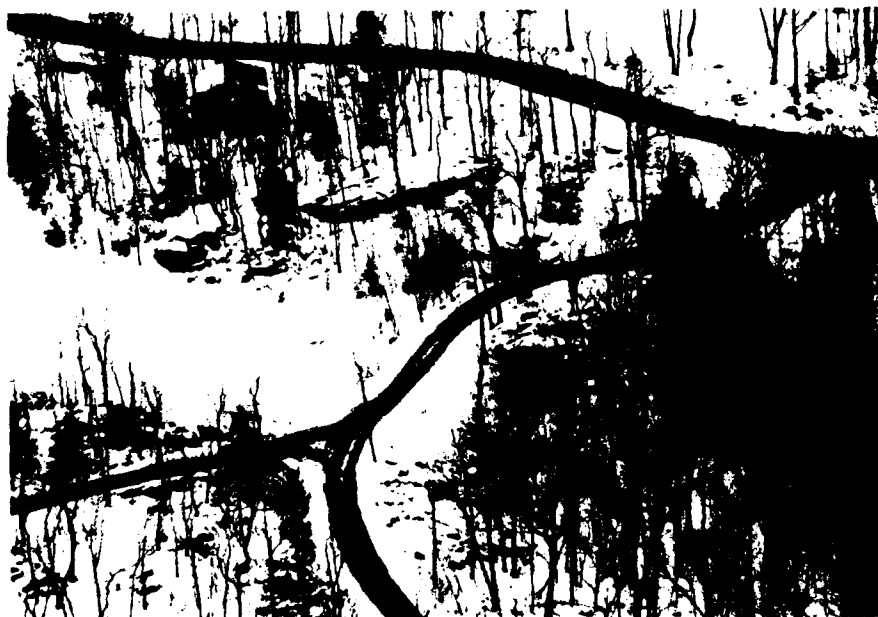
PHOTO 2

CREST OF DIKE WITH DOWNSTREAM FACE TO  
THE RIGHT AND LAKE TO THE LEFT

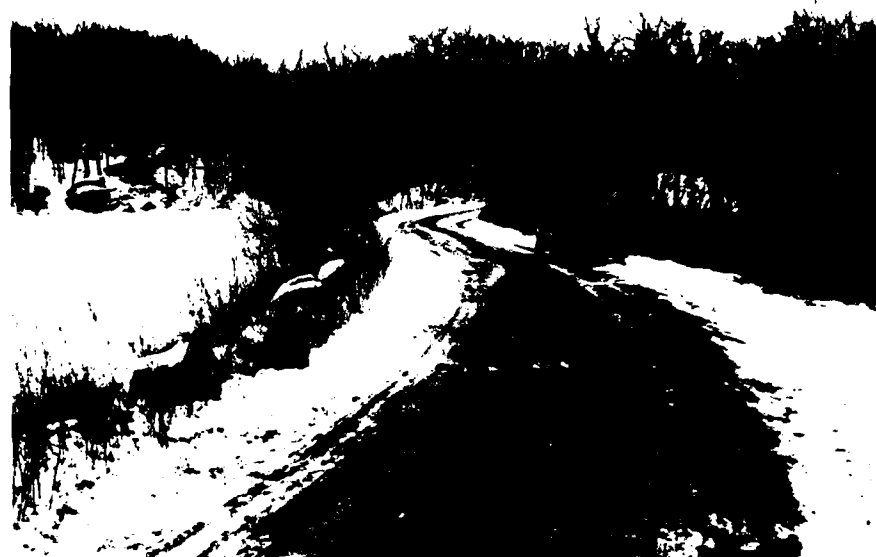
PHOTO 4  
CREST OF DAM

The crest of dam appeared to be generally evenly graded. The upstream side contained tall grass, weeds and small trees. Also, a series of boulders were observed along the upstream side of the dam and appeared to be for a decorative purpose. Boulders on the upstream side were observed at the waterline, but their placement appeared haphazard and they did not appear to be riprap. Most of the surface of the dam was obscured by snow at the time of inspection.
