**Name Of Dam:** UNIVERSITY COMMONS DAM  
**Location:** RICHMOND, VIRGINIA  
**Inventory Number:** VA. NO. 76008

# PHASE I INSPECTION REPORT NATIONAL DAM SAFETY PROGRAM

**SCHNABEL ENGINEERING ASSOCIATES, P.C./  
J. K. TIMMONS AND ASSOCIATES, INC.  
February, 1981**

FEBRUARY, 1981

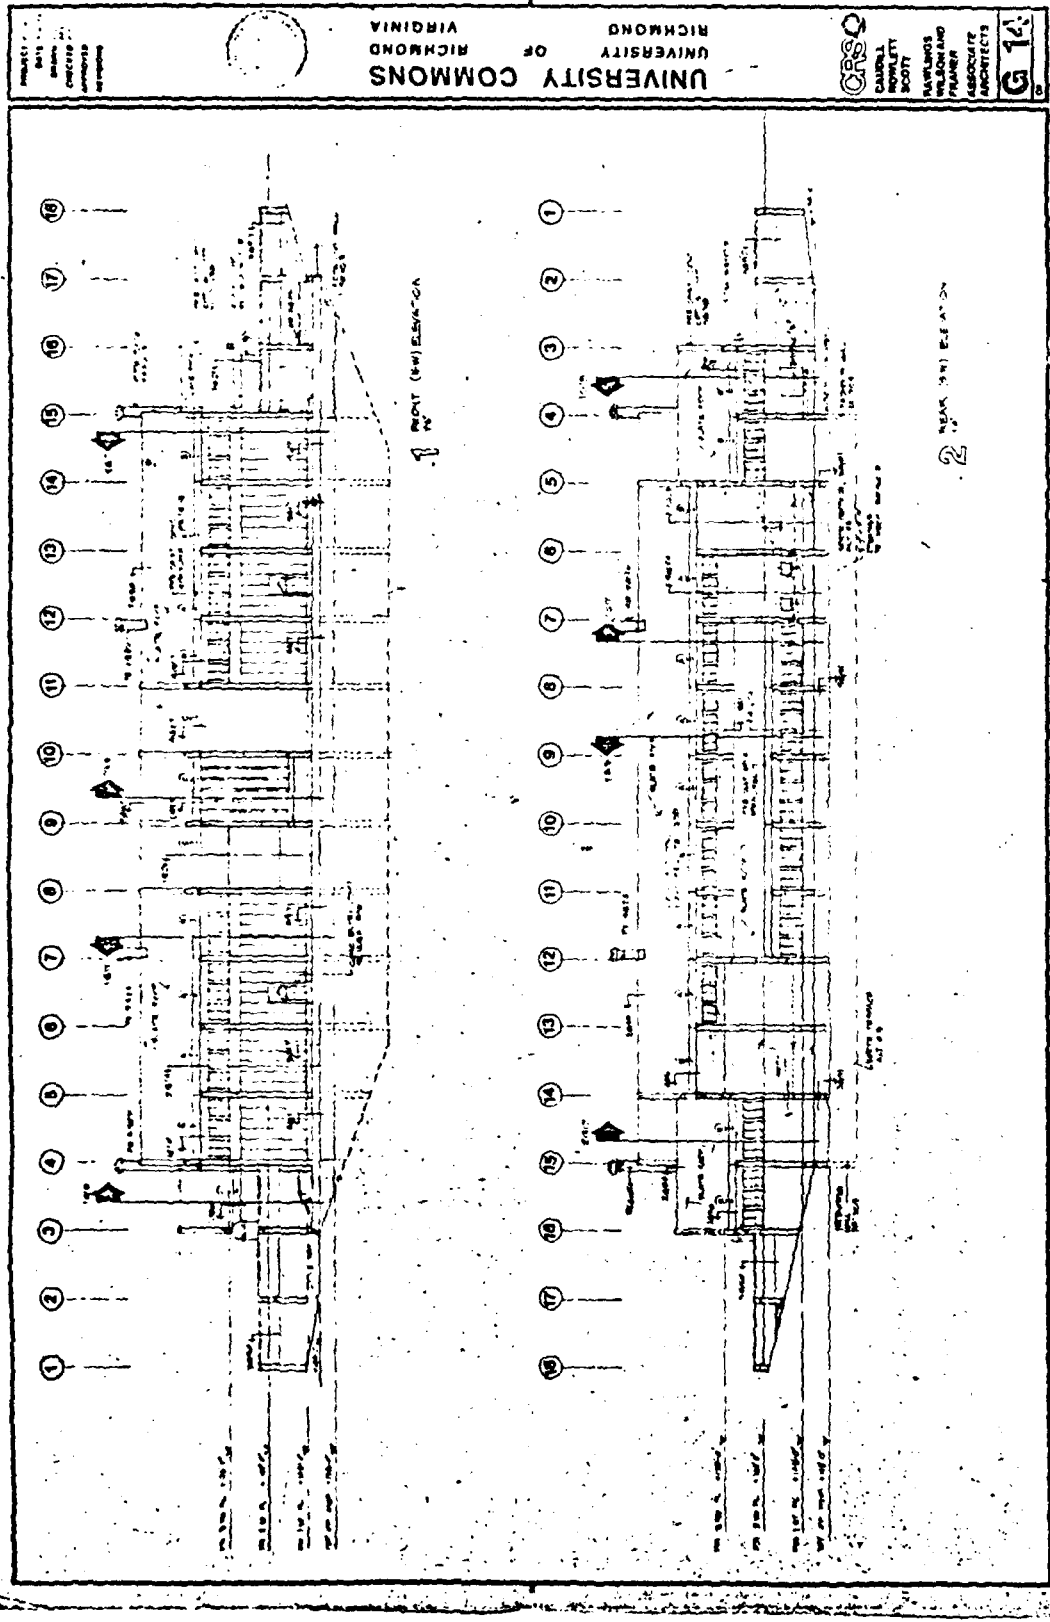
PLATE NO. 2

The University Commons building was constructed over the dam crest and is supported on deep piers within the dam which are situated on spread footings supported on rock. The 264 ft spillway runs under the building with the building comprising the balance of the dam length beyond the spillway to the left abutment. The abutments are part of the building foundation. (see Plate 2, Appendix I)

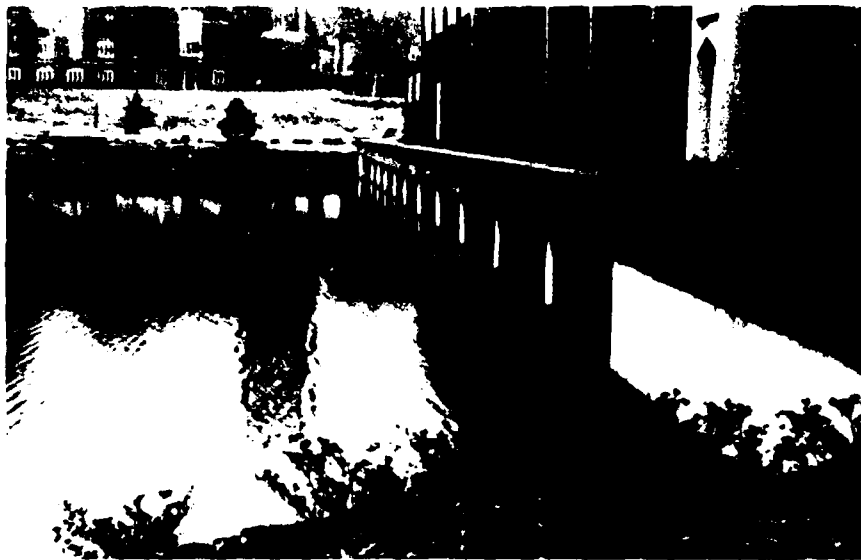
Photo No. 1

Upstream Face of Dam

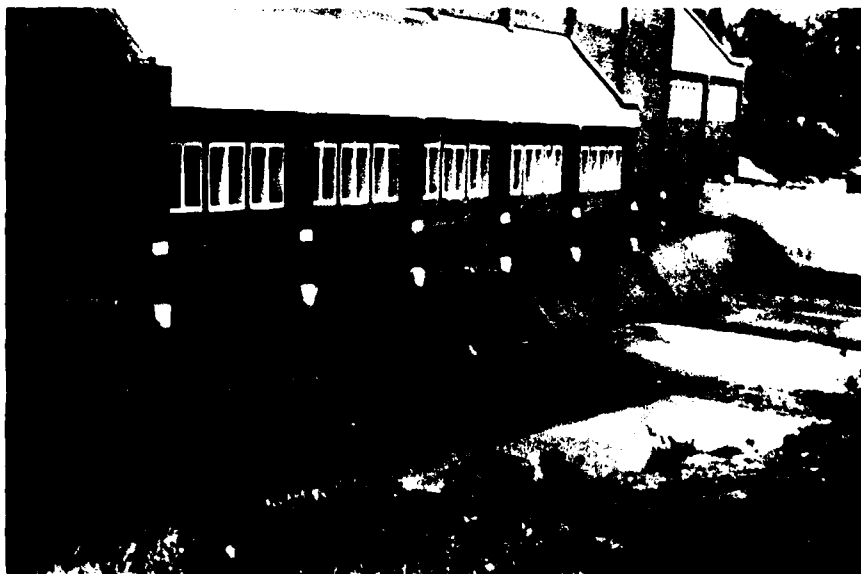
Photo No. 2

3.1.2 Dam and Spillway: The upstream slope of the embankment was submerged and not observed. The dam crest or spillway approach was covered with a reinforced concrete membrane and submerged. The downstream slope is made up of the spillway, spillover area and discharge channel. These areas are covered with a reinforced concrete membrane. Vertical hairline cracks in the concrete membrane on the spillway section (IH:IV slope) were observed. Horizontal hairline cracks in the concrete along the crest of the spillway were also observed. No other signs of deterioration such as spalling or peeling of concrete at the concrete spillway, approach channel, discharge channel and lake drain pipe were observed. These structures were functioning properly at the time of inspection. (See Photos, Appendix II).

Spillway and Downstream Face of Dam

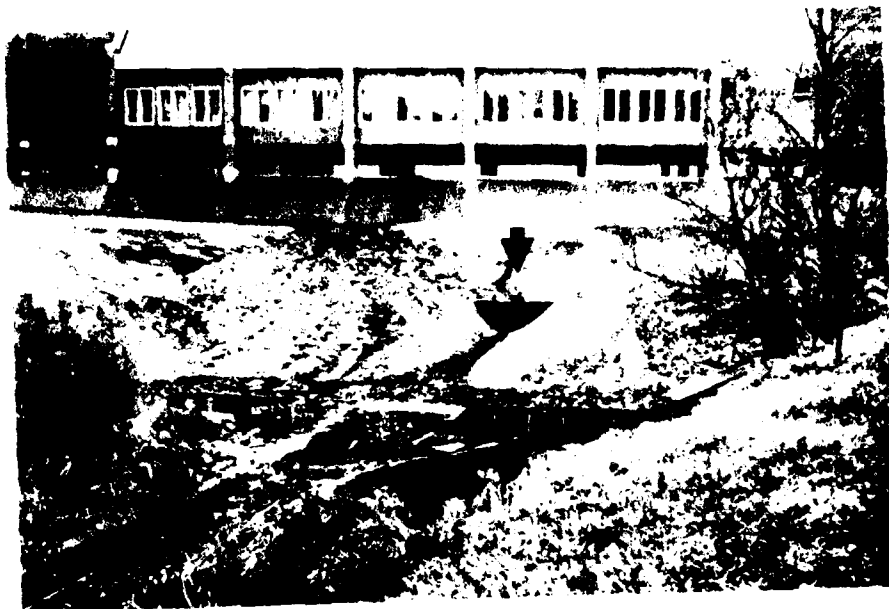
Photo No. 3

Drain Pipe Outlet (arrow) and Approach  
Channel Clearance

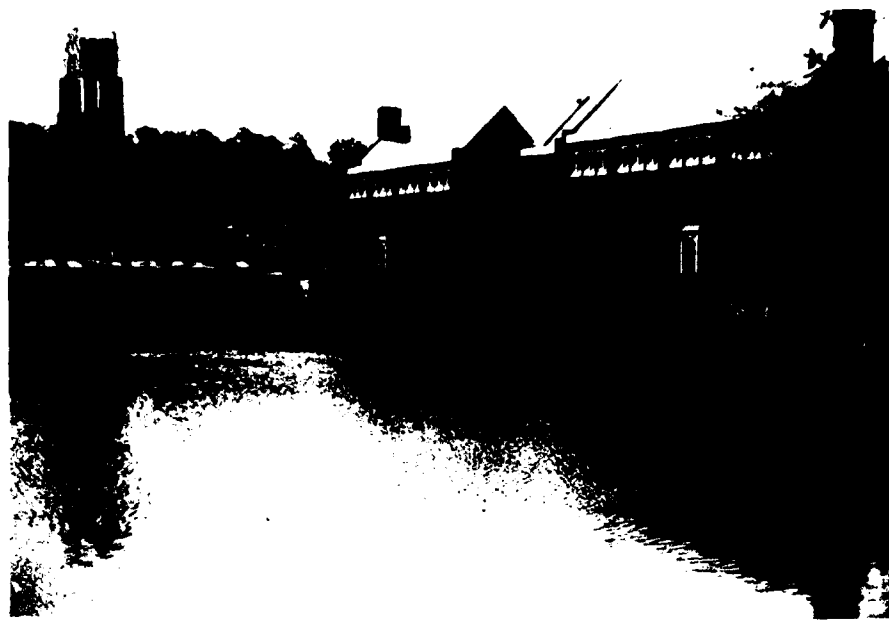
Photo No. 5

Approach Channel Under University  
Commons Building

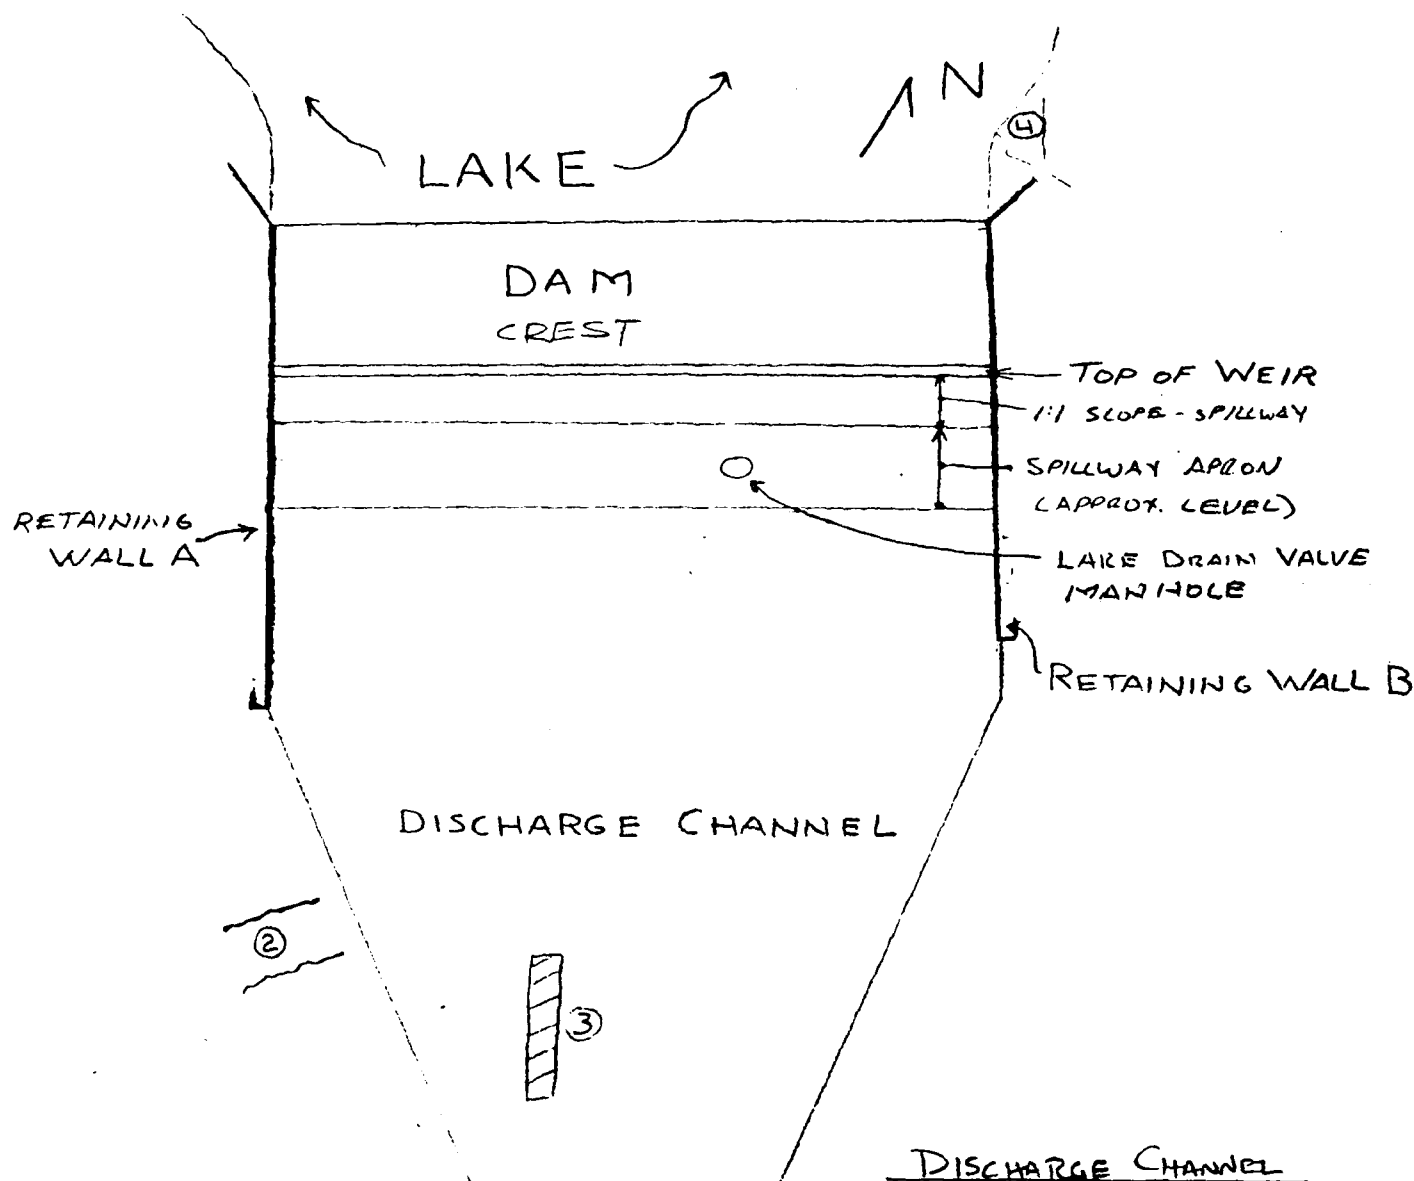
SHEET 1

Some discoloration and seepage (less than 1 gpm) was noted in the vicinity of the construction joints in the discharge channel concrete membrane approximately 80 ft downstream of the spillway (see Field Sketch, Appendix III, Sheet 1).

There was evidence of past erosion at the lower end of the outlet channel where the earth channel and natural channel slopes begin. The erosion had been repaired with broken concrete rip rap.

| VISUAL EXAMINATION OF | OBSERVATIONS | REMARKS OR RECOMMENDATIONS |
|---|---|---|
| RIPRAP FAILURES | Riprap was present at the downstream end of the discharge channel on the left side in an area previously eroded. See Field Sketch, Sheet 1. | None |

Possible seepage was noted from several of the joints in the downstream concrete apron. See Sheet 1. This seepage was marked by discoloration of the concrete at the joints, indicated possible seepage through the embankment. Seepage was estimated at less than 1 gpm.

1. ERODED AREA - 30 TO 40 FT LONG, 15 FT WIDE, FILLED IN WITH LARGE CONCRETE BLOCKS

2. SMALL EROSION GULLIES, 1 FT x 3 FT, ALONG CHANNEL SIDE SLOPES

7.3.2 The seepage from the discharge channel concrete membrane should be monitored. If any increase in seepage flow rates are observed, a professional Geotechnical Engineer should be contacted to evaluate the problem and make recommendations for required corrective measures.

These seepage areas should be monitored for any increase in water condition such as the presence of fines in the water.
