Name Of Dam: SPRING VALLEY LAKE
Location: CITY OF ROANOKE, VIRGINIA
Inventory Number: VA 77002

PHASE I INSPECTION REPORT NATIONAL DAM SAFETY PROGRAM

NOVEMBER 1980

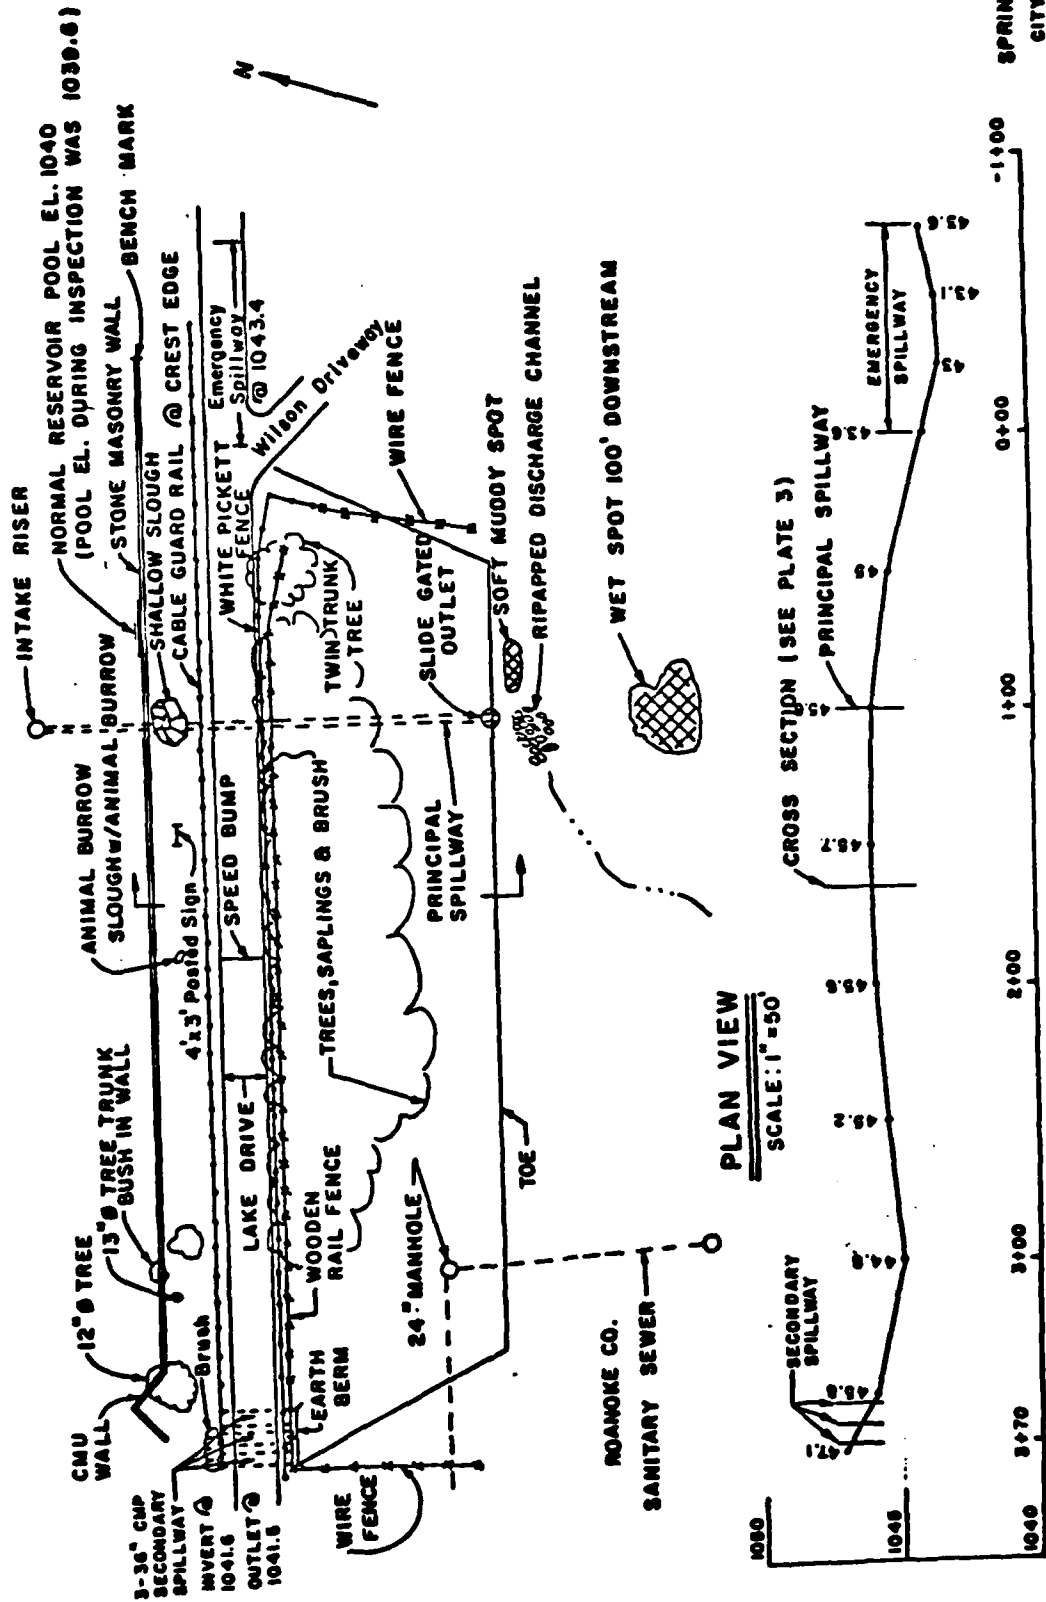
PLATE II

The upstream slope is covered with trimmed grass. Also, there are three trees and some brush on the slope as located on Plate II, Appendix I. The downstream slope is sparsely vegetated with grass. Portions of the slope are vegetated with bushes, saplings, and trees as shown in Photo. No. 3, Appendix II. The immediate downstream area is a fenced horse pasture area and the animals graze on the downstream slope.
