Name Of Dam: WINDSOR LAKE
Location: CITY OF ROANOKE
Inventory Number: VA 77001

PHASE I INSPECTION REPORT NATIONAL DAM SAFETY PROGRAM

NOVEMBER 1980

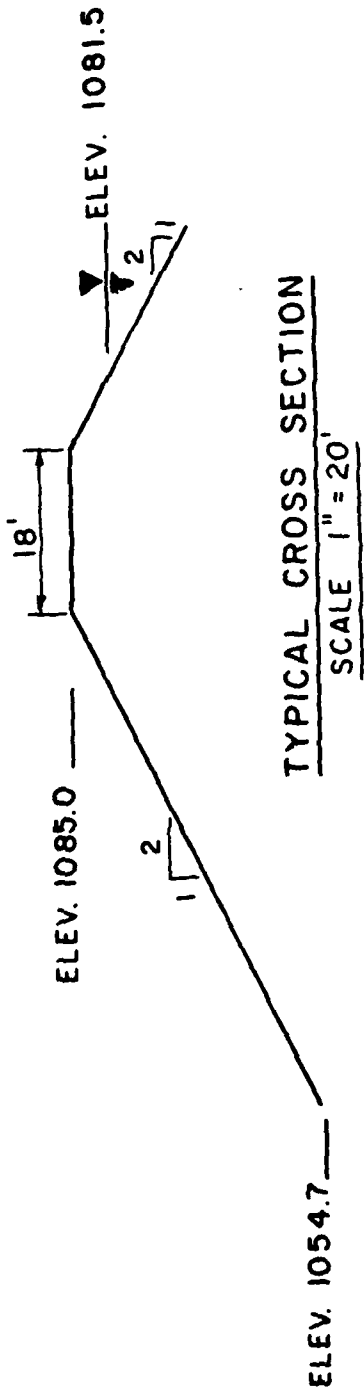
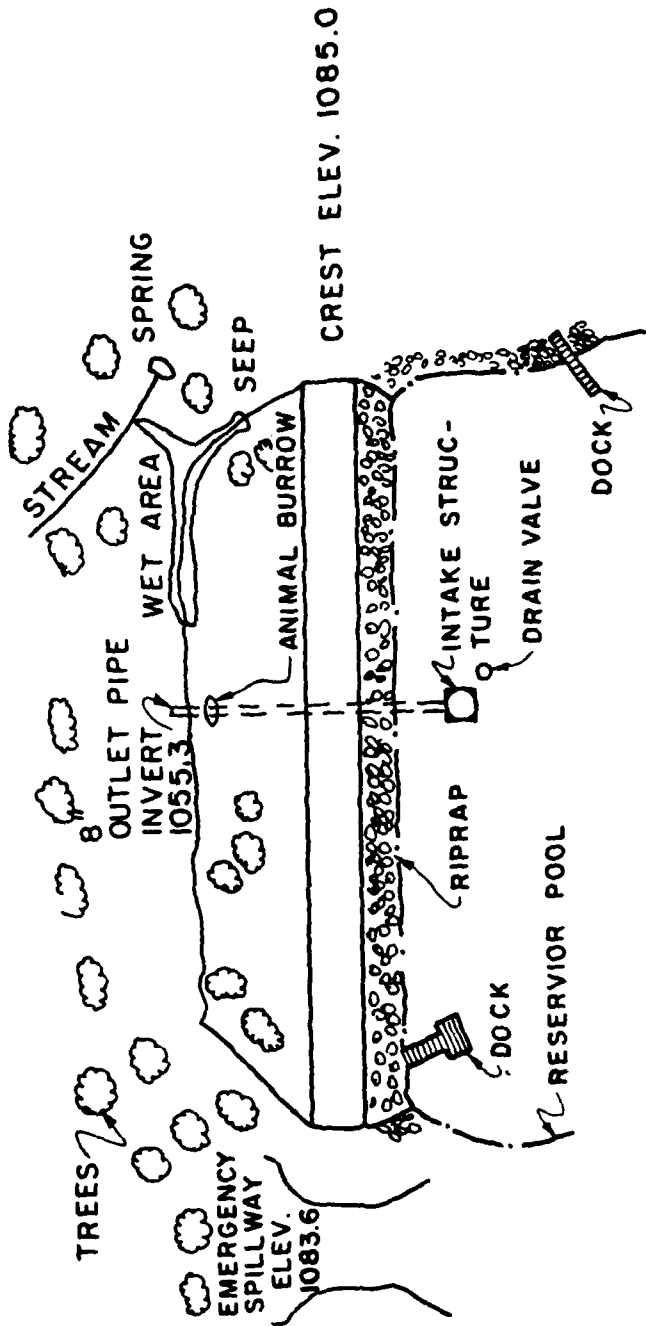
PLAN VIEW OF THE DAM
NOT TO SCALE

There are no signs of surface cracks, unusual movement, sloughing, misalignment, or riprap failures. However, there are several bare spots located on the crest approximately 50 feet right of the left abutment. Also, a small hole about 8 inches in diameter is located on the upstream face just above the principal spillway outlet pipe. (See Plate II, Appendix I).

A wet area is located along the downstream toe. It extends from the right abutment approximately 30 feet towards the principal spillway outlet pipe. Cattails and reeds are growing in this area. (See Plate II, Appendix I).

A seep is located on the downstream right abutment at elevation 1065.2. Its flow runs down the abutment saturating the toe, and continues downstream. The flow is clear but the rate was not measured. (See Plate II, Appendix I).

- a. The bare spots on the crest should be regraded and reseeded.
- b. The small hole above the principal spillway outlet pipe should be backfilled with compacted material and seeded.
- c. The wet area along the toe, the spring in downstream right abutment area, and flow from the principal spillway outlet pipe should be monitored for an increase in flow during periodic inspection and after higher pool levels in the reservoir. The seeps should be monitored for increased flow.
- d. The small shrubs on the face of the dam should be cut off at their roots.

i. The trees and shrubs along the toe of the dam should be cut off at ground level annually as a part of the maintenance program to provide access to monitor the seep, the wet area, and the spring in the downstream area.
