Name of Dam: Lake Land'or Dam

Location: Caroline County, Commonwealth of Virginia

Inventory Number: VA 03309

# PHASE I INSPECTION REPORT NATIONAL DAM SAFETY PROGRAM

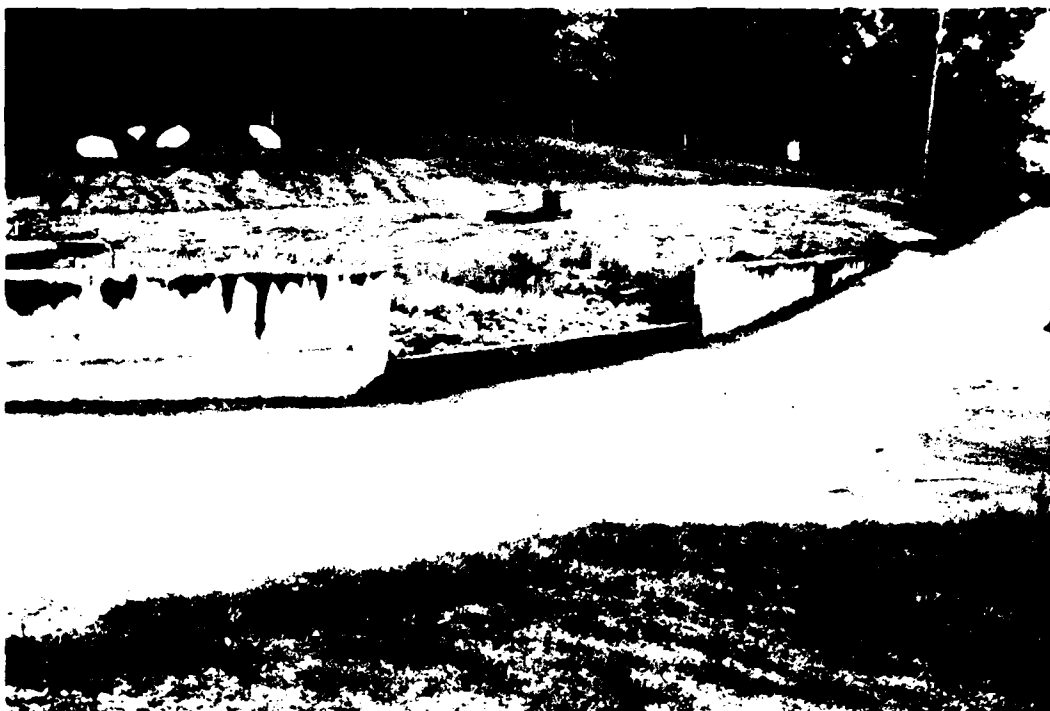
**PHOTO 1. Spillway and Left Abutment Area**

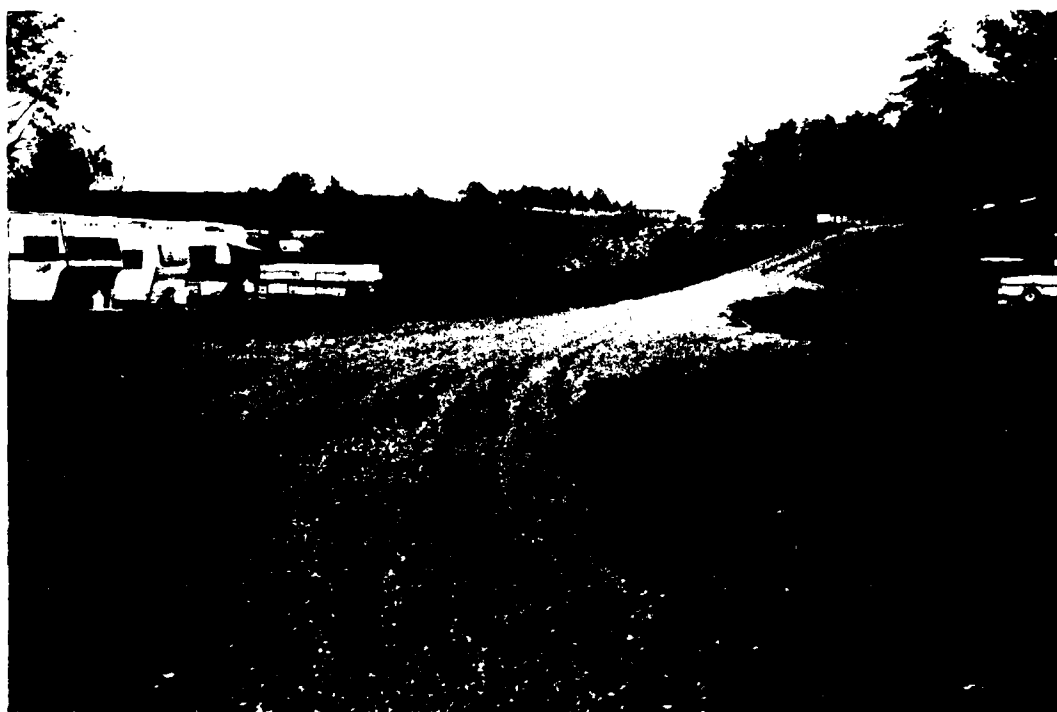
**PHOTO 2. Camper Storage and Campground Immediately  
Downstream of Spillway**

VISUAL EXAMINATION OF	OBSERVATIONS	REMARKS OR RECOMMENDATIONS
DISCHARGE CHANNEL (Continued)	erosion has occurred along the right side of the riprapped discharge channel. The discharge channel is narrow and obstructed near the outlet. Campers are stored immediately adjacent to the spillway discharge channel.	
BRIDGE AND PIERS	N/A

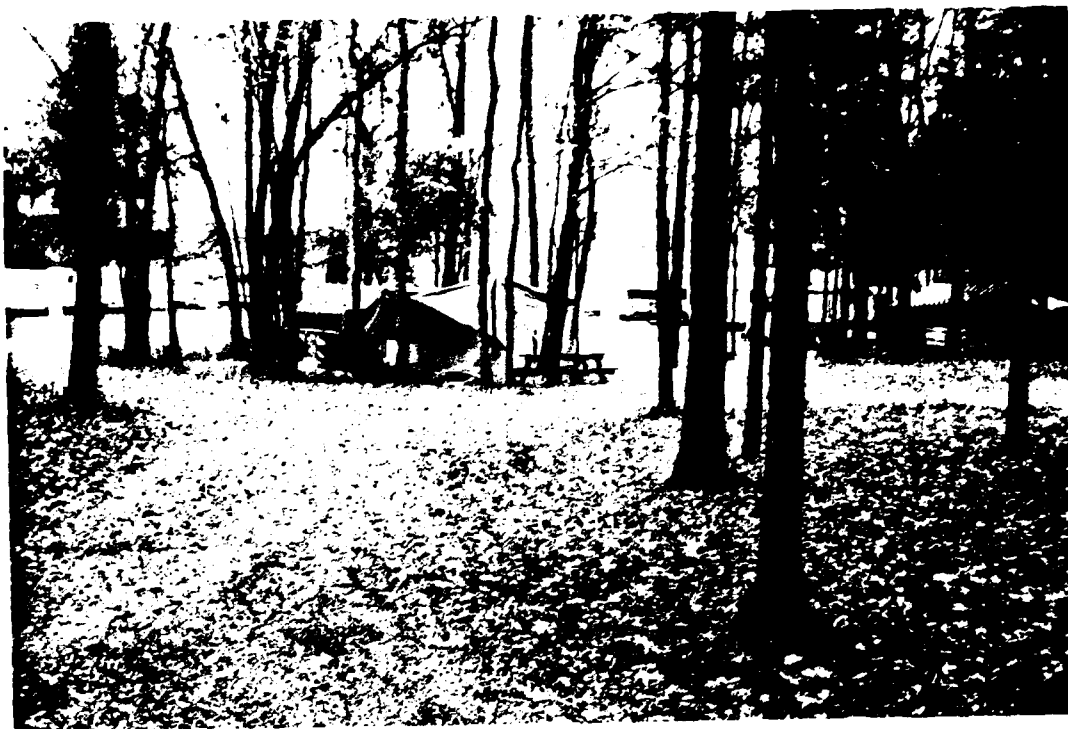
**PHOTO 3. Campground with Spillway in Background**

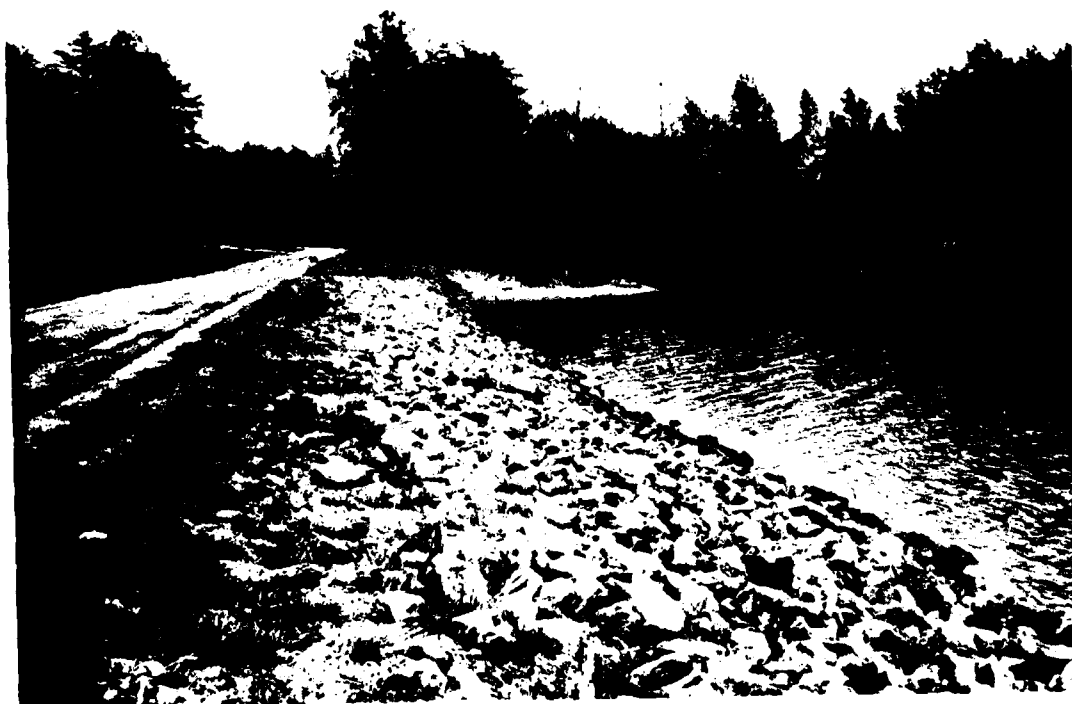
**PHOTO 4. Right Abutment Area**

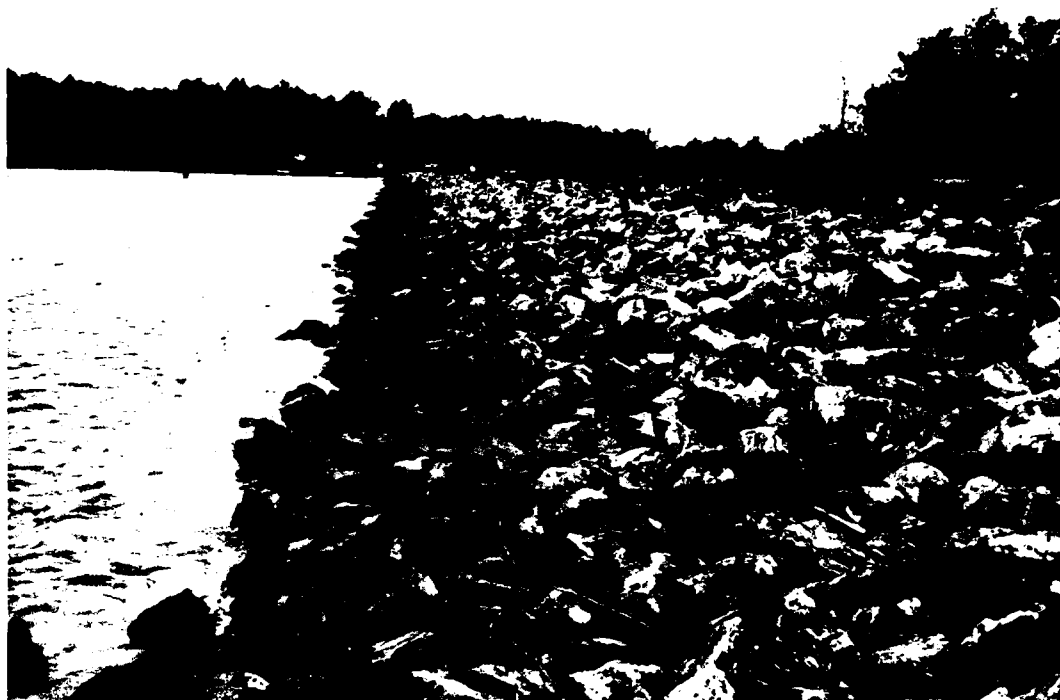
The support tower and stem for the emergency drain are badly corroded, unstable and may fail if operated. The outlet of the emergency drain is buried by material eroded from the embankment above.

**PHOTO 5. Riprap on Upstream Embankment, Emergency Drain Control and Support in Left Background**

VISUAL EXAMINATION OF	OBSERVATIONS	REMARKS OR RECOMMENDATIONS
EMERGENCY GATE	An emergency drain is located approximately 600 ft. from the left abutment. A gate valve hand control is located approximately 75 ft. off-shore. The gate valve supporting tower and mechanism are badly corroded and very unstable and may not operate.	The valve stem and support tower should be tested for operation and repaired with non-corrosive materials.

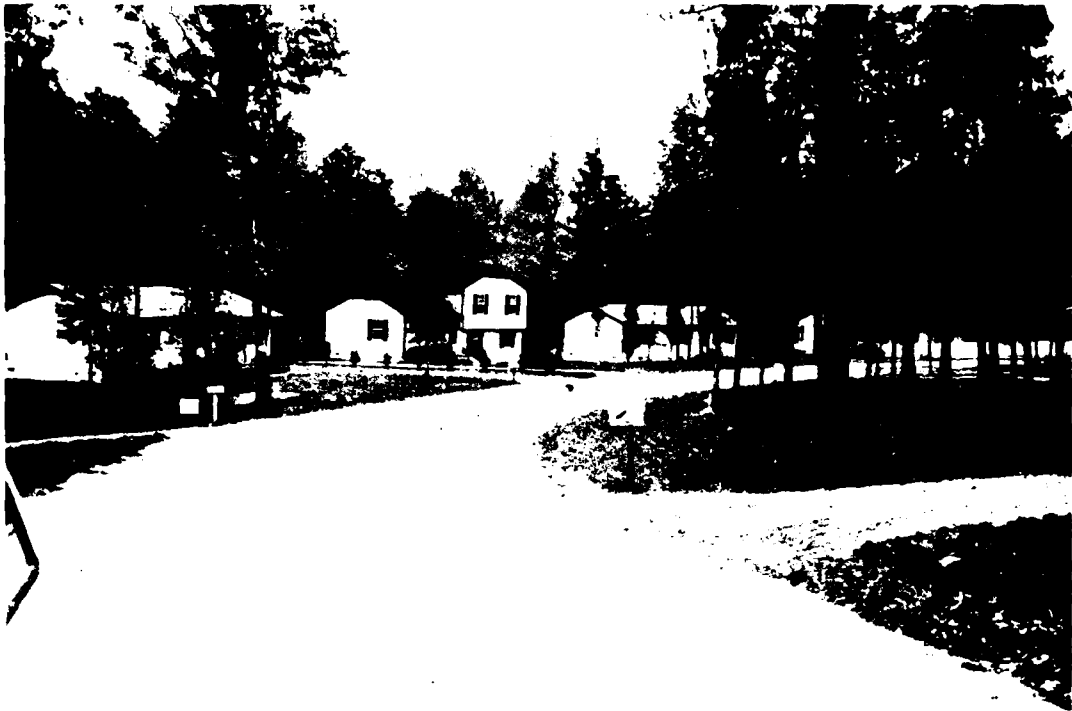
**PHOTO 7. Houses Downstream of the Dam, in Plan on West Side of U. S. Route 1**

Approximately 2.5 mi. downstream, at the U.S. Route 1 bridge, a housing development and trailer park are located on the left side of the river. Most of the structures are 30 ft. above the stream, but several houses are only 10 ft. above and could be damaged.

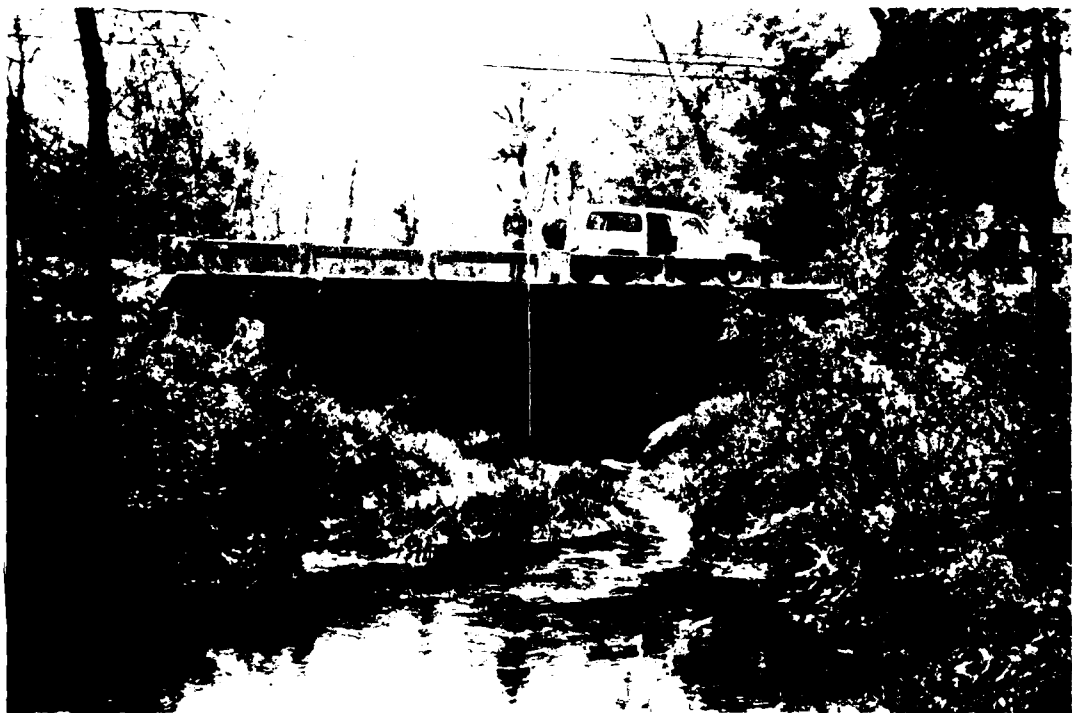
**PHOTO 8. Bridge for U. S. Route 1, Downstream of Dam**
