Name of Dam: Lake Heritage Dam

Inventory Number: VA 03332

PHASE I INSPECTION REPORT NATIONAL DAM SAFETY PROGRAM.

Name of Dam: Lake Heritage Dam
State: Commonwealth of Virginia
County: Caroline
USGS 7.5 Minute Quadrangles: Ladysmith, Virginia and
Hewlett, Virginia
Stream: Unnamed Tributary to Stevens Mill Run
Date of Inspection: 27 October 1980

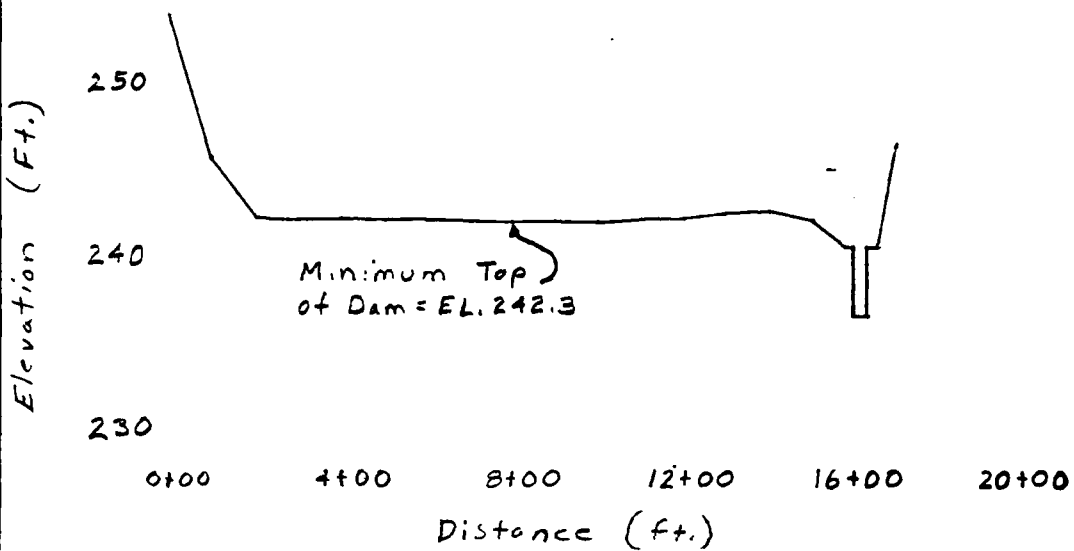
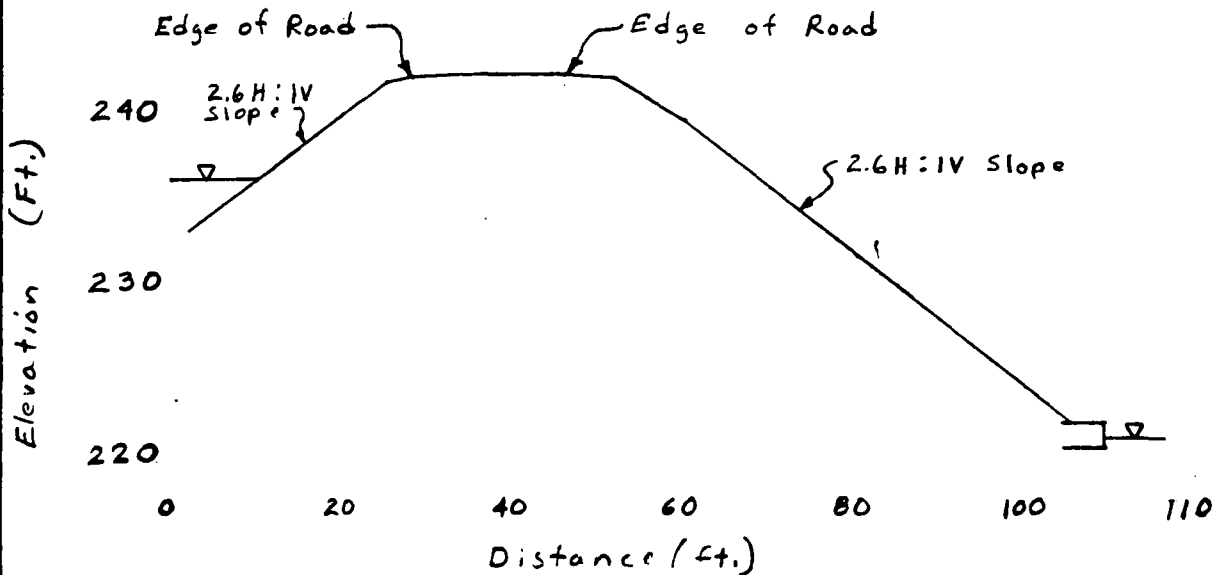
PLATE 7

Upstream & Downstream Slopes 2.6H:1V
 Crest Width 27 feet
 Height of Dam 21.3 feet
