Name Of Dam: WHEATLANDS
Location: FREDERICK COUNTY, VIRGINIA
Inventory Number: VA 06913

PHASE I INSPECTION REPORT NATIONAL DAM SAFETY PROGRAM.

Wheatlands Dam. (Inventory Number VA-06913),
Potomac River Basin. Frederick County,
Virginia. Phase I Inspection Report.

PREPARED BY
NORFOLK DISTRICT CORPS OF ENGINEERS
803 FRONT STREET
NORFOLK, VIRGINIA 23510

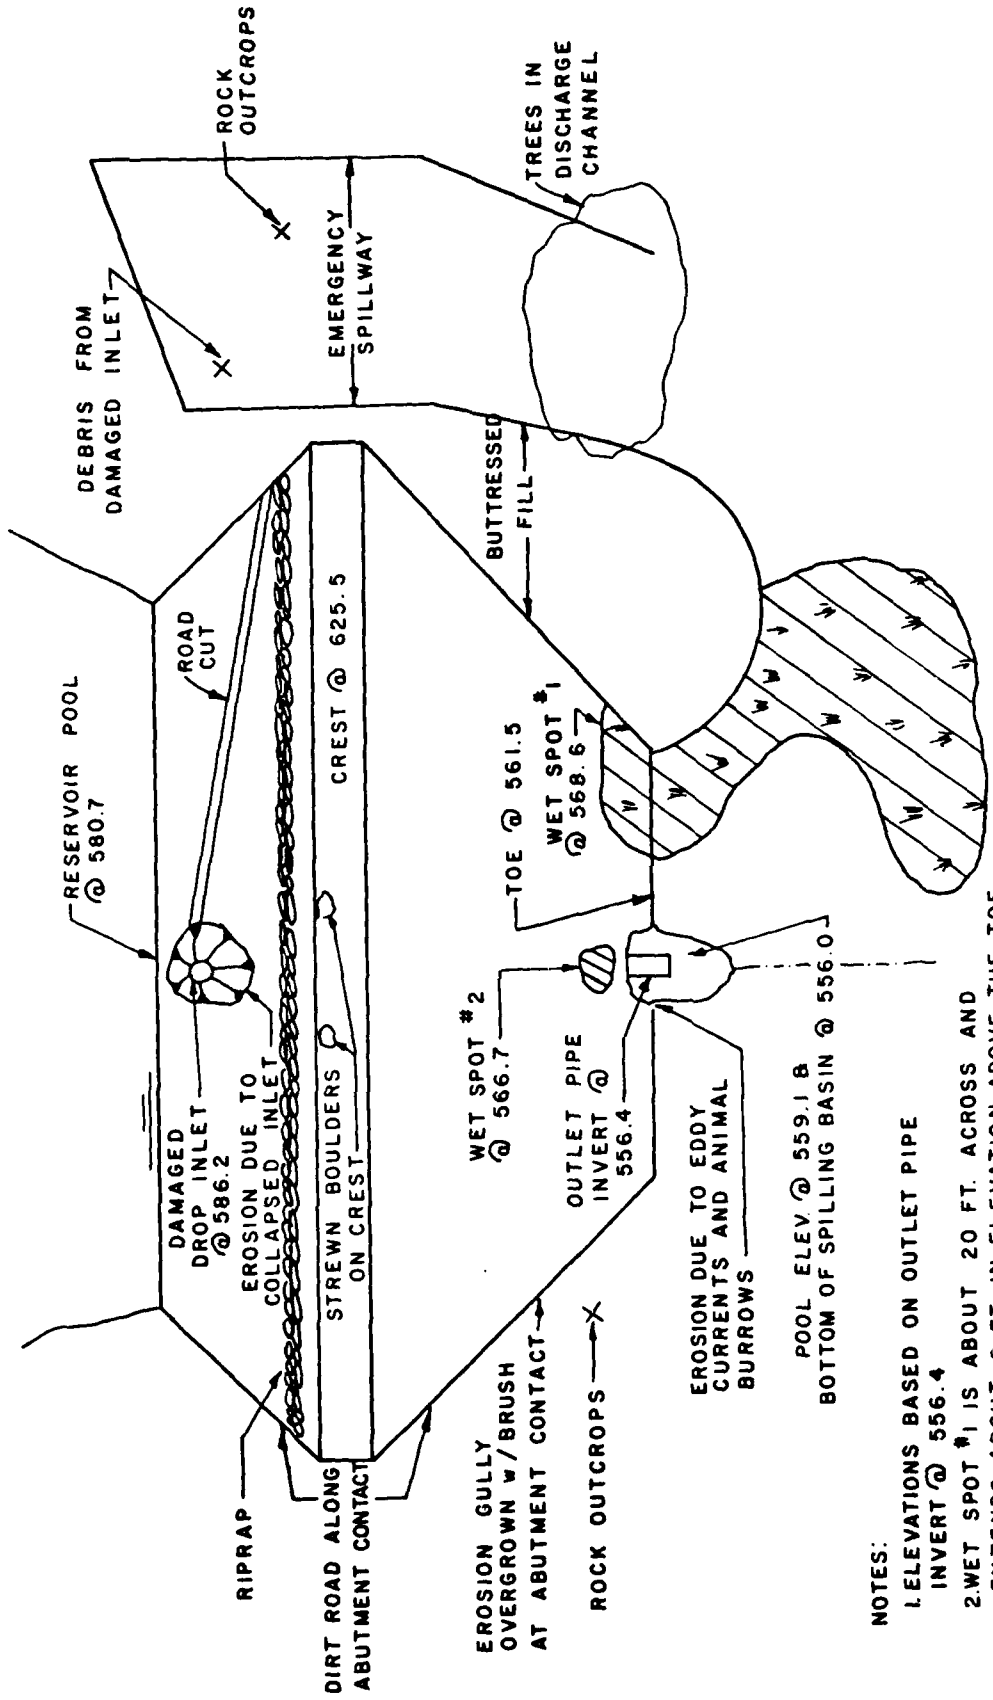
FIELD SKETCH
WHEATLANDS DAM
 FREDRICK, CO. VA.
 29 OCTOBER 80
 N.T.S.
PLATE I
APPENDIX III

- NOTES:
1. ELEVATIONS BASED ON OUTLET PIPE INVERT @ 556.4
 2. WET SPOT #1 IS ABOUT 20 FT. ACROSS AND EXTENDS ABOUT 6 FT. IN ELEVATION ABOVE THE TOE. THE SPOT SUPPORTS SWAMP LIKE VEGETATION. THE WET SPOT EXTENDS ABOUT 100 FT. DOWNSTREAM, HARBORS SWAMP LIFE GROWTH AND HAS STANDING WATER.
 3. A SECOND WET SPOT IS LOCATED ABOUT 10 FT. UP FROM THE DISCHARGE PIPE. THE SPOT IS ABOUT 7' ROUND.
