Name of Dam: Piedmont Geriatric Hospital Dam

Location: Nottoway County, Commonwealth of Virginia

Inventory Number: VA 13520

## PHASE I INSPECTION REPORT NATIONAL DAM SAFETY PROGRAM

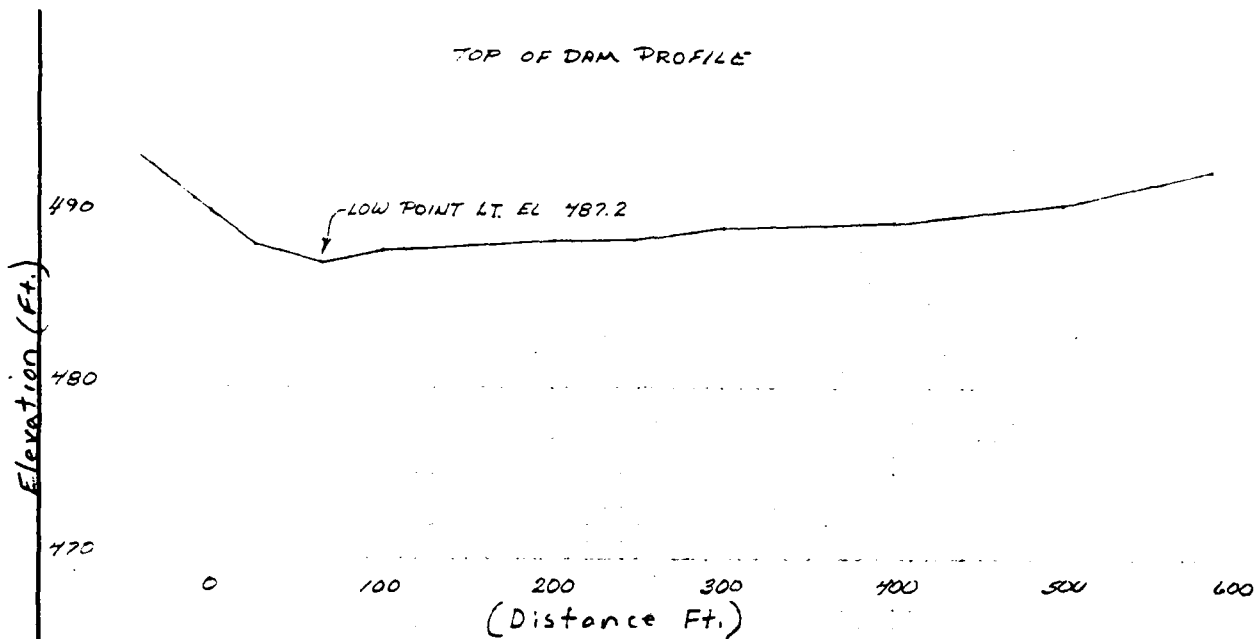
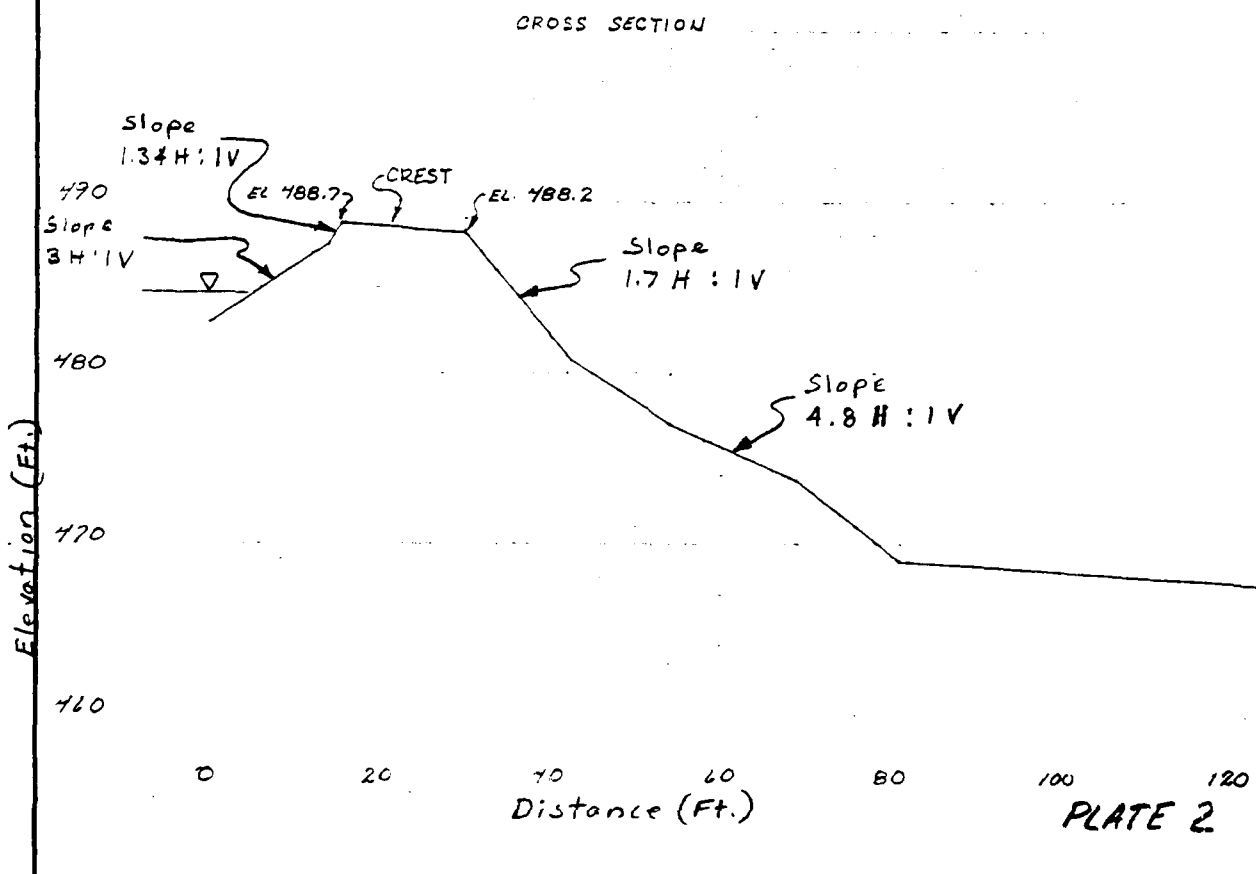
PLATE 2

Plate 2: Top of Dam Profile and Typical Dam Cross Section

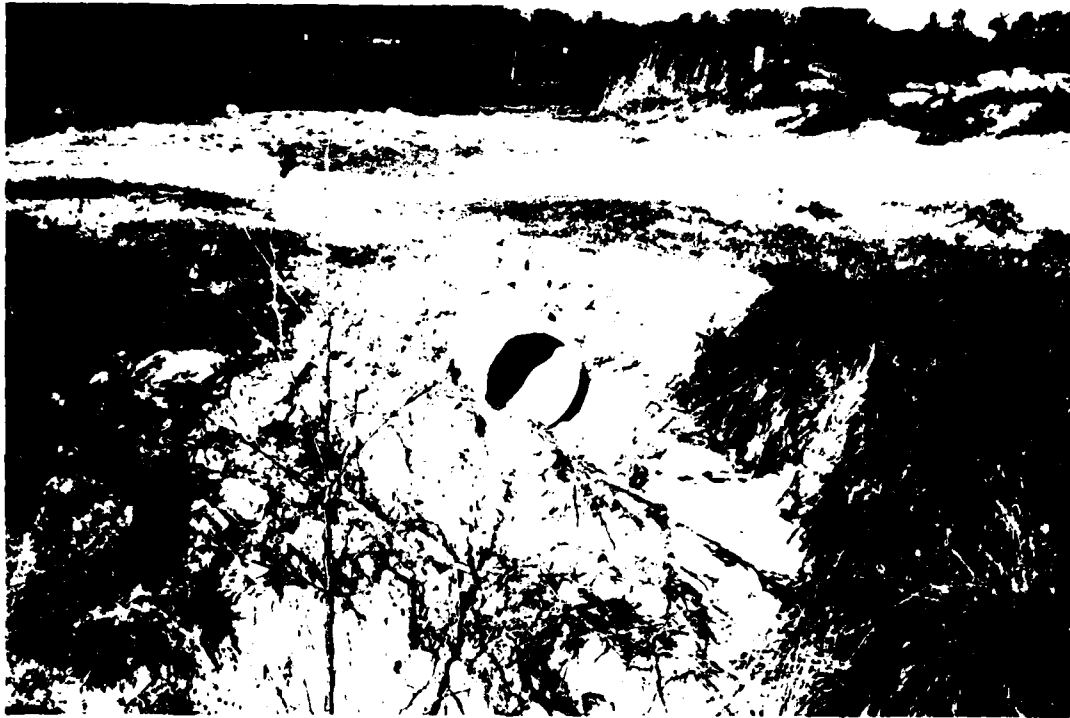
**PHOTO 5. New Emergency Spillway Outlet**
