Name Of Dam: COLLEGE LAKE  
Location: CITY OF LYNCHBURG, VIRGINIA  
Inventory Number: VA 68002

## PHASE I INSPECTION REPORT NATIONAL DAM SAFETY PROGRAM

PREPARED BY  
NORFOLK DISTRICT CORPS OF ENGINEERS  
803 FRONT STREET  
NORFOLK, VIRGINIA 23510

IN CONJUNCTION WITH  
COMMONWEALTH OF VIRGINIA  
STATE WATER CONTROL BOARD  
NOVEMBER 1980

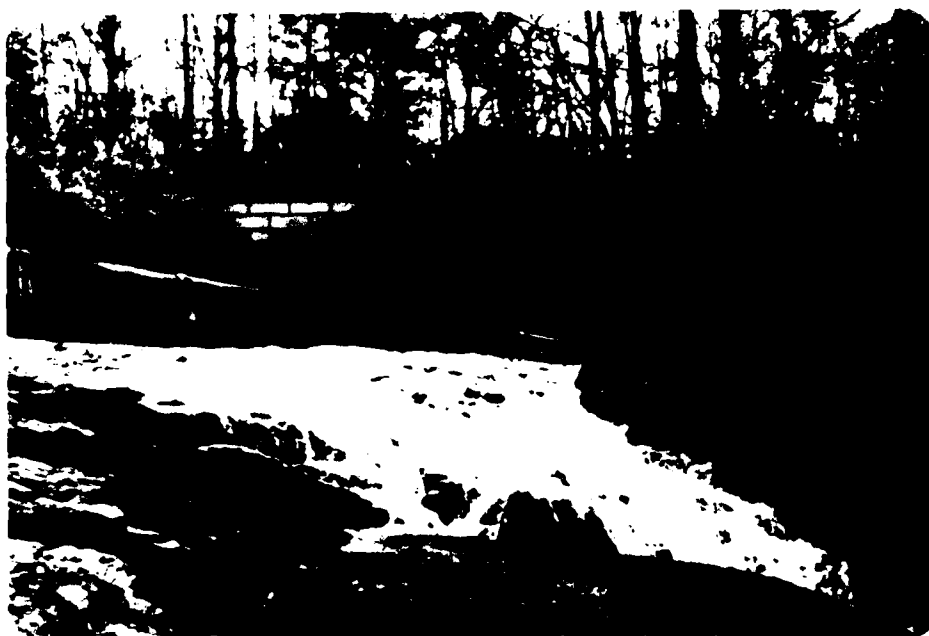
SPILLWAY

3.1.3 Spillway: The spillway consists of a deteriorated masonry weir across an open rock cut through the right abutment. The approach channel to this is clear with the exception of vegetation and brush on each side of the channel. There is a concrete arch bridge carrying U. S. Rt. 221 spanning the outlet channel of the spillway. Also there is a 24-inch and an 15-inch ductile iron sewer line passing through the opening under the bridge on the right side in the outlet channel. The bed of the outlet channel is a sound outcrop of metamorphic rock.

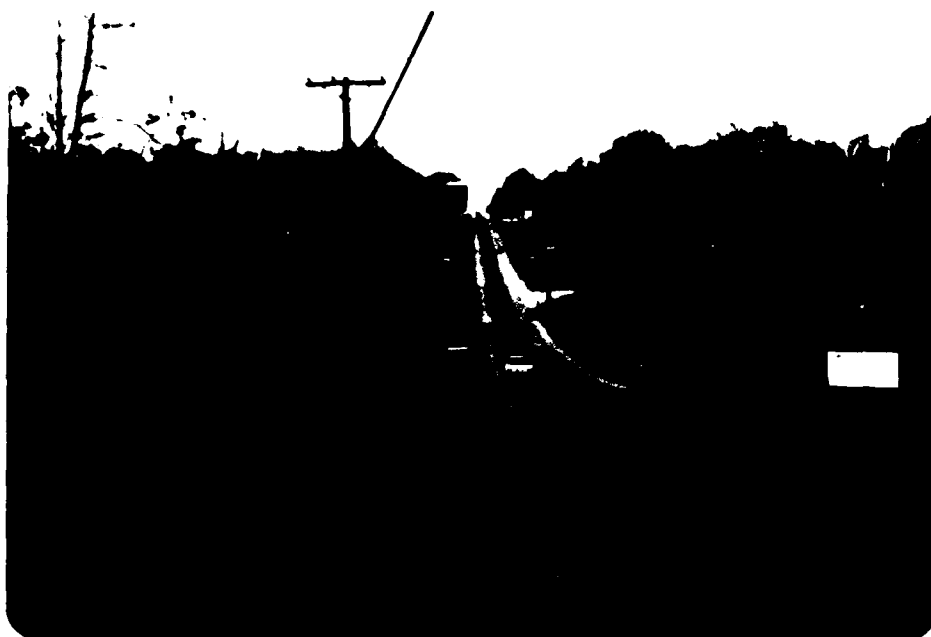
PHOTO \*1 CREST OF DAM

| VISUAL EXAMINATION OF | OBSERVATIONS | REMARKS OR RECOMMENDATIONS |
|---|---|---|
| VERTICAL AND HORIZONTAL ALIGNMENT OF THE CREST | Appears to be good. Asphalt pavement of roadway was in good condition. | None |

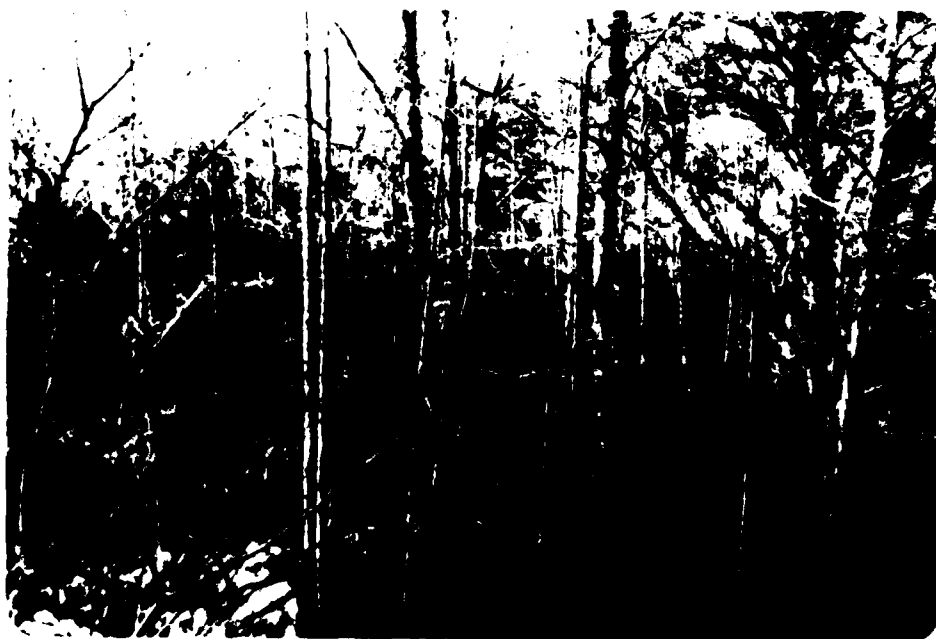
There are no signs of surface cracks, unusual movement, sloughing, or misalignment. However, there is a bench on the upstream face which is apparently the result of riprap failure and wave action. There are numerous animal burrows near the left abutment on the downstream face.

PHOTO \*2 DOWNSTREAM FACE

- a. The animal burrows should be dressed with compacted fill and seeded.
- b. Place compacted fill in the area of the face eroded by wave action, reseed, and protect with riprap at the wave line area.
- c. Remove the brush and cut all trees. All trees greater than three inches in diameter should have their root structure and root ball removed. The subsequent holes should be filled with well compacted earth and seeded.
- d. Locate the wheel to the sluice gate stem and determine if the gate works. If it is not operable, make the necessary repairs to make it functional.

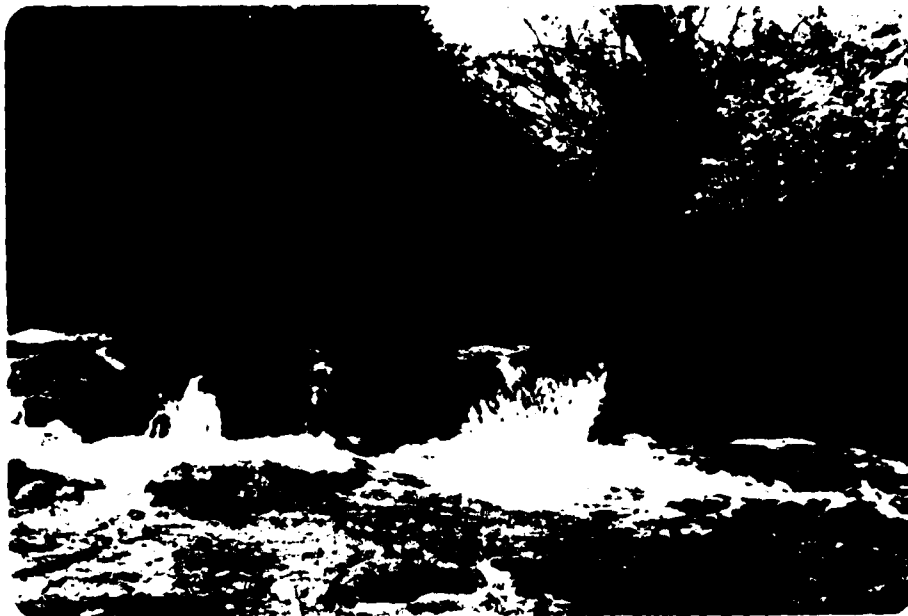
A weir was constructed in the spillway in 1939 to raise the pool level of the reservoir to elevation 633.0. Based on verbal conversations of long time City of Lynchburg employees, this weir was removed to accommodate the construction of sewer lines through the spillway and was not replaced after the sewer lines were constructed.

PHOTO # 5 RESERVOIR AREA & STONE  
REMNANTS OF PREVIOUS EFFORTS  
TO RAISE POOL LEVEL

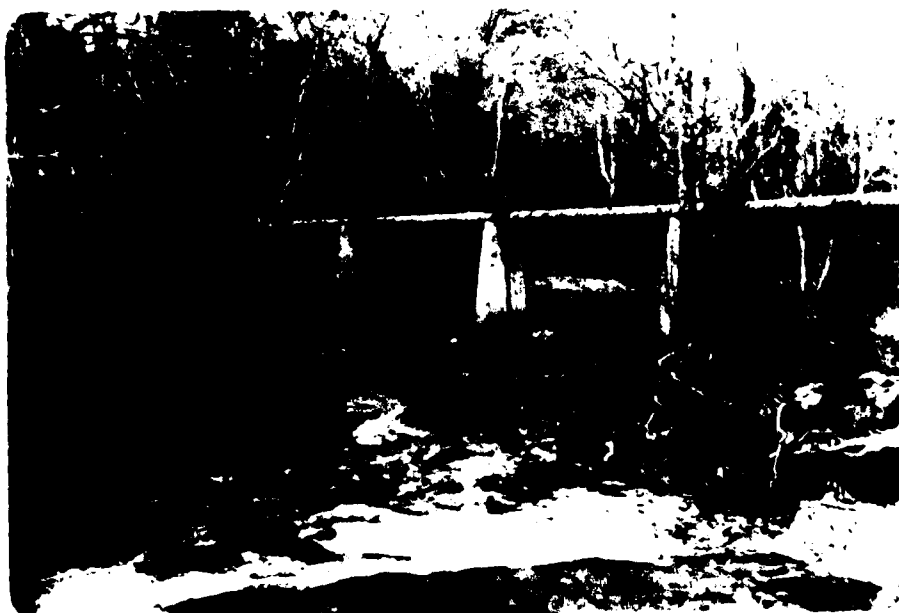
PHOTO # 6 AREA DOWNSTREAM OF SPILLWAY  
DISCHARGE CHANNEL

| VISUAL EXAMINATION OF | OBSERVATIONS | REMARKS OR RECOMMENDATIONS |
|---|---|---|
| CONDITION<br>(OBSTRUCTIONS,<br>DEBRIS, ETC.) | The channel was clear of obstructions<br>except for a 24" sewer line which<br>crosses the channel at a high level.<br>The banks were heavily wooded. | None |
