Name Of Dam: LAKELAND
Location: CAMPBELL COUNTY.
Inventory Number: VA 03111

PHASE I INSPECTION REPORT
NATIONAL DAM SAFTY PROGRAM

PREPARED BY
NORFOLK DISTRICT CORPS OF ENGINEERS
803 FRONT STREET
NORFOLK, VIRGINIA 23510

NOVEMBER 1980

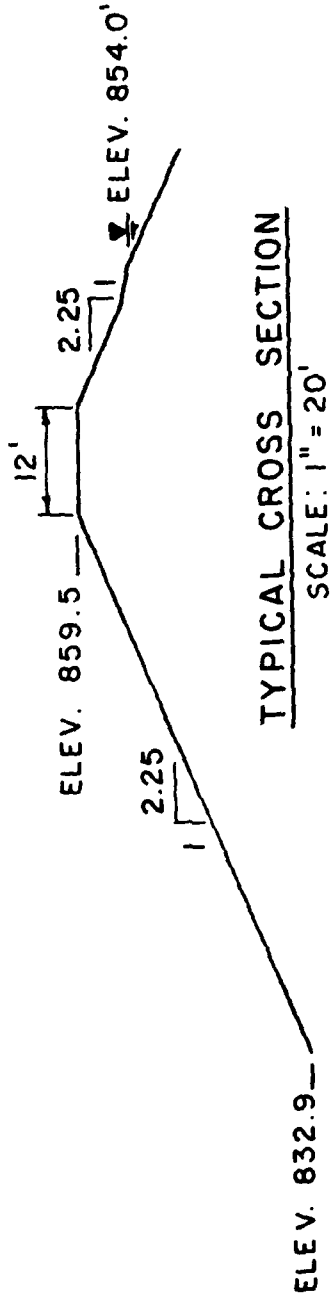
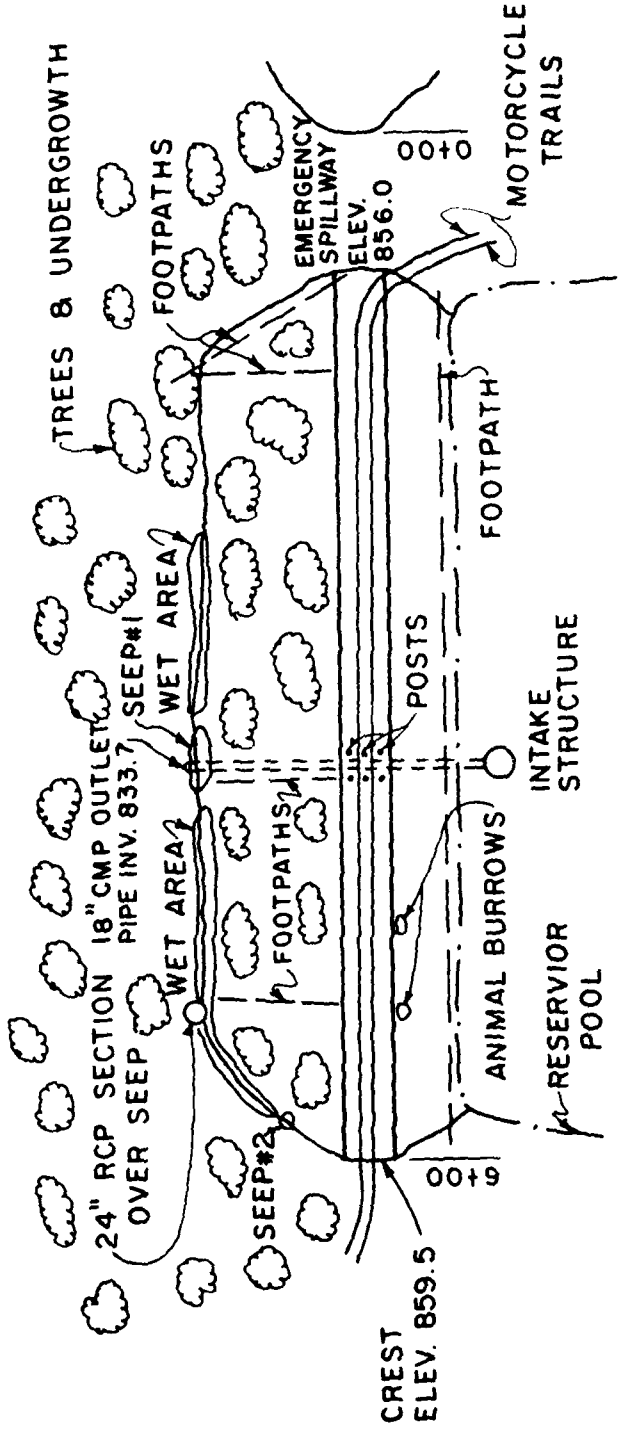
LAKELAND DAM
CAMBELL COUNTY
8 OCTOBER 1980
PLATE II

3.1.2 Embankment: The embankment is in good condition. A sketch showing a plan view and cross section is provided on Plate II, Appendix I. An overall view of the crest is provided at the beginning of the report.

There are no signs of surface cracks, unusual movement or misalignment. However, there are two animal burrows located on the upstream face of the dam (See Plate II, Appendix I) at station 4+50 and 5+00. The burrow at station 4+50 is about 8 inches in diameter and over 4 feet deep. There is a local sloughing of material around the burrow. The burrow at station 5+00 is much smaller. Two motorcycle trails run up the upstream right abutment, cross the crest and continue up the left abutment. A foot path runs along the waterline on the upstream face and several footpaths run down the downstream face from the crest to the toe.

a. The animal burrows should be filled with compacted material, the surrounding area dressed and seeded.
