TECHNICAL REPORT SL-81-4

# TEST AND ANALYSIS OF UPGRADED ONE-WAY REINFORCED CONCRETE FLOOR SLABS

Mark K. McVay

Structures Laboratory  
U. S. Army Engineer Waterways Experiment Station  
P. O. Box 631, Vicksburg, Miss. 39180

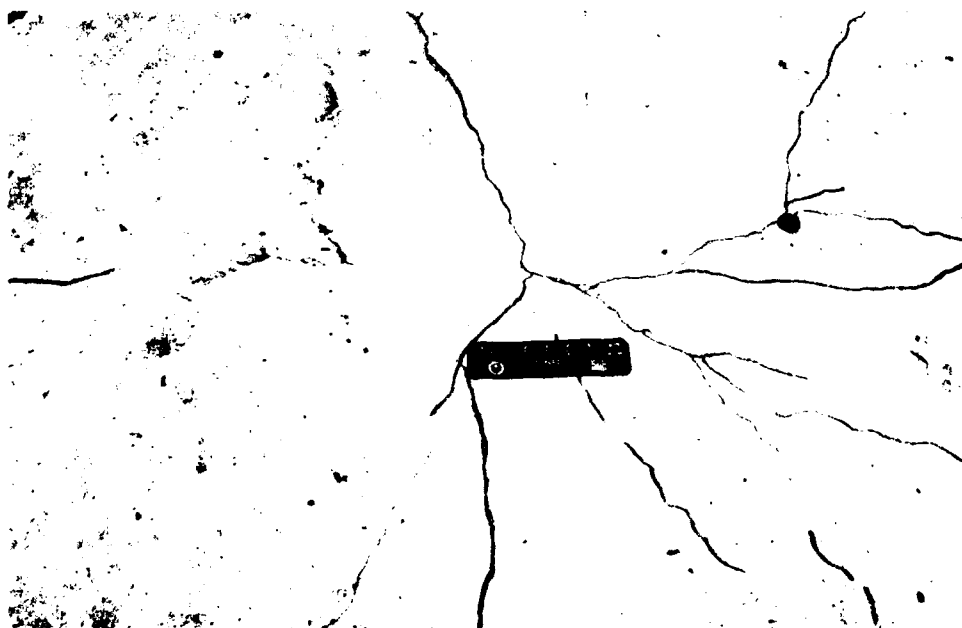
Figure 5.22 The concrete lifting up over the wooden column on load cell L1.

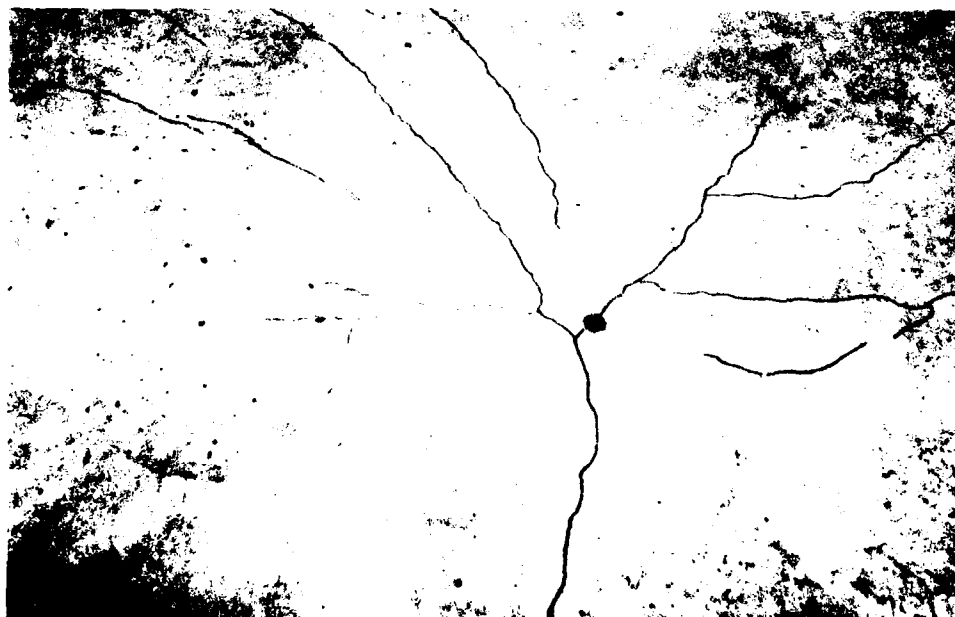
Figure 5.24 The concrete lifting up as the wooden post, on top of load cell L2, starts to punch through.

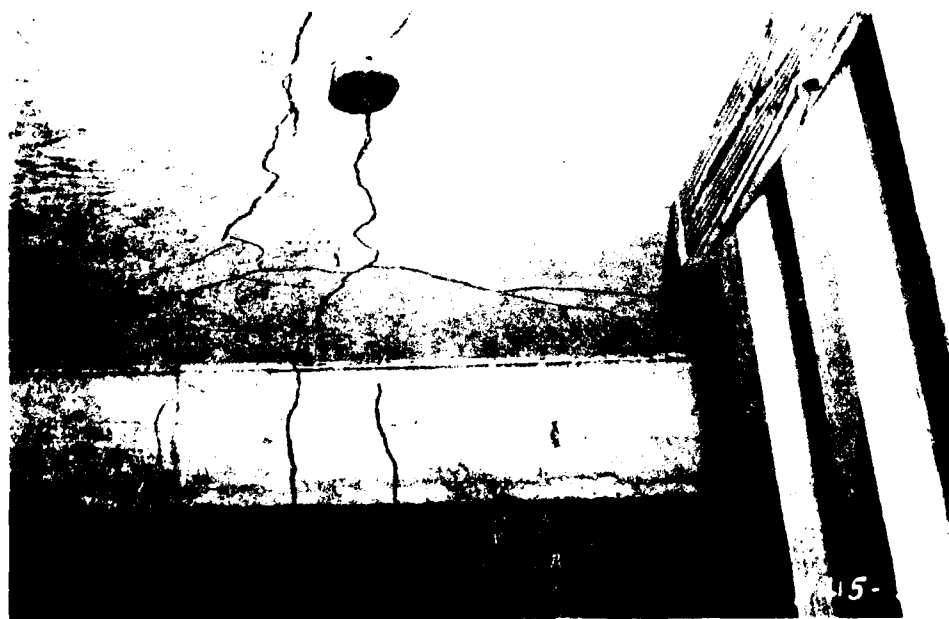
Figure 5.31 Cracks in the underside of the east slab panel at the center, after shot SLAB 2E.

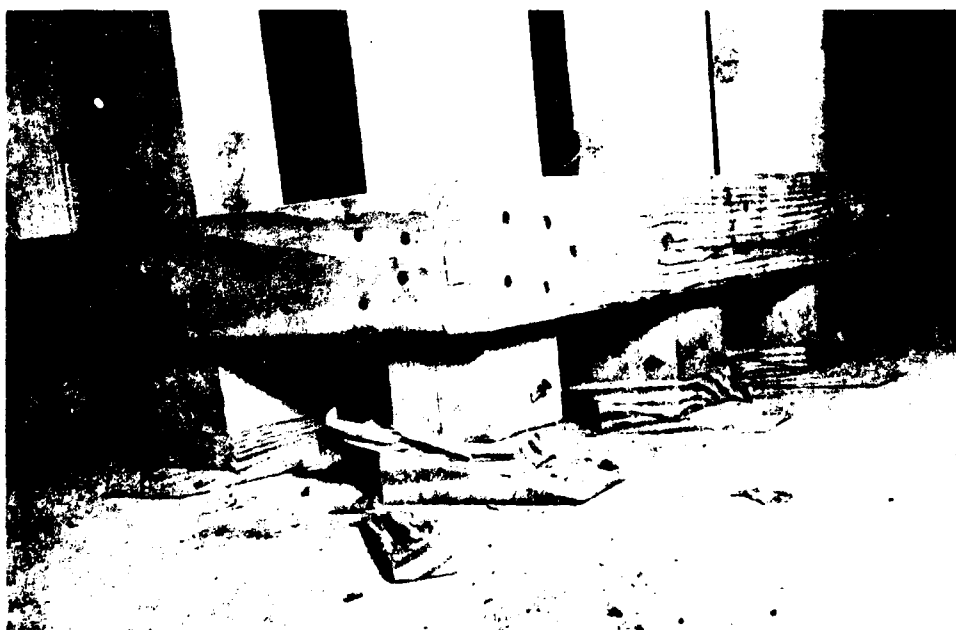
Figure 5.35 A few wedges crushed under posts in columns upgrading a slab panel, after shot SLAB 2E.

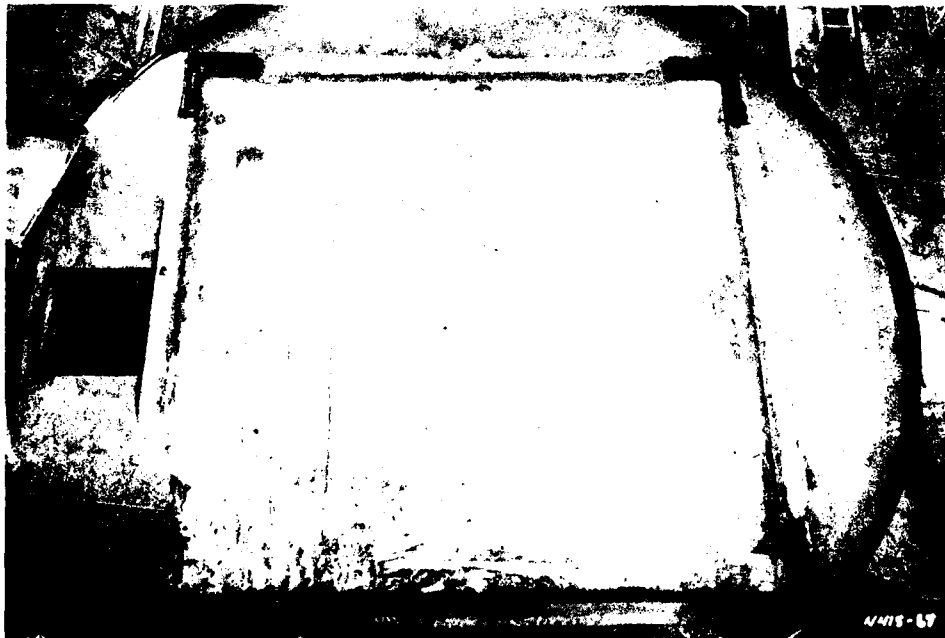
Figure 5.39 Cracks in the top of Test Structure 3 after shot SLAB 3A.
