NMRI-81-47

81 - 47
HUMAN ENGINEERING EVALUATION
OF THE
HYPERBARIC RESEARCH FACILITY
(PHASE 1)

J.I. Brady and M.D. Curley

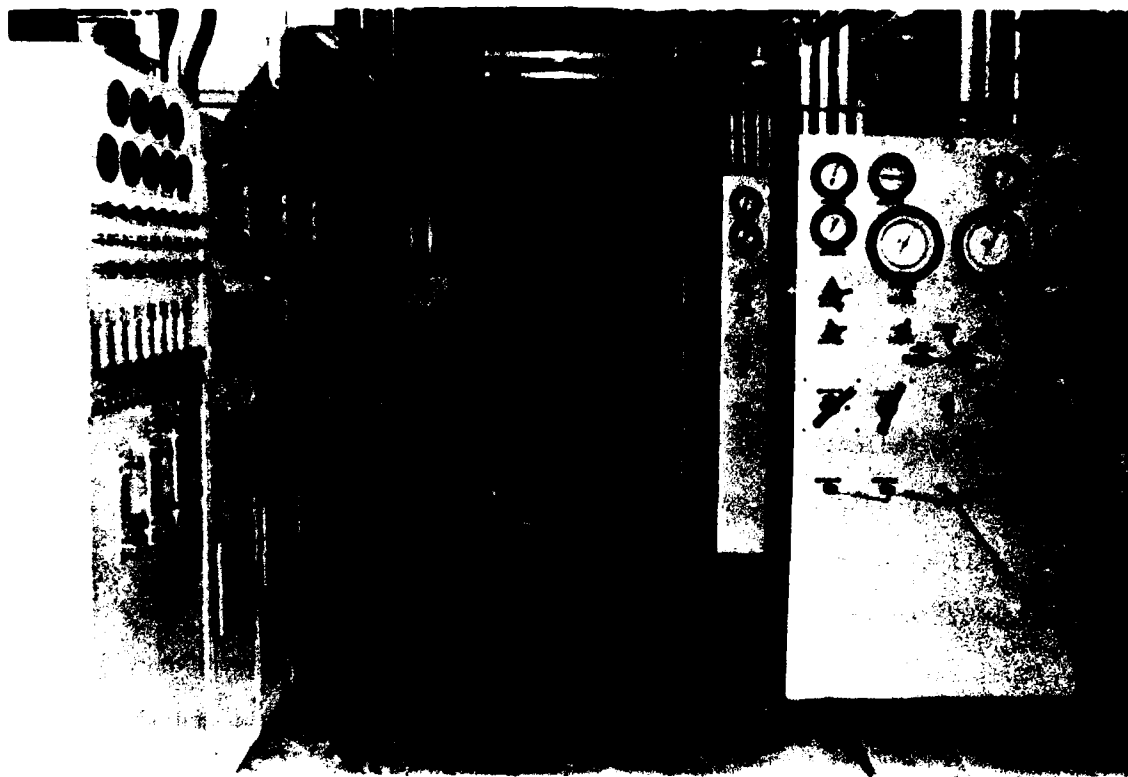
- (5) After much consideration, it is felt that completely enclosing the control area for purposes of sound attenuation is impractical due to the extent of overhead piping (Fig. 3). The major sound sources should be attenuated if possible at their sources (i.e., ACS blowers and building air conditioning). A solution involving the wearing of

Fig. 3. Operating and local panels in master control area. Note extent of overhead piping.

ear protectors by personnel should be avoided if at all possible. (Priority 1)

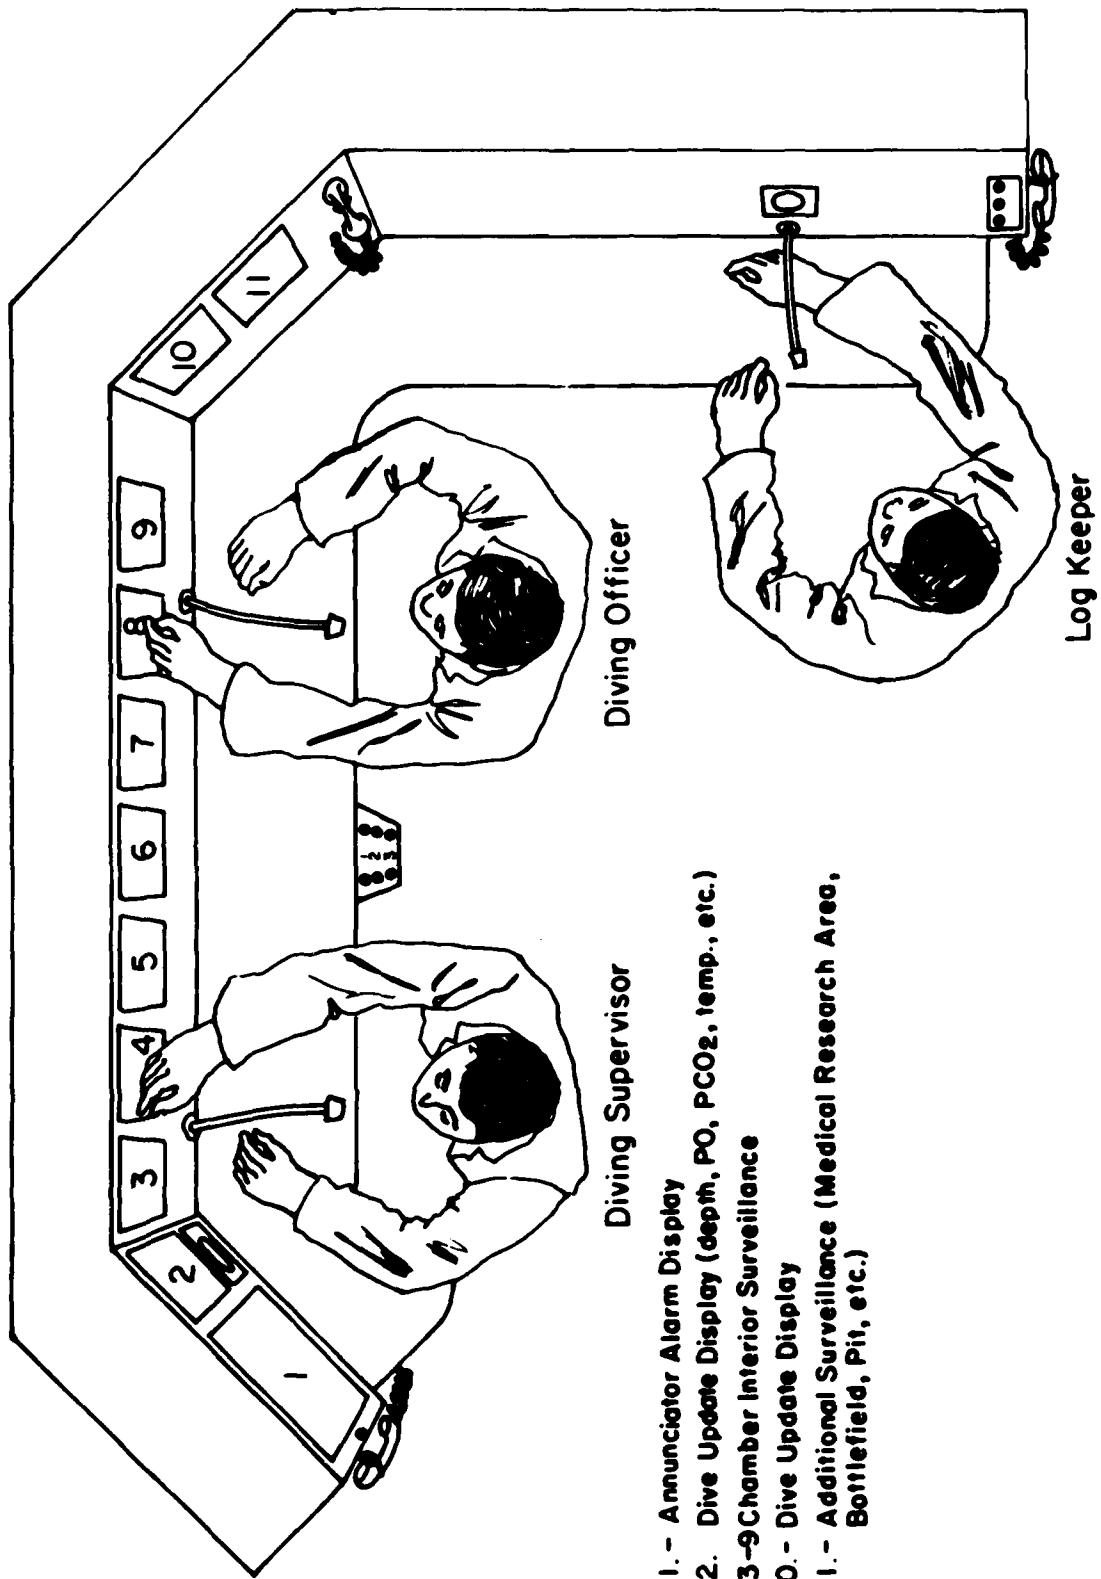
(7) The present console design does not provide an adequate diving officer and diving supervisor watch station. Such a watch station should function primarily as a central monitoring location. Figures 5 and 6 show a recommended layout for this watch station. Figure 7 indicates the suggested location for the station. This location provides a complete view of the master control consoles, as well as easy access to the medical research area and visitor observation areas. (Priority 2)

Fig. 5. Possible layout for a central monitoring console to accommodate the diving officer, diving supervisor, and log keeper.

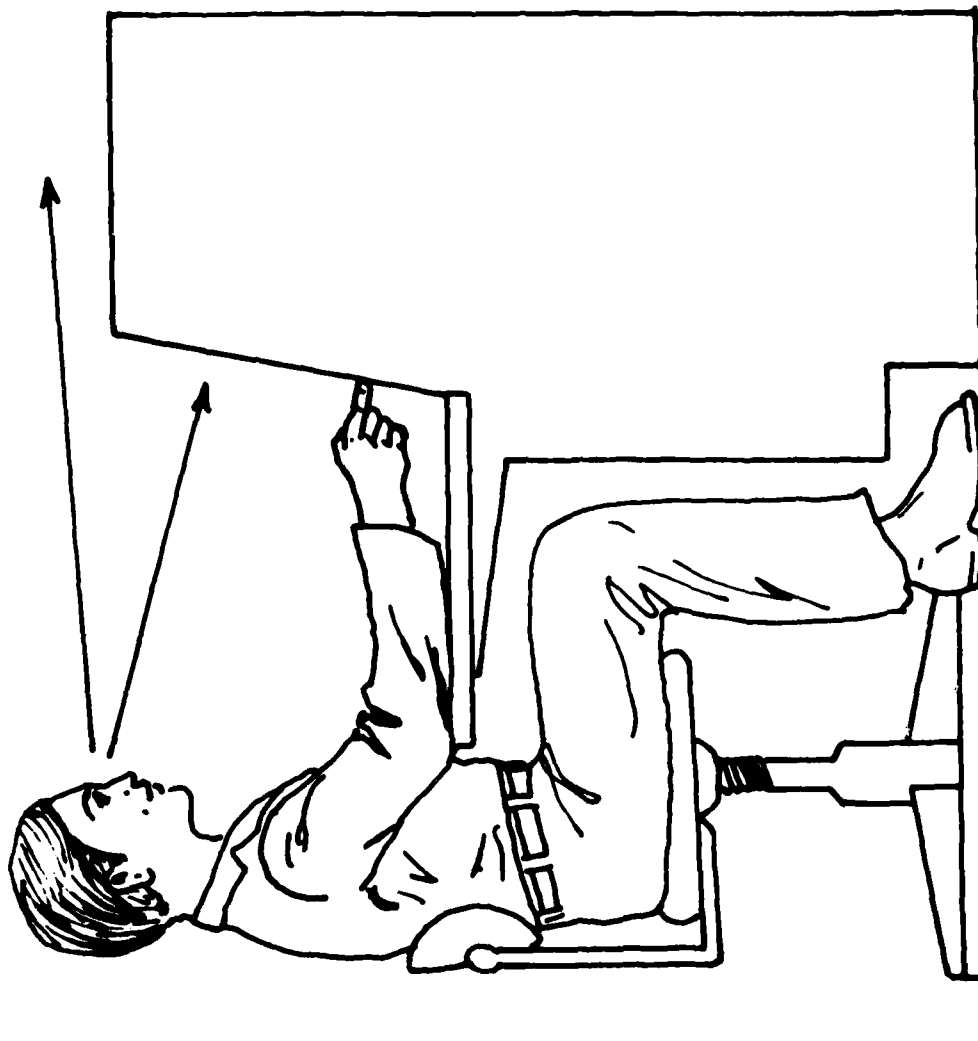
Fig. 6. Side view of a central monitoring console for a seated operator.

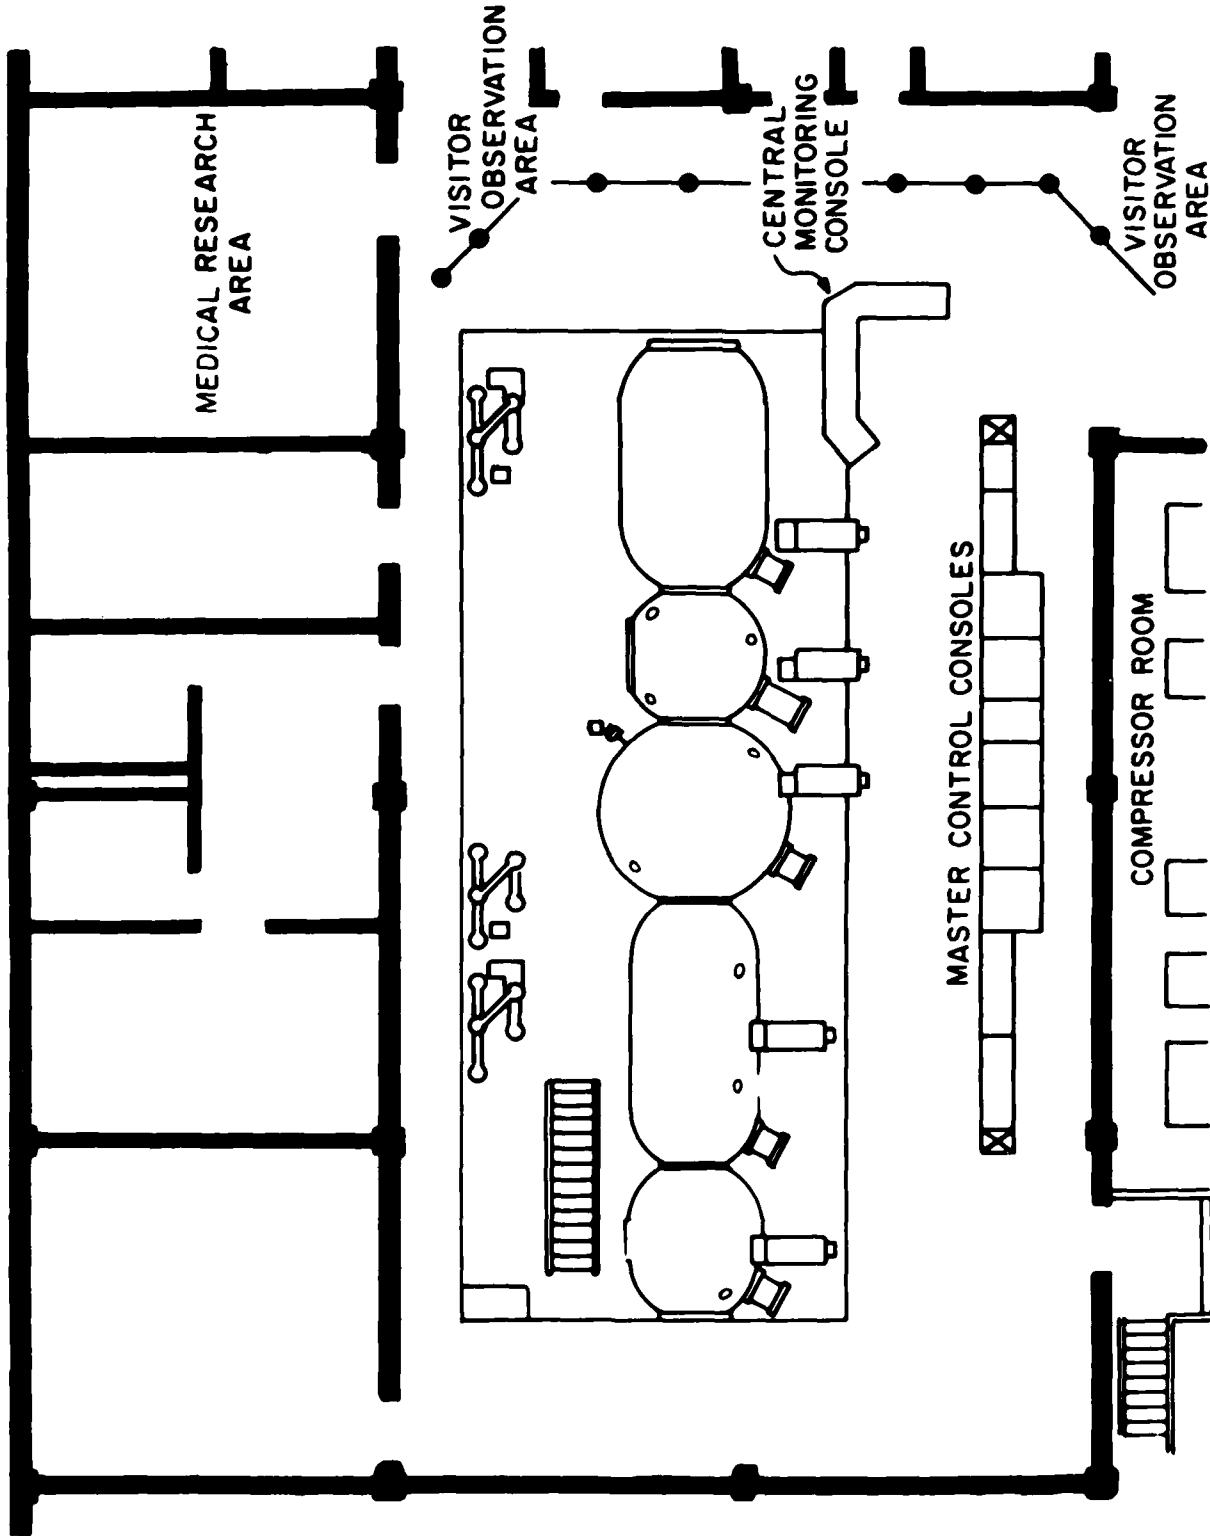
Fig. 7. Recommended location of central monitoring console.

Until now, a location for the biomedical research equipment and research personnel during diving operations was not allocated. The recommended site for such a capability was shown previously in Fig. 7. (Priority 1)

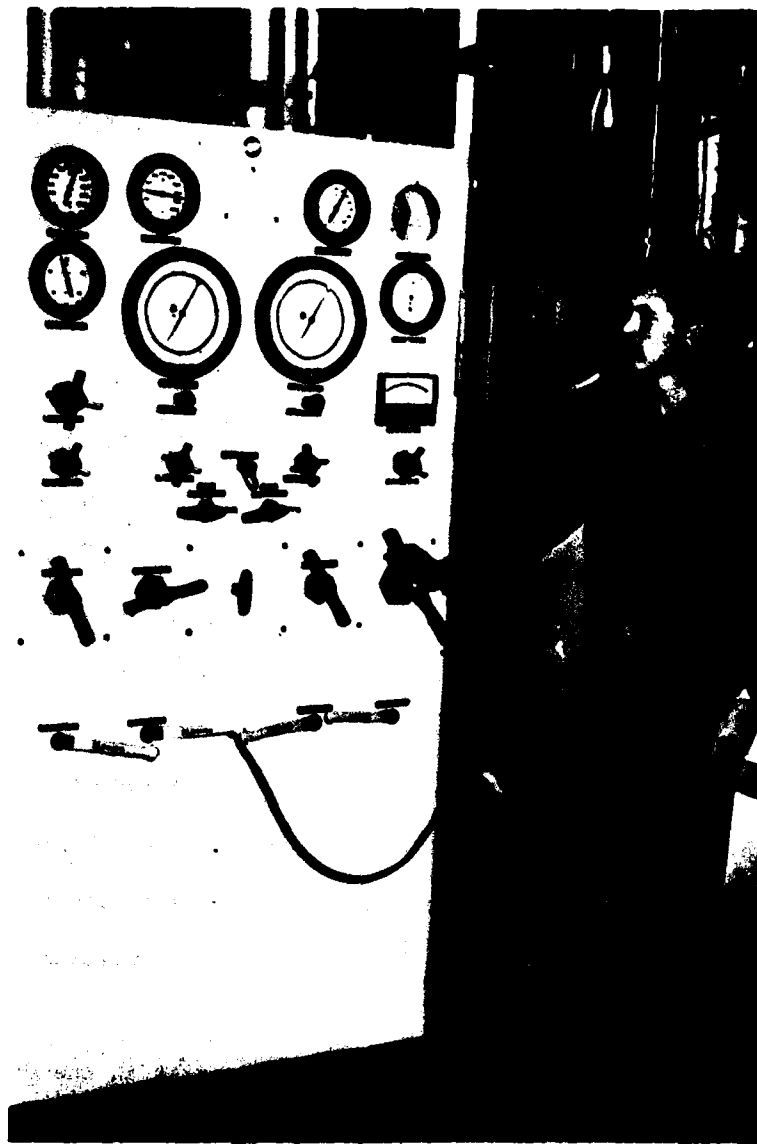
- (15) A selectable TV monitor capability should exist in the Office of the Director of Hyperbaric Medicine Program Center. (Priority 4)
- (16) The sound-powered phone cord on the local panels (Fig. 8) should exit on the chamber side of the panel to prevent cord interference with valve operation on the panel front. (Priority 3)

Fig. 8. Local panel with sound-powered phone cord amidst panel valving.

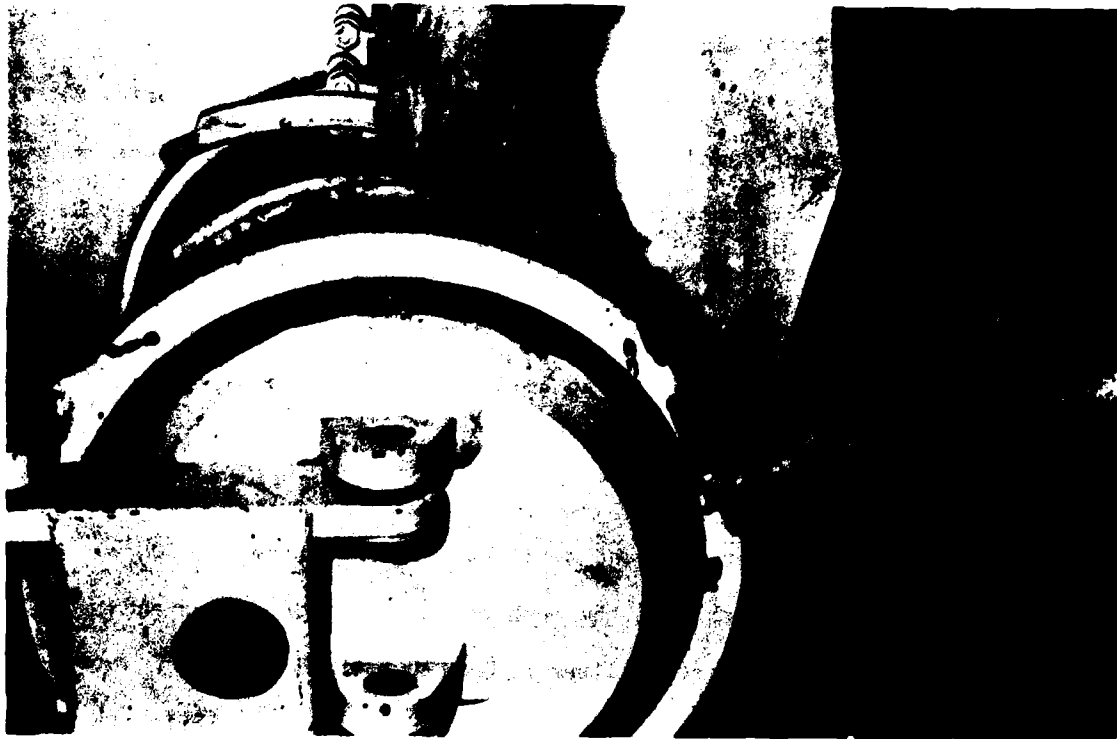
- (17) The present design of the external medical lock hatch causes inefficient and time-consuming delays in its opening and closing (Fig. 9). Alternative design configurations should be investigated. (Priority 1)

Fig. 9. Present design of external medical lock hatch.

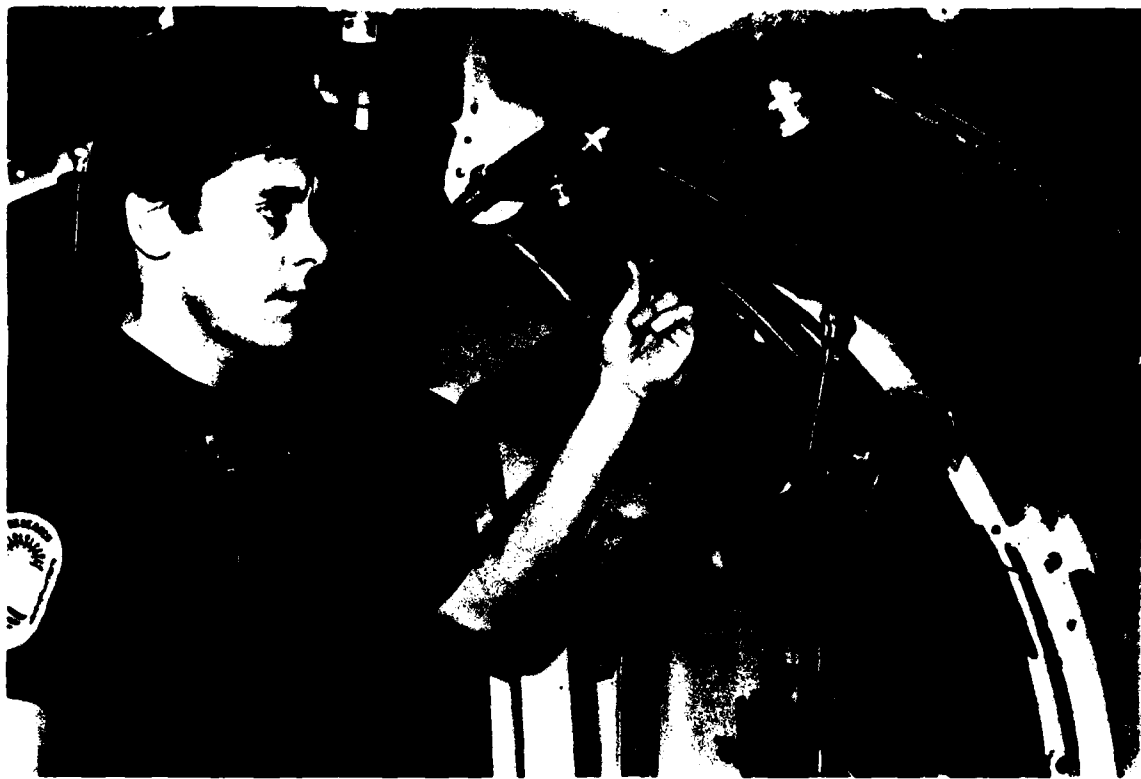
- modification of the FES pressure tracking system may be necessary if the problem is to be corrected. (Priority 1)
- (24) The design of the present FES lanyard pull inside the chamber may result in frequent inadvertent activations (Fig. 13). A lever or pushbutton design can still be operated quickly and yet would not lend itself to inadvertent operation. (Priority 2)

Fig. 13. Fire extinguishing system lanyard pull in D chamber. A pull on the cord activates the system causing a water spray to drench the chamber contents.

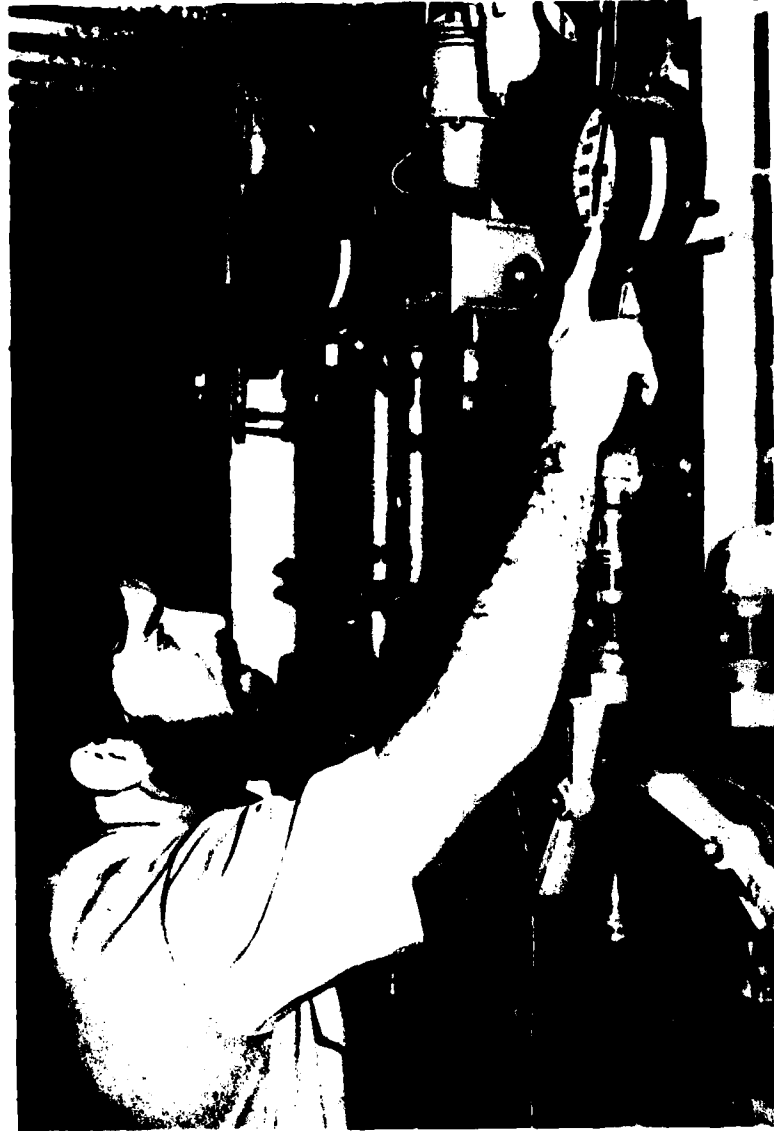
- (26) Bank pressure gauges in the bottlefield should be repositioned or at least tilted down for more efficient viewing (Fig. 14). (Priority 4)
- (27) A slightly elevated walkway (1-2 in.) through the bottlefield alleyway will provide better footing, easier access to some difficult to reach valves, and greater readability of the bank gauges (Fig. 15). However, it should not be so high as to cause head clearance problems with lights, etc. (Priority 4)

Fig. 14. Fifth percentile diver having difficulty reading bottlefield bank pressure gauge.

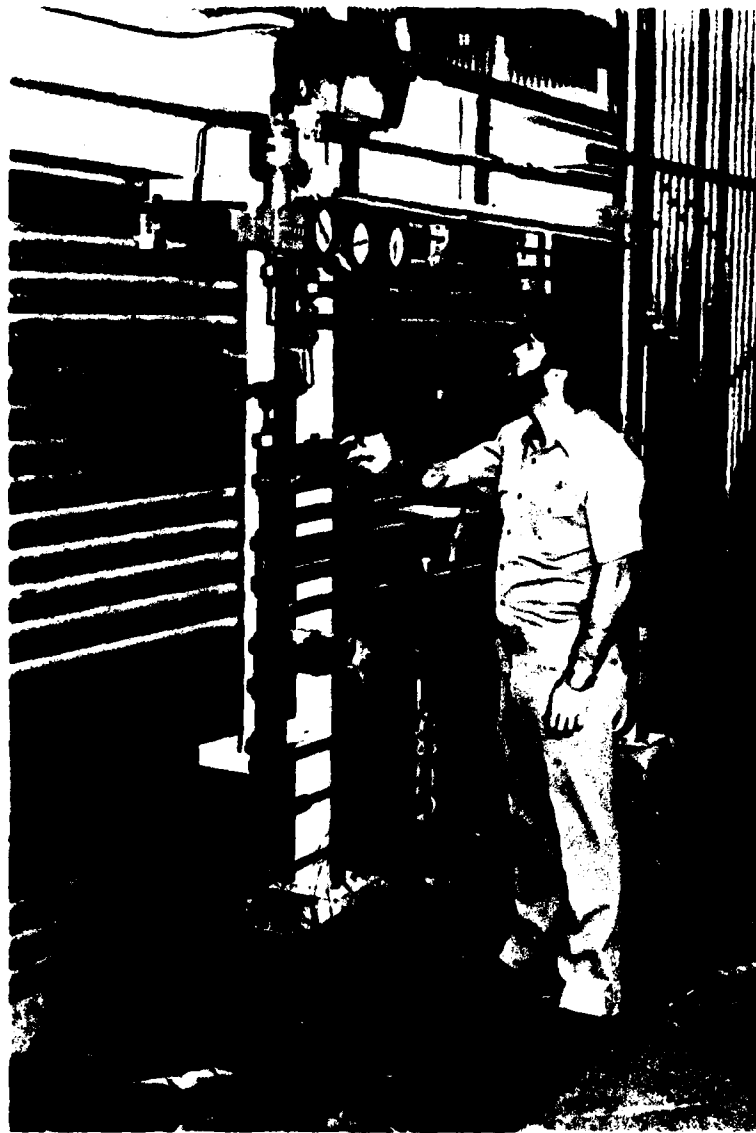
- (28) A protective roof or hood to shield the bottlefield oxygen regulators and their associated valves from ice and snow in the winter is recommended (Fig. 16). (Priority 2)

Fig. 16. Bottlefield oxygen regulators and valving are located outside and have no protection from inclement weather.

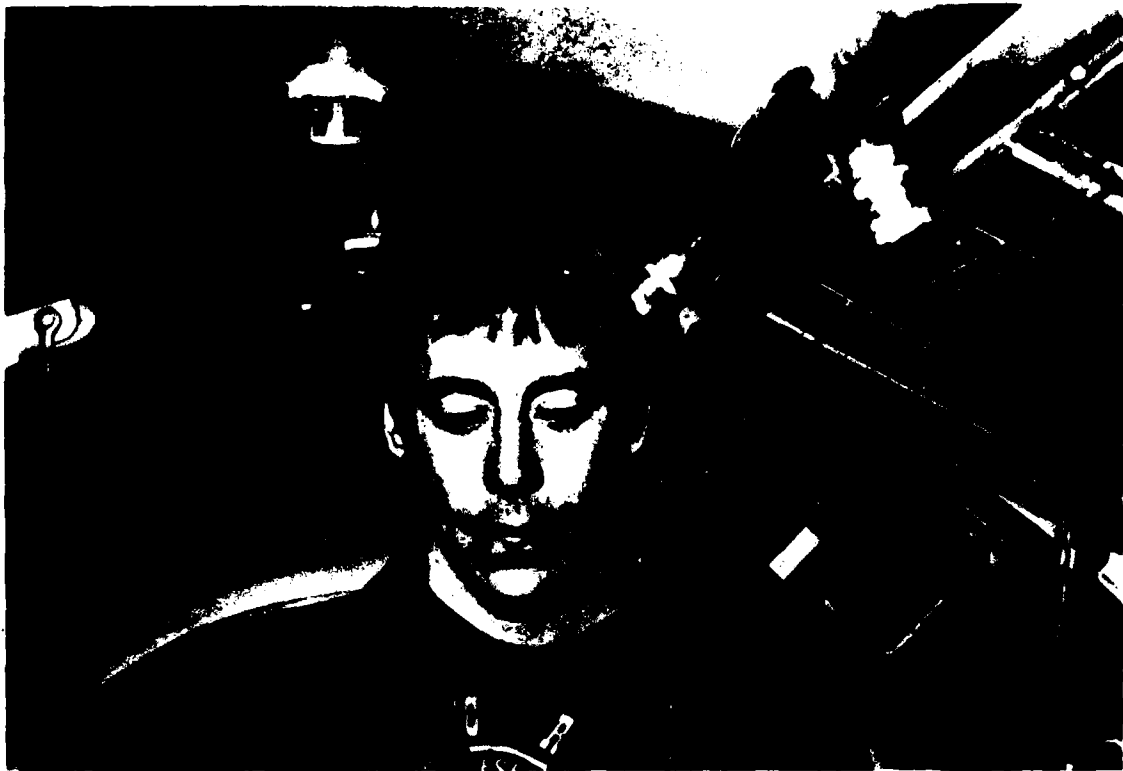
Fig. 17. Fire extinguishing system spray nozzles pose possible head impact problems for divers.

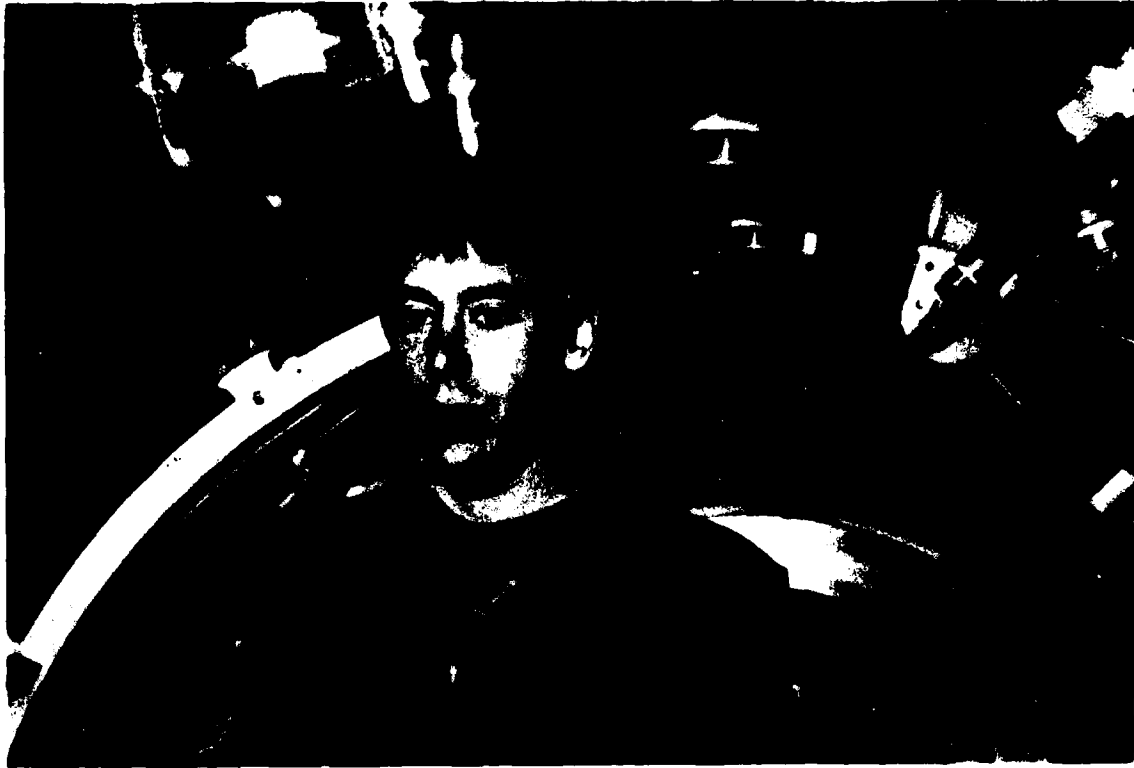
Fig. 18. Screened overhead penetrators pose head injury possibilities for divers over 71 in.

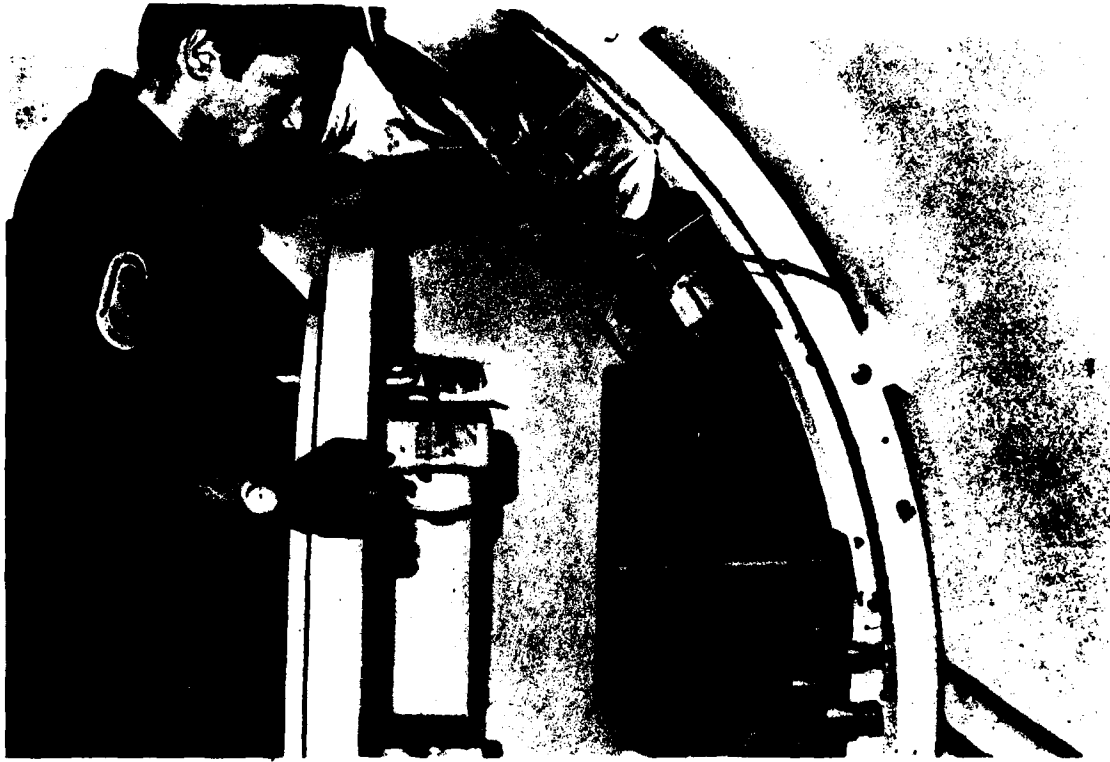
Fig. 20. Hatch opened in D chamber and obscuring the fold-down sink.

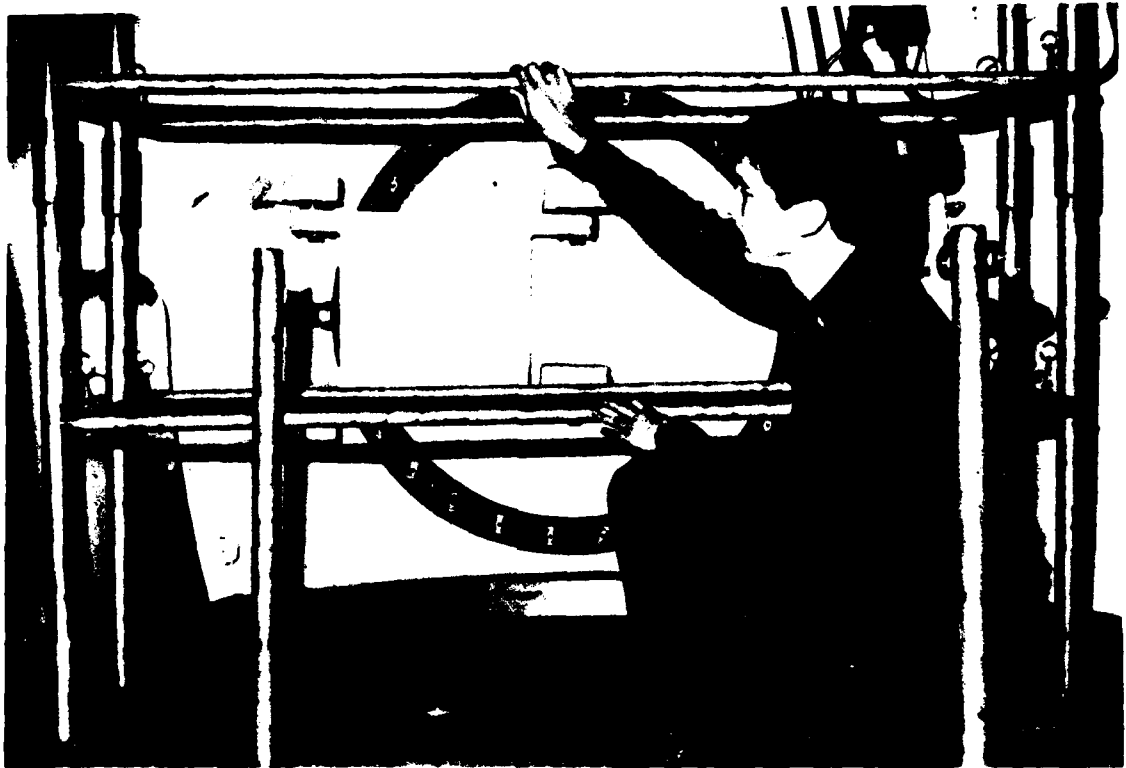
- (38) The removable bunks in C chamber (Fig. 23) should be moved to permanent locations in other chambers. See Fig. 24 for recommended locations. (Priority 2)

Fig. 23. Removable brackets for bunks in C chamber.

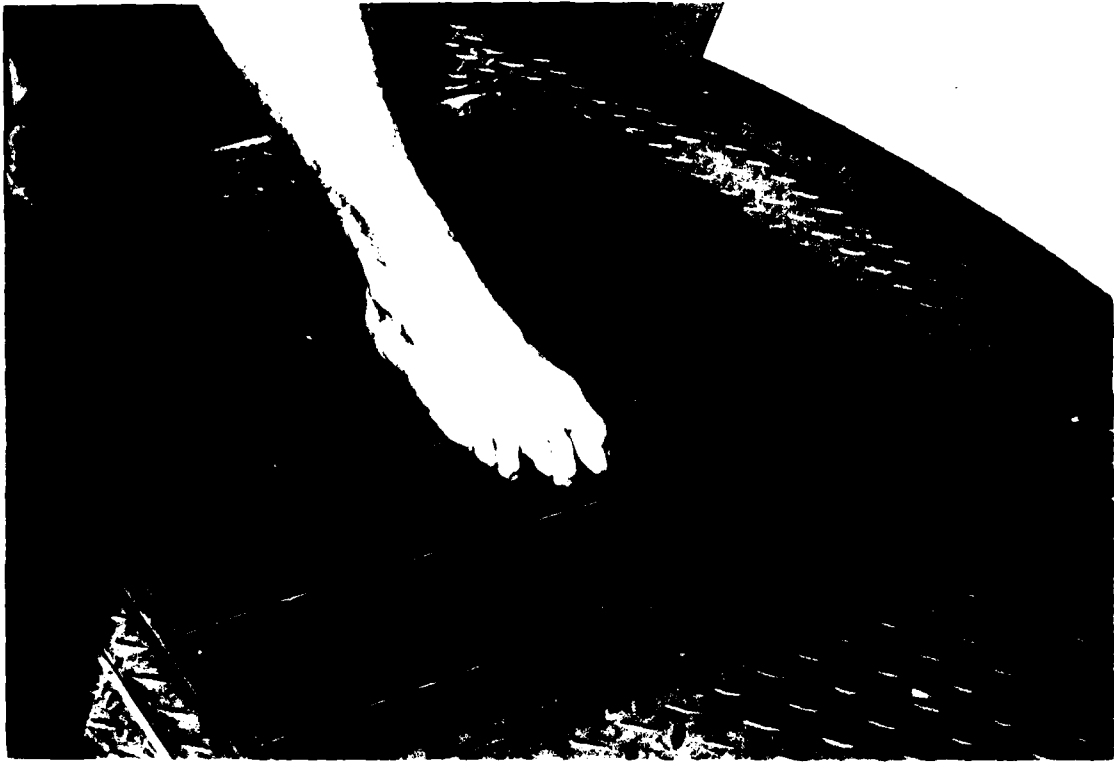
- (43) The current grate on the deck in the shower (Fig. 26) should be replaced with a finer mesh design which will be more comfortable to the feet and less likely to produce toe and foot injuries. (Priority 3)

Fig. 26. Present design of shower deck plate. Note large gaps in mesh which could lead to toe and foot injuries.

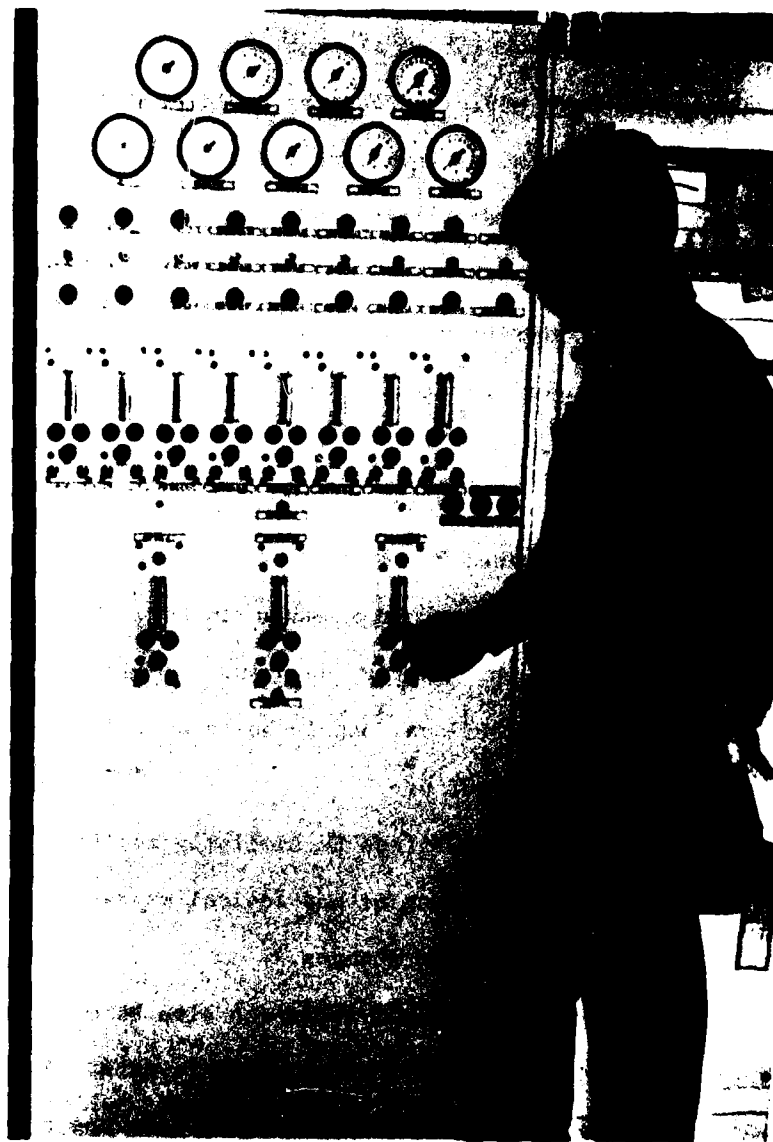
(52) Figure 28 shows the present design of the gas analysis patch panel. As can be seen, no attempt was made to group components by function or to color-code them in a manner to clarify their purpose to an

Fig. 28. Present design of the gas analysis patch panel.

operator. Figure 29 shows the recommended changes. This layout does not require the movement or alteration of any of the hardware (although several more efficient designs could be devised). It simply employs functional grouping and color coding. This design should improve operator recognition and readability while reducing errors. (Priority 2)

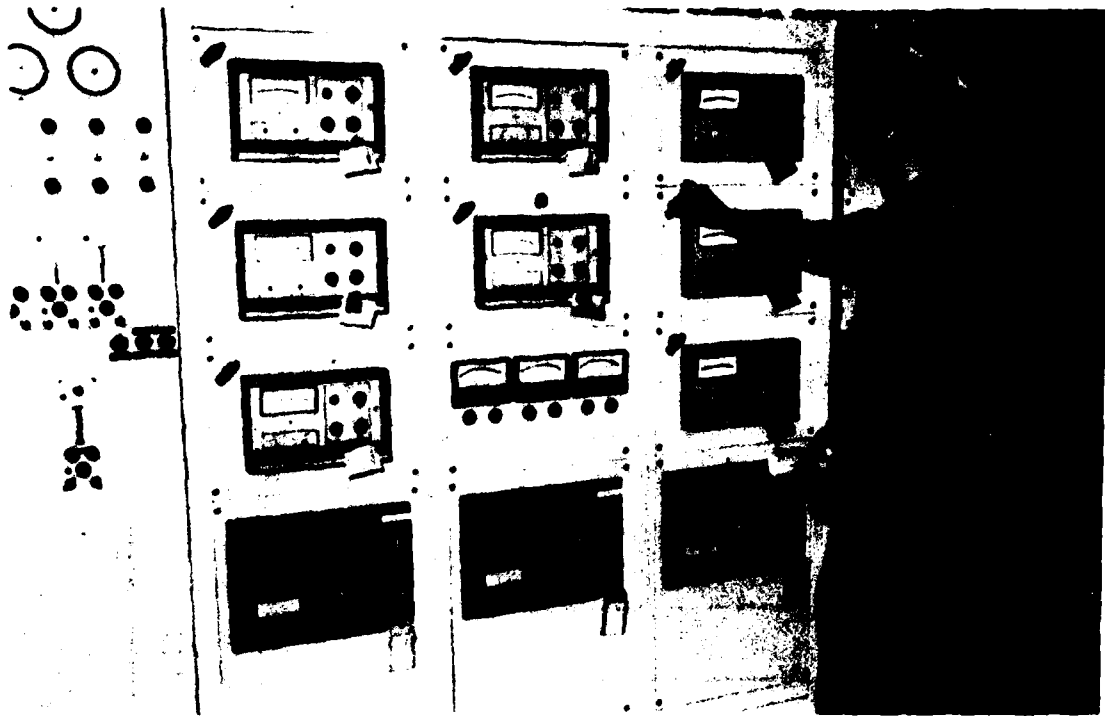
Fig. 30. Present design of gas analysis instrumentation panel.

- (53) Figure 30 shows the present gas analysis instrumentation panel. The recommended changes are similar to those above (see Fig. 31). (Priority 2)
- (54) Figure 8 showed the face of a local control panel. Greater clarity of function can be obtained by concise gas paths and simple noncoded labeling. The recommended scheme is shown in Fig. 32. (Priority 2)

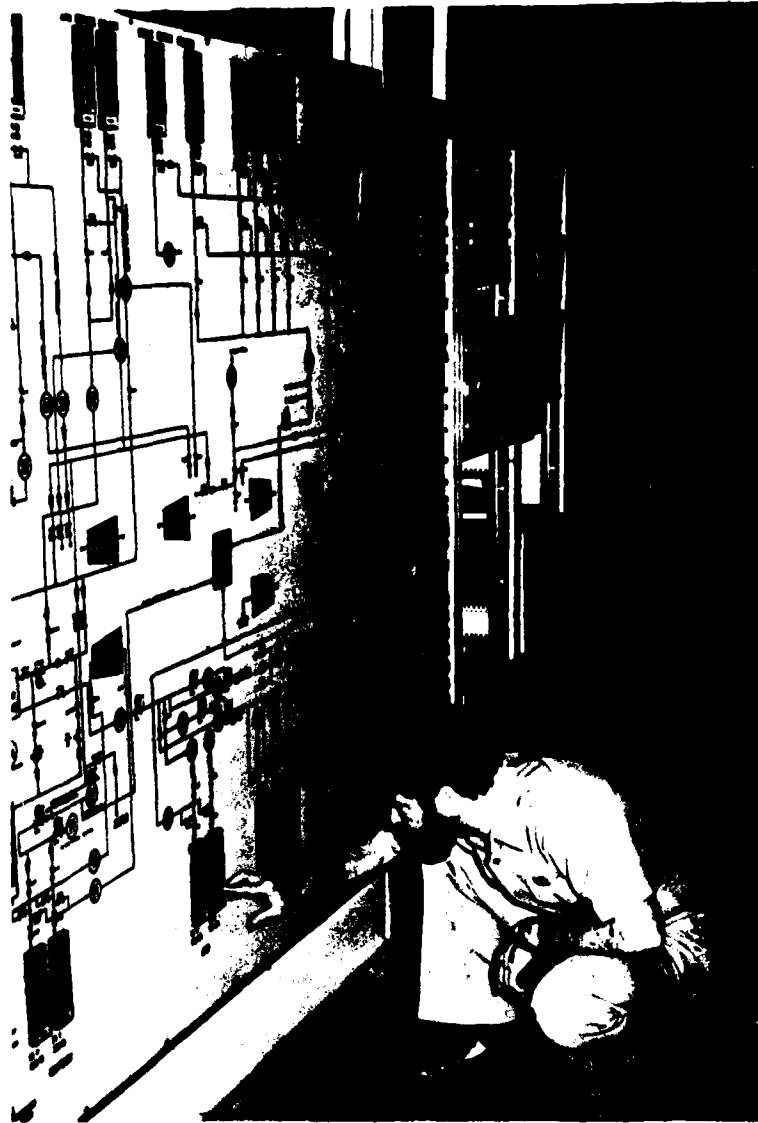
Fig. 35. Present position of pressure gauges on gas status panel.

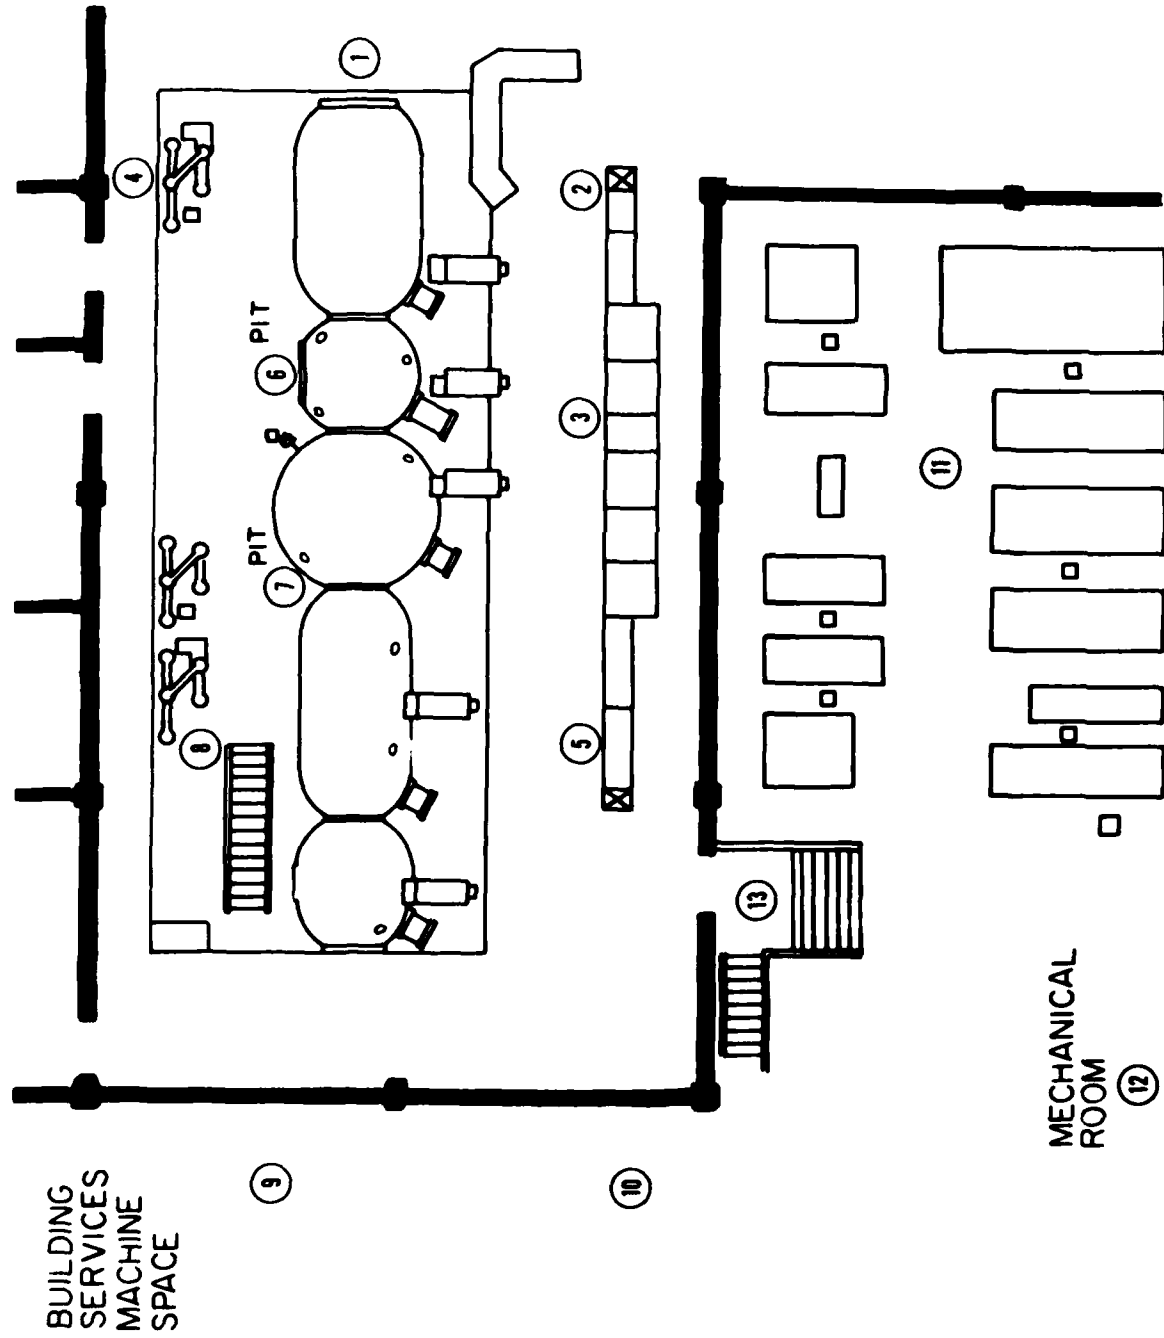
- (1) As previously mentioned, recorded noise levels in several places within the HRF approach the upper limit of the OSHA standards for an 8 h exposure. Figure 36 indicates the 13 locations where sound levels were periodically recorded. The circled numbers rank the locations from the lowest noise level [1] to the highest [13]. The lower noise levels which occur in the vicinity of the operating panels are still high enough to fatigue operators exposed to them for lengthy periods of time and to reduce communication efficiency between members of the diving watch as well as between the diving watch and divers within the chamber. The major contributors to the noise levels in the immediate chamber

Fig. 36. The 13 locations in which noise levels were measured. The higher the number, the higher the recorded noise level.

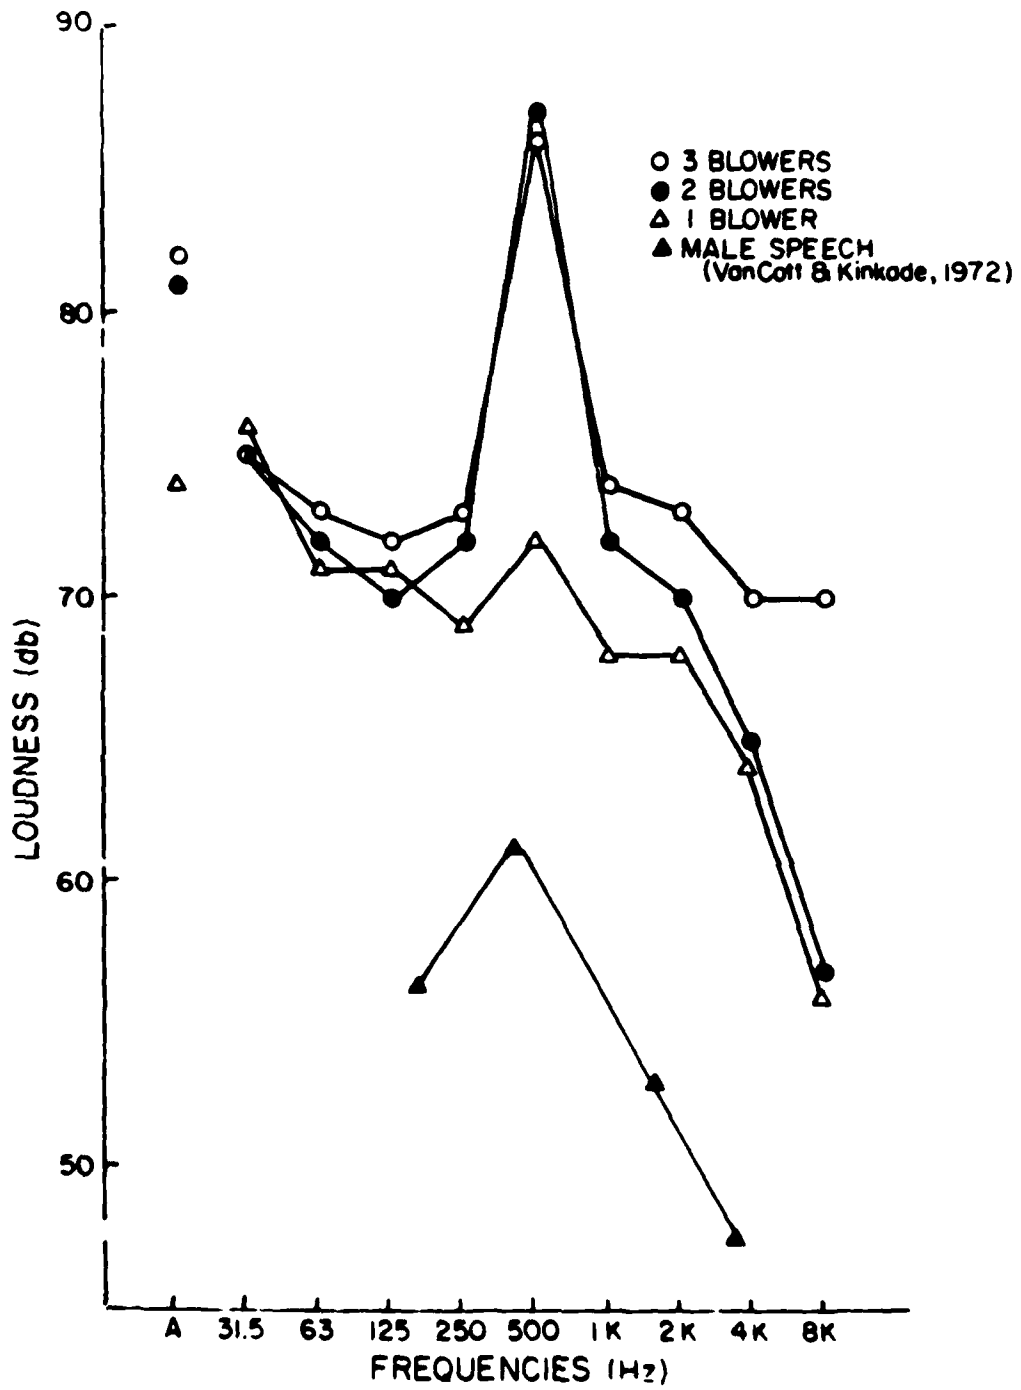
area are the building air conditioning system and the motors, which drive the life-support blowers for the chambers. Octave band analysis of the noise spectrum associated with the building air conditioning system and 1, 2, or 3 ACS blowers is shown for three locations in the immediate chamber area (Fig. 37, 38, and 39). As can be seen, the peak noise levels produced by these machines, fall in the same frequency range as the peak levels in male speech at conversational intensities. Thus, ear protectors to attenuate the peak noise frequencies will also reduce an individual's ability to understand human speech, since they share the same peak frequencies. Consequently, personnel-worn ear protectors, while reducing the danger of hearing damage due to the high noise intensity, will reduce communication capabilities markedly. Anything less than optimal communication conditions in the operator control areas of the hyperbaric saturation diving system is unacceptable. It is felt that the primary noise sources can and must be effectively attenuated at their sources. The highest noise levels (85-98 dB) were observed, not surprisingly, in the compressor room adjacent to the chamber area. A sound-protected office is already planned for personnel working in this area, but personnel should wear ear plugs (or similar equipment) when working around the compressors and machinery. (Priority 1)

Fig. 27. Octave band analysis of the noise spectrum associated with the building air conditioning system and 1, 2, or 3 ACS blowers recorded at master console. Peak levels in male speech at conversational intensities are also provided.
