Name of Dam: Gaines Mill Dam

Location: Hanover County, State of Virginia

Inventory Number: VA 08506 ✓

6
PHASE I INSPECTION REPORT
NATIONAL DAM SAFETY PROGRAM

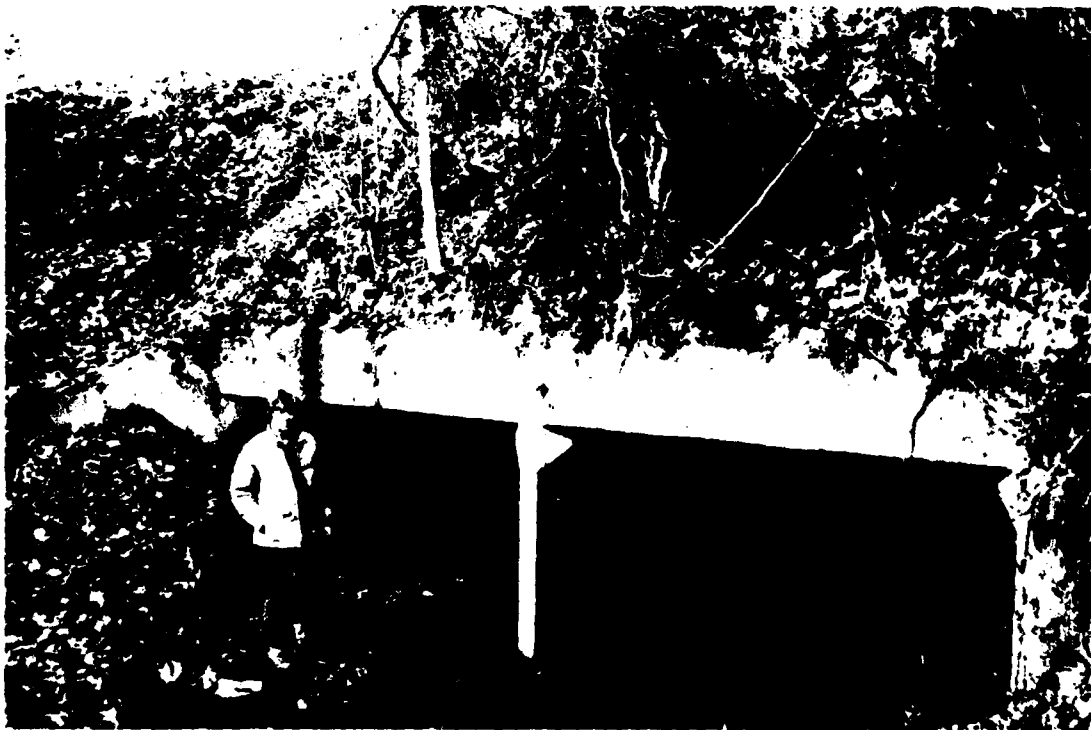
PHOTO 4. Culverts Under VA Route 186

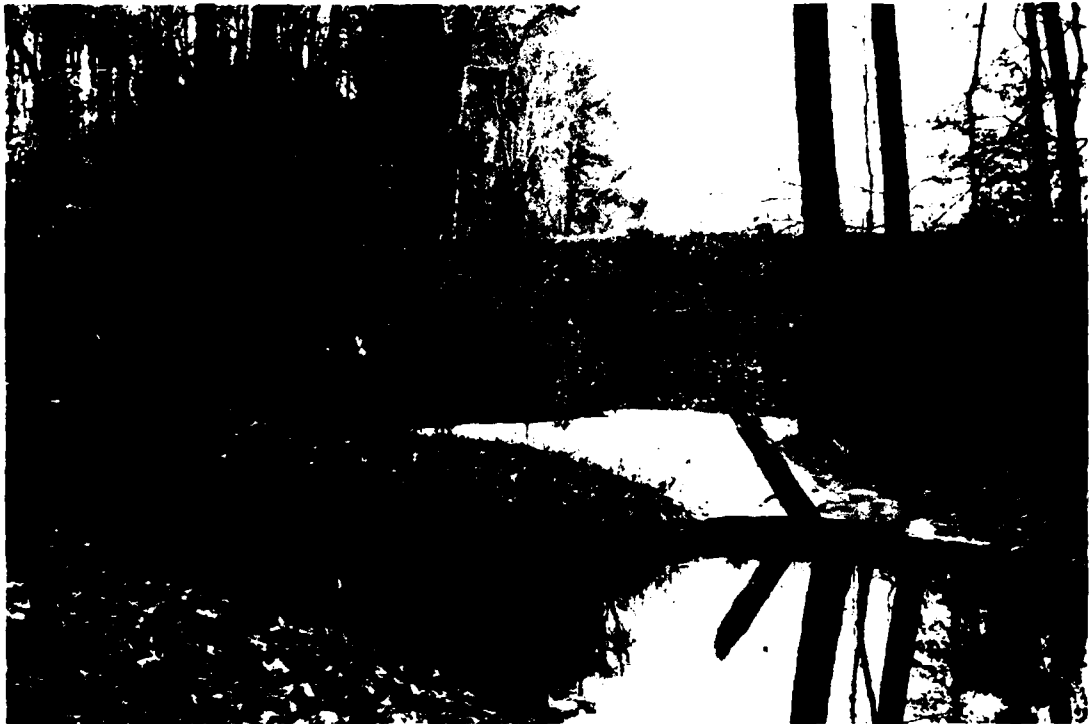
PHOTO 7. Ponded Area at Toe of Downstream Embankment
