Name Of Dam: UPPER APPLE MTN. & LOWER APPLE MTN.

Inventory Number: VA. 18711 & VA. 18709

## PHASE I INSPECTION REPORT NATIONAL DAM SAFETY PROGRAM

MARCH 1981

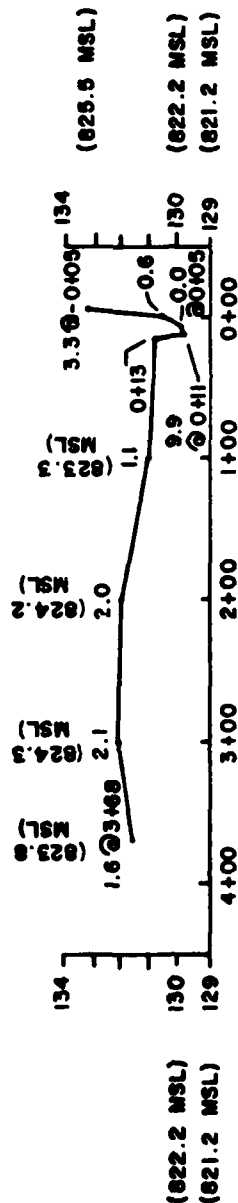
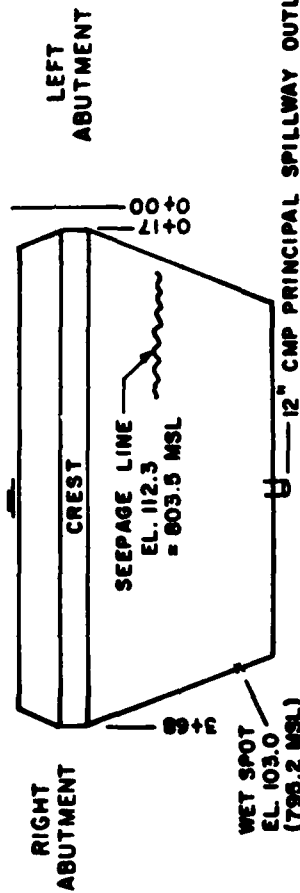
PLATE II

### CREST PROFILE

### PLAN VIEW
