| REPORT DOCUMENTATION PAGE | | READ INSTRUCTIONS<br>BEFORE COMPLETING FORM |
|--|---|--|
| 4. TITLE (and Subtitle)<br>Phase I Inspection Report<br>National Dam Safety Program.<br>Cockram Mill Dam (Inventory Number<br>Patrick County, VA 14105), Roanoke | | 5. TYPE OF REPORT & PERIOD COVERED<br>Final rept. 7 |

NAME OF DAM: COCKRAM DAM  
LOCATION: PATRICK COUNTY  
INVENTORY NUMBER: VA 14105

PHASE I INSPECTION REPORT  
NATIONAL DAM SAFETY PROGRAM

DECEMBER 1980

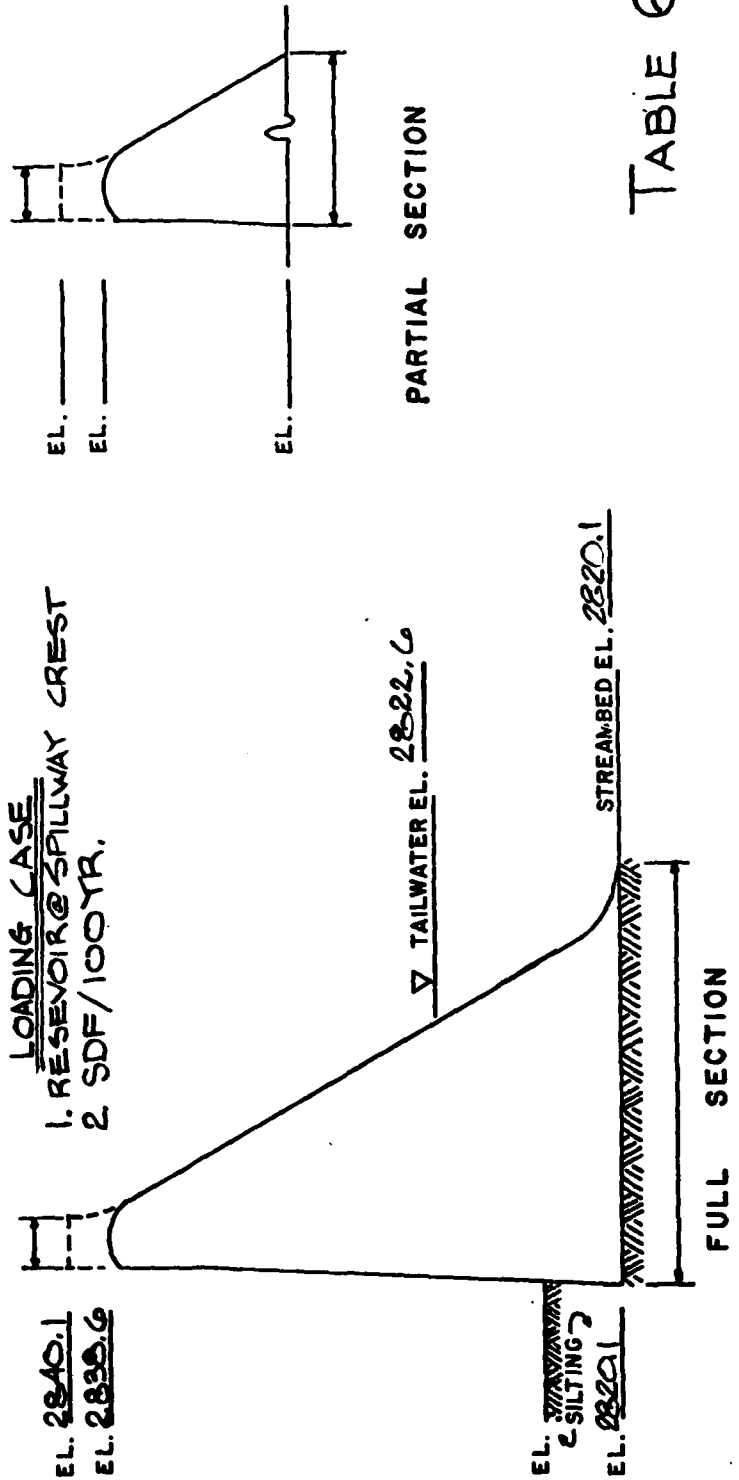
TABLE 6.1

6.1 Stability Analysis: A preliminary stability analysis was performed based on field measurements taken below the wooden walkway at the gated outlet through the dam. A one-foot section of the dam was analyzed. The results of this analysis indicate that the dam is stable under normal conditions with reservoir level at the crest of the spillway. When the 100 year flood load is applied, however, the dam is on the verge of overturning. Results of the stability analysis are summarized in Table 6.1.

6.3 Evaluation: Since the preliminary stability analysis indicates that the dam is on the verge of overturning when the 100 year storm is applied, the dam is considered to be unsafe during flood conditions.

A preliminary stability analysis of the spillway section based on field measurements at the gated outlet was performed. See Table 6.1. This analysis indicates that during flood conditions of the 100 year storm the dam is on the verge of failure. For this reason, the dam has been assessed as "unsafe non-emergency".

The first priority for further study should be to perform a stability analysis for the dam as an entire unit. The analysis for this report was based on a one foot wide section and neglects any increase in dam base width due to the slight observed arch along the crest of the dam.

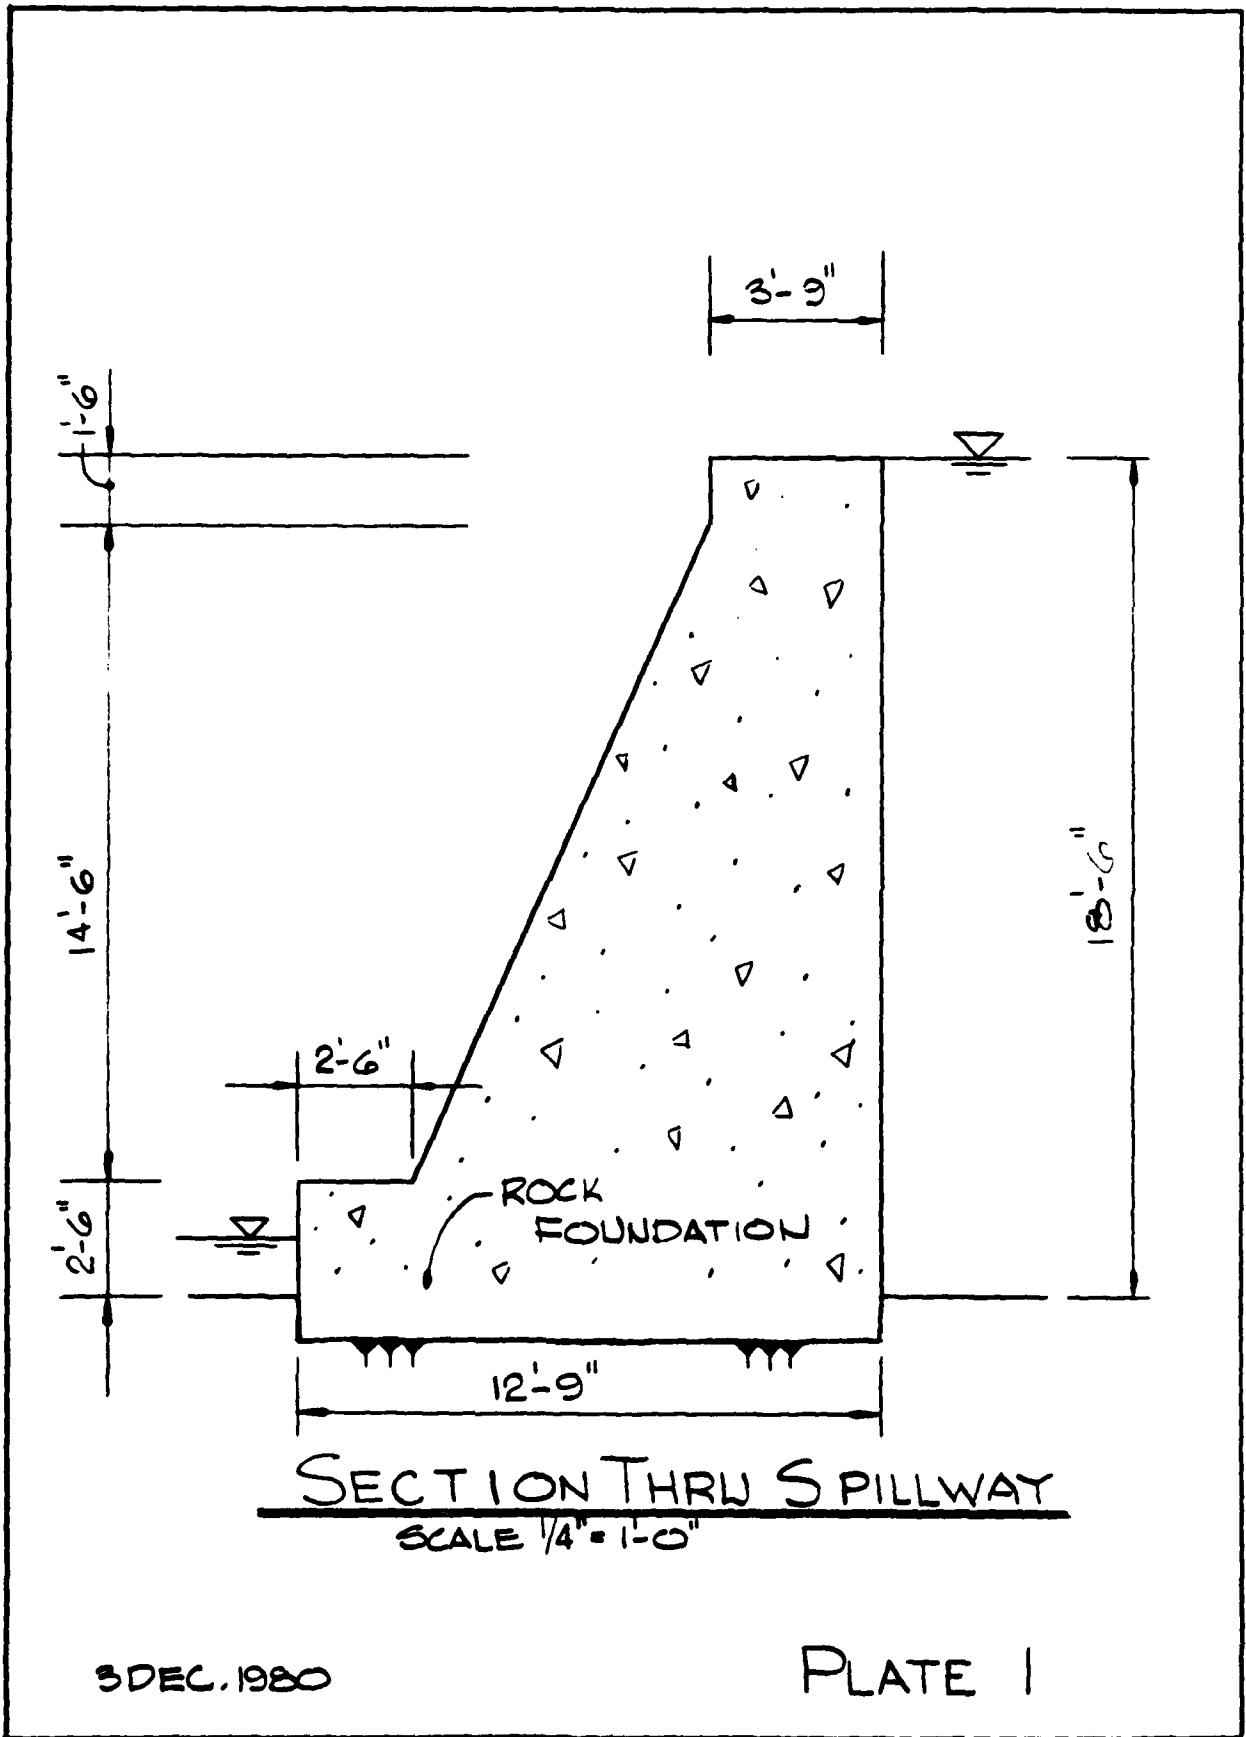
PLATE 1

1.2.1 Dam and Appurtenances: Cockram Dam is a concrete gravity structure about 150 feet long and 19.9 feet high. The base of the dam is 12.75 feet wide. See Plate 1. The dam is founded on rock. The crest of the concrete rectangular 85 foot long spillway is at elevation 2838.56 (ft. m.s.l.). The crest of the spillway is 3.75 feet wide and serves as a walkway. Hand rails are provided across the spillway on the upstream and downstream side of the spillway crest. A four foot wide rectangular notch, located near the center of the spillway, with invert elevation at 2837.06 is blocked by a piece of safety tread type metal plate.

The cross section developed during this field inspection (See Plate 1) is adequate to perform a preliminary evaluation of the overflow section for overturning and sliding. If more detailed analysis is performed in the future, dimensions indicated on Plate 1 should be field verified. This cross section was developed below the wood walkway at the outlet near the right abutment.
