Name Of Dam: MOORE

Location: PITTSYLVANIA COUNTY

Inventory Number: VA 14323 ✓

## PHASE I INSPECTION REPORT NATIONAL DAM SAFETY PROGRAM

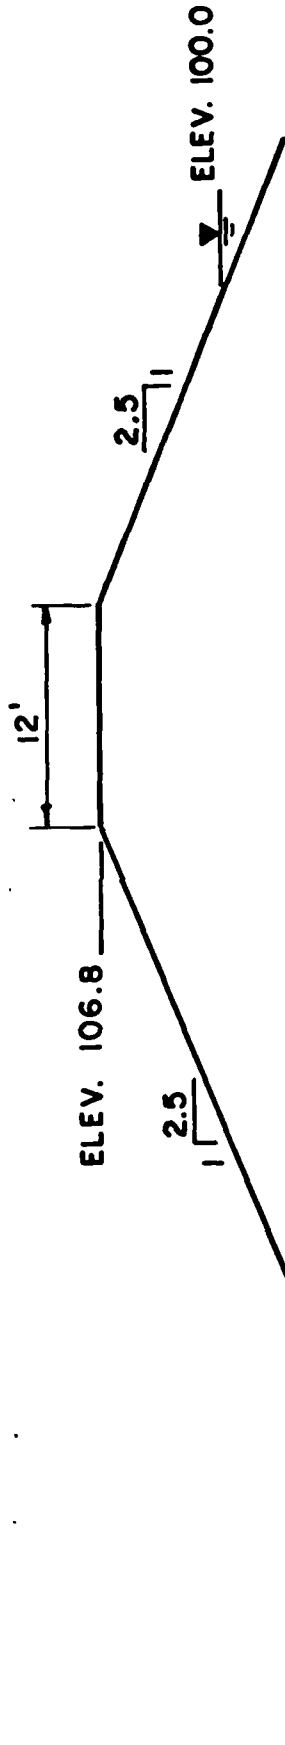
# TYPICAL CROSS SECTION

3.1.2 Embankment: A sketch of the embankment showing a cross section and crest profile is provided on Plate II, Appendix I. A plan view is given on Plate III, Appendix I.
