Name of Dam: Beatties Millpond Dam
Location: Hanover County, State of Virginia
Inventory Number: VA 08535

**PHASE I INSPECTION REPORT
NATIONAL DAM SAFETY PROGRAM**

Name of Dam: Beatties Millpond Dam
State: Commonwealth of Virginia
County: Hanover
USGS 7.5 Minute Quadrangles: Seven Pines, VA and Quinton, VA
Stream: Sandy Valley Creek
Date of Inspection: 15 January 1981

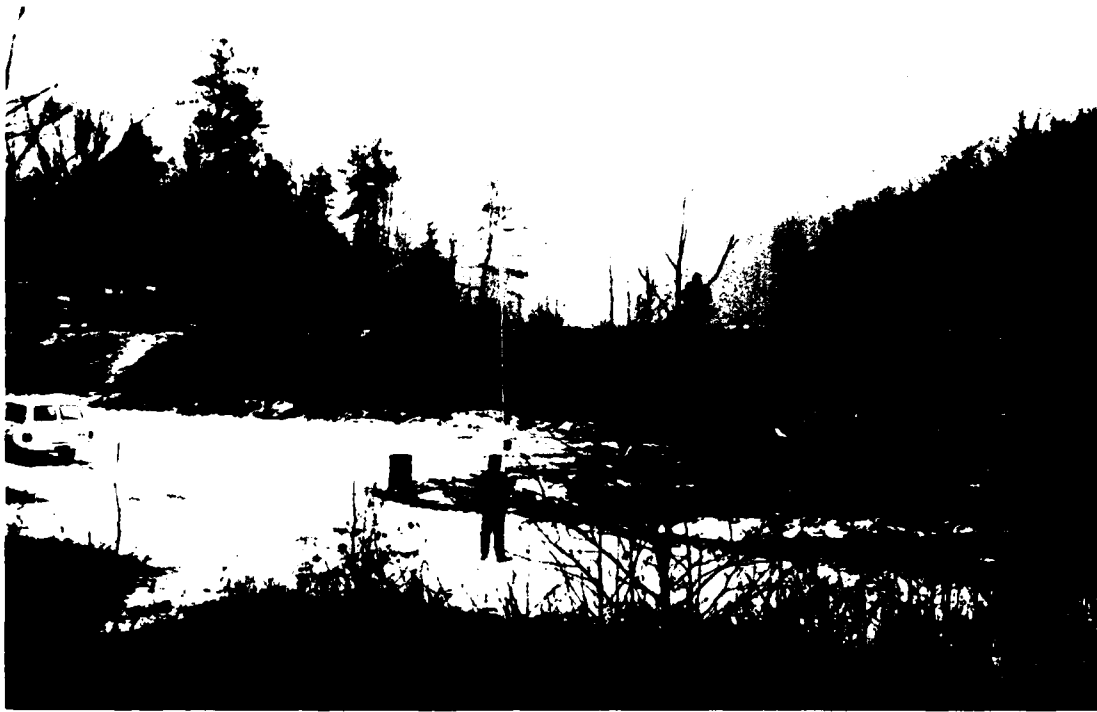
PHOTO 1. Downstream Embankment of Dam

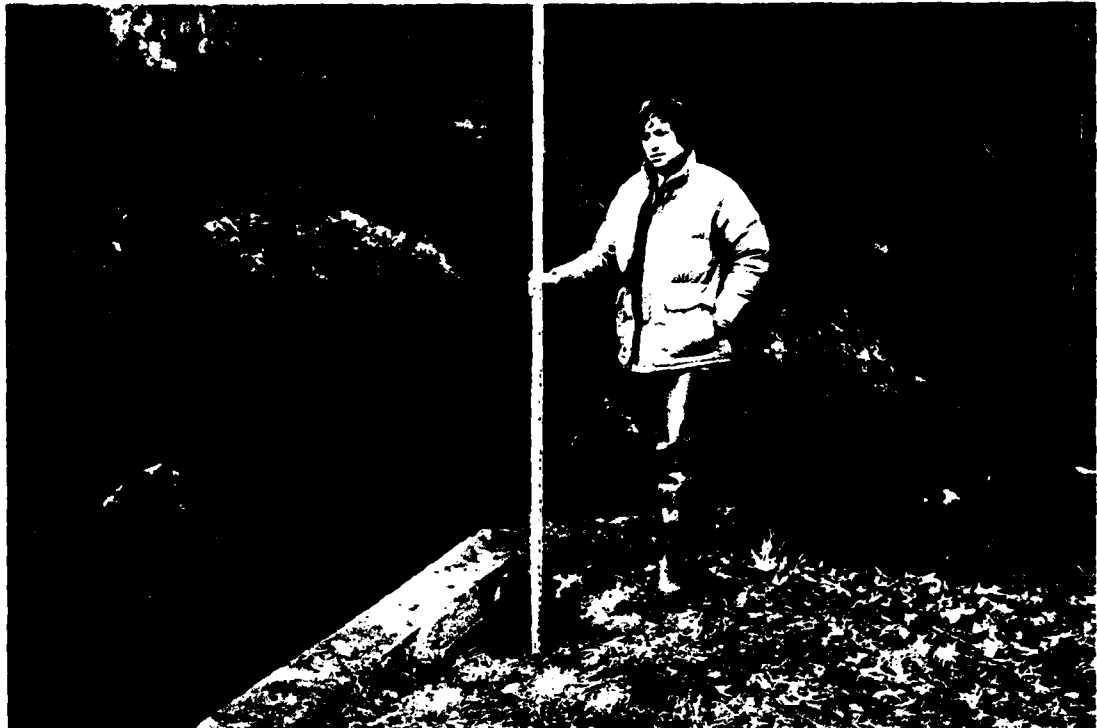
PHOTO 5. Hole Behind Right Training Wall
