Name of Dam: Horners Dam

Location: Westmoreland County, State of Virginia

PHASE I INSPECTION REPORT

NATIONAL DAM SAFETY PROGRAM

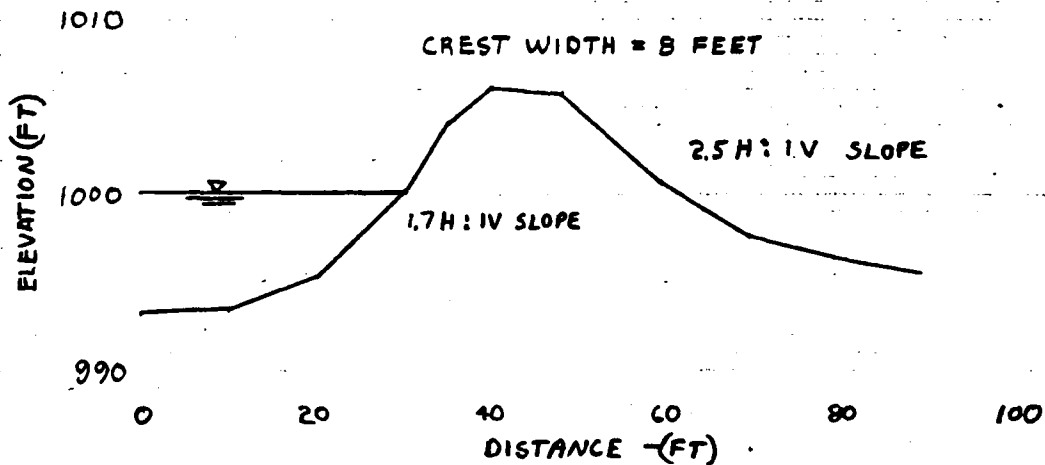
DAM CROSS SECTION AT STA. 4+60

At Station 4+60, located about 120 feet from the right abutment, the downstream slope was observed to be 2.5H:1V. The slope at this location is representative of the embankment in general. The upstream slope at Station 4+60 was found to be 1.7H:1V. Based on inspection of the dam spillways and appurtenances, the dam does not appear to have facilities for draining the reservoir in the event of an emergency, and is thus not considered susceptible to sudden drawdown.
