Name Of Dam: HIDDEN VALLEY LAKE

Location: WASHINGTON COUNTY

Inventory Number: VA 19104 ✓

# PHASE I INSPECTION REPORT NATIONAL DAM SAFETY PROGRAM

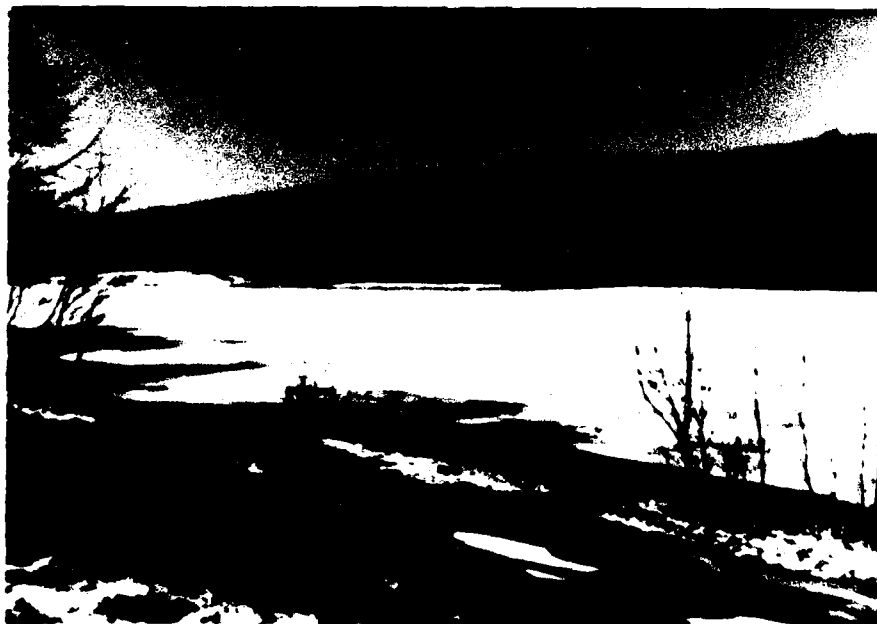
OVERALL VIEWS  
HIDDEN VALLEY LAKE DAM  
25 FEBRUARY 1981

DAM

RESERVOIR AREA
