Special Report 81-10

FABRIC INSTALLATION TO MINIMIZE REFLECTION CRACKING ON TAXIWAYS AT THULE AIRBASE, GREENLAND

Robert A. Eaton and Randy Godfrey

UNITED STATES ARMY CORPS OF ENGINEERS
COLD REGIONS RESEARCH AND ENGINEERING LABORATORY
HANOVER, NEW HAMPSHIRE, U.S.A.

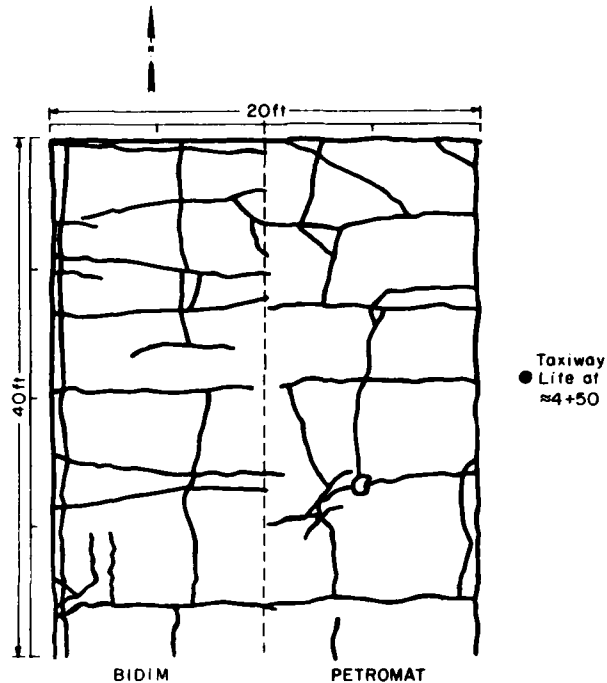
Figure 6. Preconstruction cracks in taxiway 3 (June 1978).

During the crack filling operation, we saw that there were approximately four times as many cracks on the PETROMAT side (east) as on the BIDIM (west) side of taxiway 3. The cracks in the entire fabric area were remapped as they were significantly different than the premilling cracks which had been mapped four weeks before (Fig. 6-9).

The milled surface was cleaned with a tractor-mounted sweeper brush, and any cracks, ranging from 1/2 to 1 in. wide and deep, were cleaned, filled with a 3/8-in. asphalt mix, and compacted by a pneumatic roller. The cracks were filled by hand shovel, starting at the far southwest corner (station 2+50) and proceeding northward on the west side of the taxiway (Fig. 2). Upon reaching station 7+50, the direction was reversed and the cracks along the east side of taxiway 3 were filled. Crack filling and shimming provides a smooth surface, ensuring a good bond between the fabric and the milled surface.

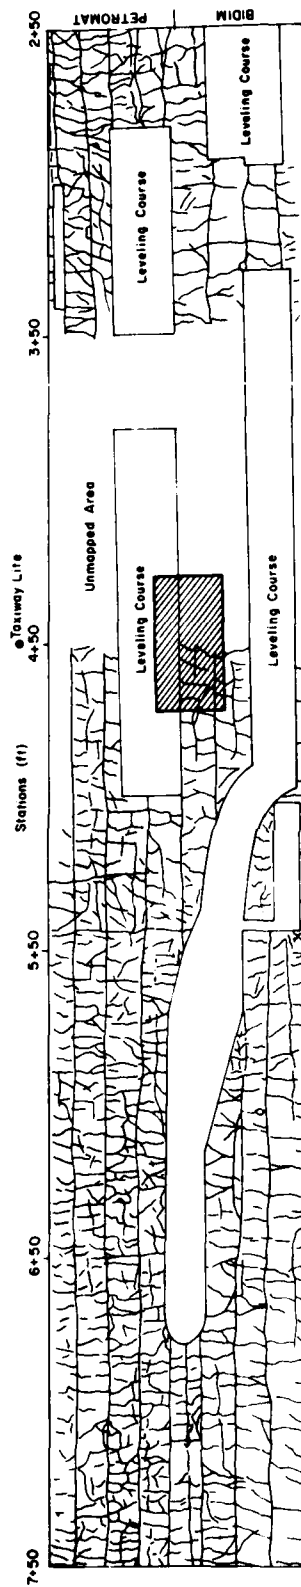
Figure 7. Map of cracks in taxiway 3 after milling (August 1978) (shaded area shown in Fig. 9).
