PASSAIC RIVER BASIN,  
TRIBUTARY TO MORSETOWN BROOK,  
PASSAIC COUNTY  
NEW JERSEY.

**CARPI LAKE DAM**  
**(NJ 00192)**

**PHASE 1 INSPECTION REPORT**  
**NATIONAL DAM SAFETY PROGRAM.**

**JULY 1981**

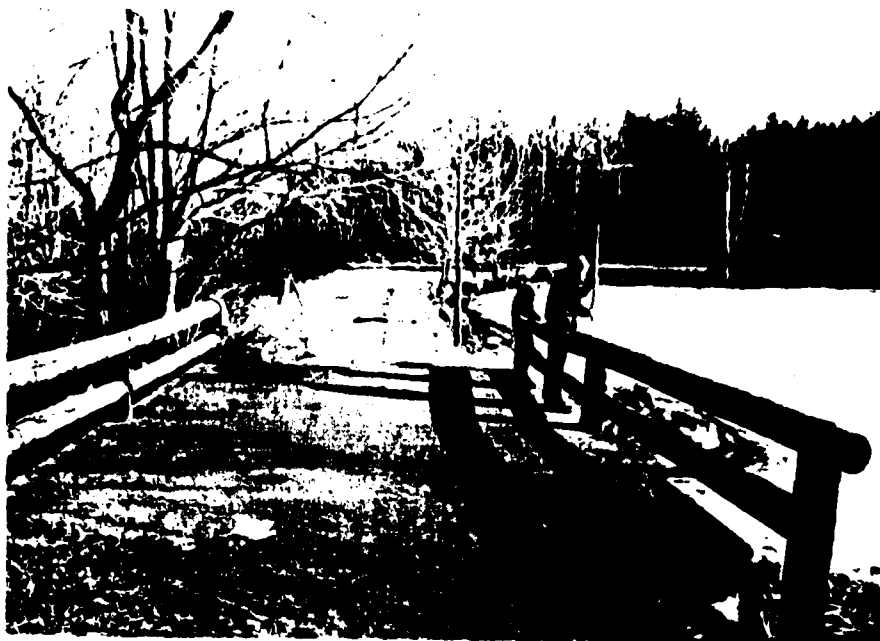
The top of the concrete corewall is spalled and eroded. No evidence of major thru wall cracking or movement was noted.

Bridge deck slab, core wall and valve box, looking from left (west) to right (east) along axis of dam.
