DELAWARE RIVER BASIN  
DELAWANNA CREEK, WARREN COUNTY  
NEW JERSEY

# DELAWARE LAKE DAM NJ 00127

PHASE 1 INSPECTION REPORT  
NATIONAL DAM SAFETY PROGRAM

AUGUST 1981

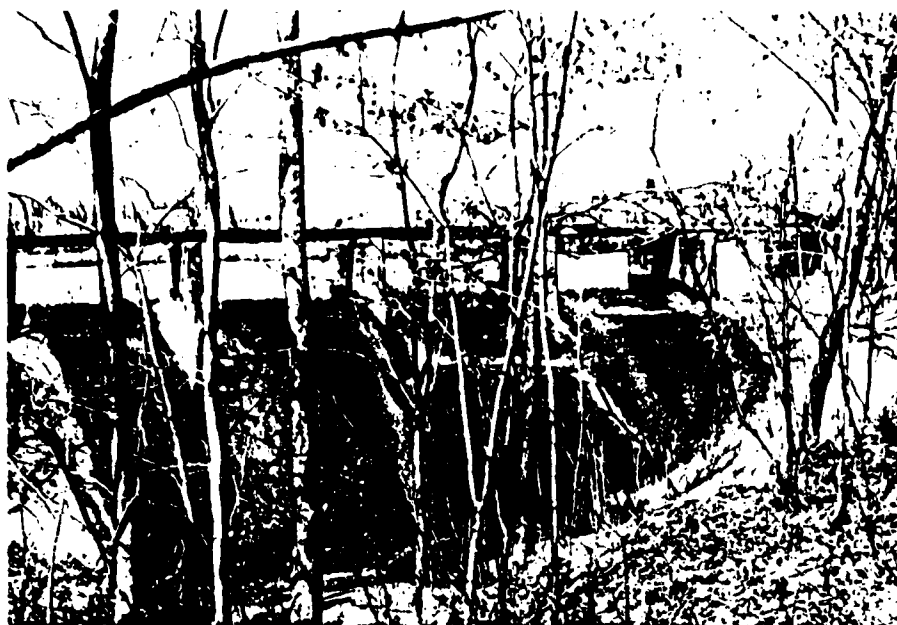
April 22, 1981

Downstream face of overflow spillway. Note repaired concrete at left (east) side (right edge of photo).
