# SMITHVILLE DAM

## NJ 00043

PHASE 1 INSPECTION REPORT  
NATIONAL DAM SAFETY PROGRAM

JULY 1981

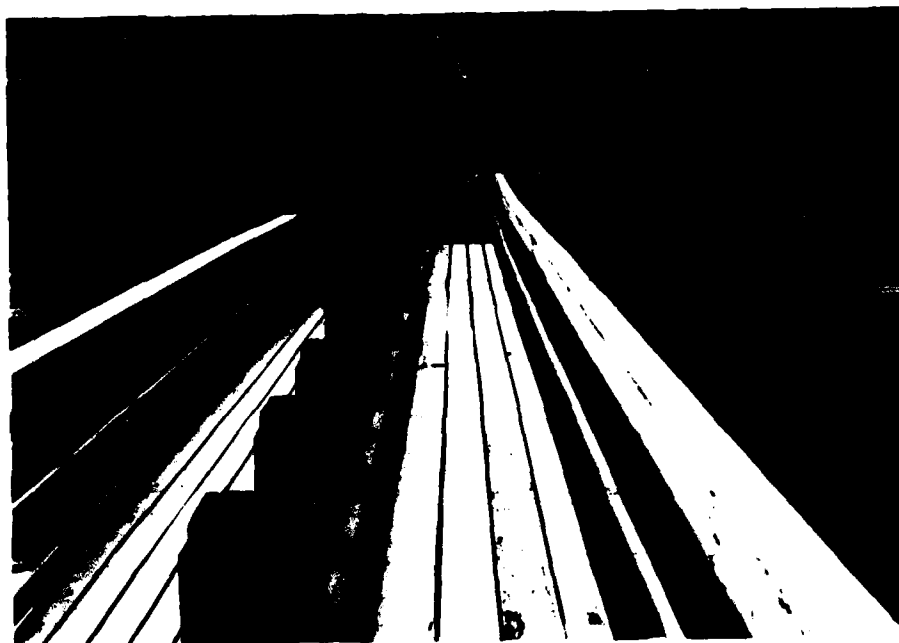
The downstream apron appeared to be concrete with timber piles at its downstream end on which the timber frames rest. The timbers bracing the frames for the gates and the walkways appeared to be sound and in generally satisfactory condition. They have all been treated for rot.

PHOTO 3  
TIMBER CATWALKS AND GATE OPERATING MECHANISMS
