DELAWARE RIVER BASIN  
MUSCONETCONG RIVER  
WARREN COUNTY  
NEW JERSEY

# NEWBURG MILL DAM

## NJ 00779

PHASE 1 INSPECTION REPORT  
NATIONAL DAM SAFETY PROGRAM

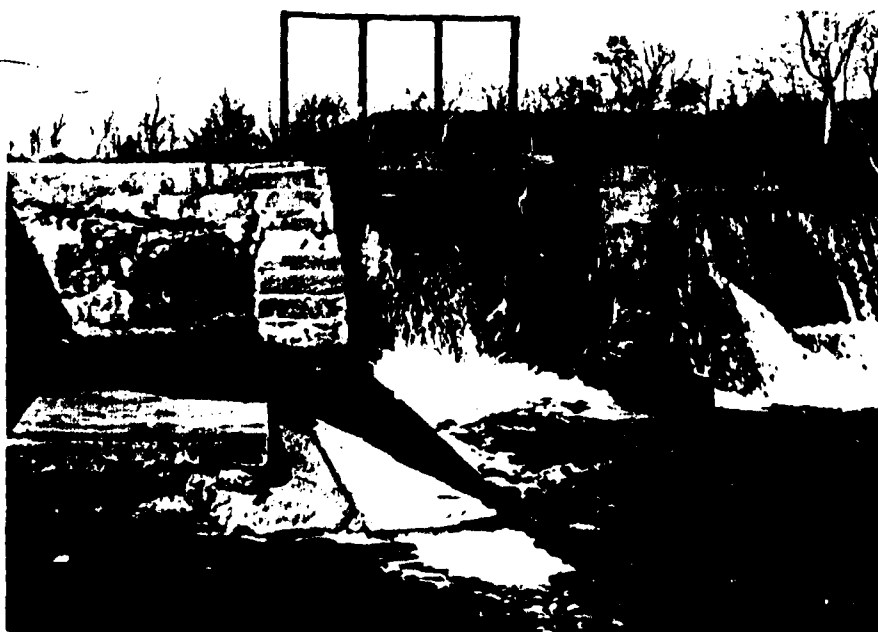
View of a stoplog structure
