| 18 REPORT DOCUMENTATION PAGE | | READ INSTRUCTIONS<br>BEFORE COMPLETING FORM | |
|---|---|---|--|
| 4. TITLE (and Subtitle)<br>Phase I Inspection Report<br>National Dam Safety Program<br>Clove Lake Dam, NJ00259<br>Sussex County, New Jersey | | 5. TYPE OF REPORT & PERIOD COVERED<br>FINAL / Rept. | |

CLOVE LAKE DAM  
OVERVIEW PHOTO

CLOVE LAKE DAM

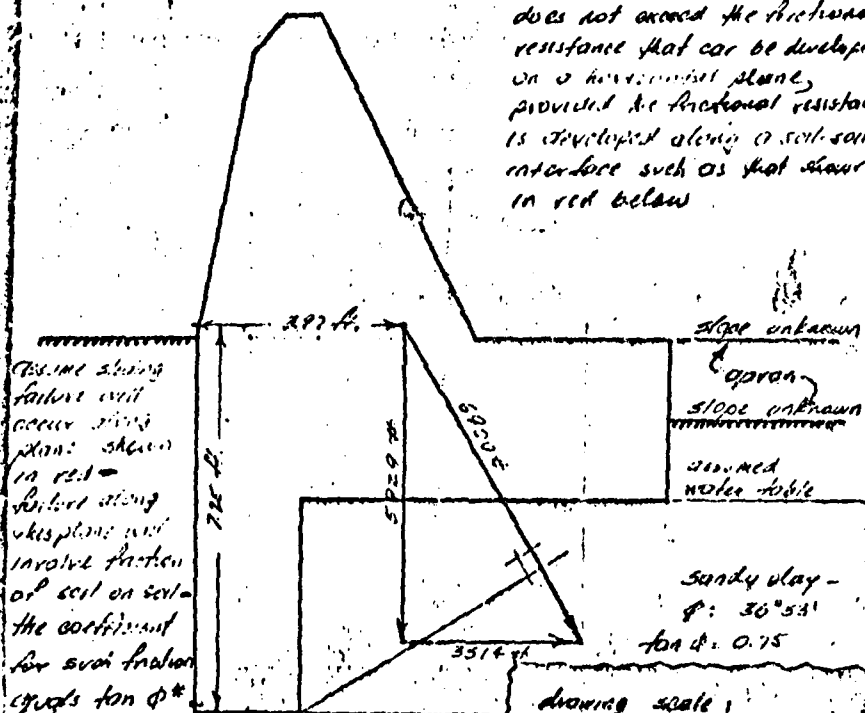
Failure along this plane will involve friction of soil on soil - the coefficient for soil friction equals  $\tan \phi^*$

neglecting the weight of soil in area shaded green, the resisting force developed along the plane of sliding is  $0.75 \times 52479 = 44374$  which is greater than the horizontal thrust

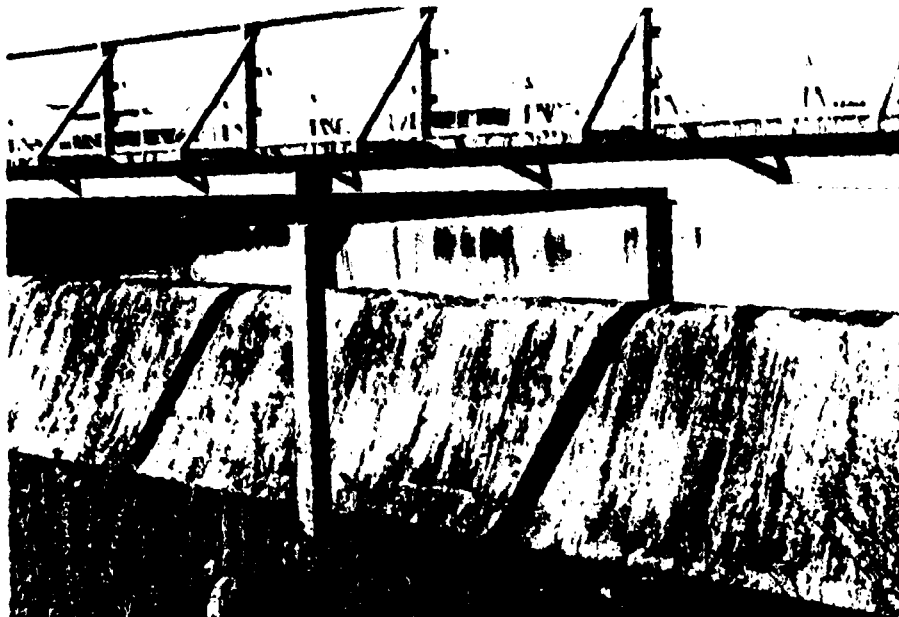
View of spalled concrete on crest of spillway 30 feet from left (south) end. Note brush in d/s channel at toe of spillway.

- (1) Design and oversee procedures to repair the concrete spillway and fish ladder, and the stoplog facilities.
- (2) Relocate the gate valve box for the twin 18-inch draw-down pipes to place the valves on the upstream side of the dam.
