DELAWARE RIVER BASIN  
TRIBUTARY TO POPHANDUSING BROOK,  
WARREN COUNTY  
NEW JERSEY

**N.J. NO NAME DAM**  
**NO. 55**  
**NJ 00815**

**PHASE 1 INSPECTION REPORT**  
**NATIONAL DAM SAFETY PROGRAM**

**AUGUST 1981**

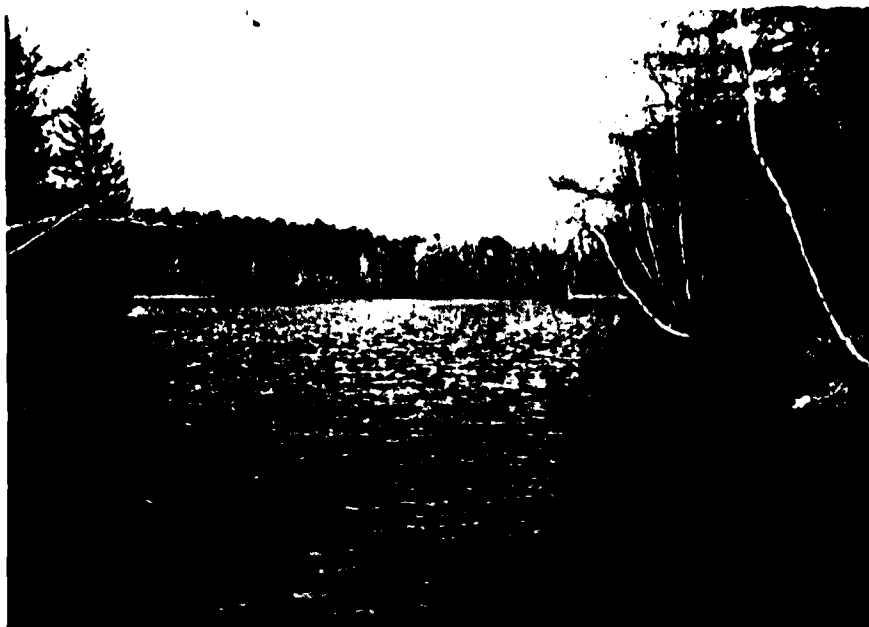
View looking southwest across reservoir from right dam abutment.
