PASSAIC RIVER BASIN  
GOFFLE BROOK, BERGEN COUNTY.  
NEW JERSEY

# MAPLE LAKE DAM NJ 00776

## PHASE 1 INSPECTION REPORT NATIONAL DAM SAFETY PROGRAM

JULY 1981

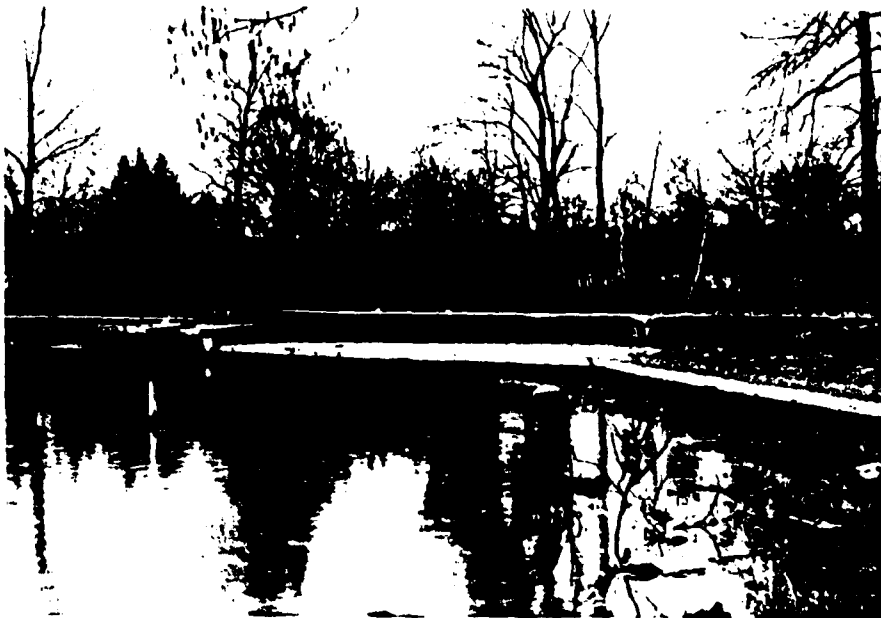
View of upstream face of dam at right abutment;  
dam appears to have a 2-ft wide corewall.

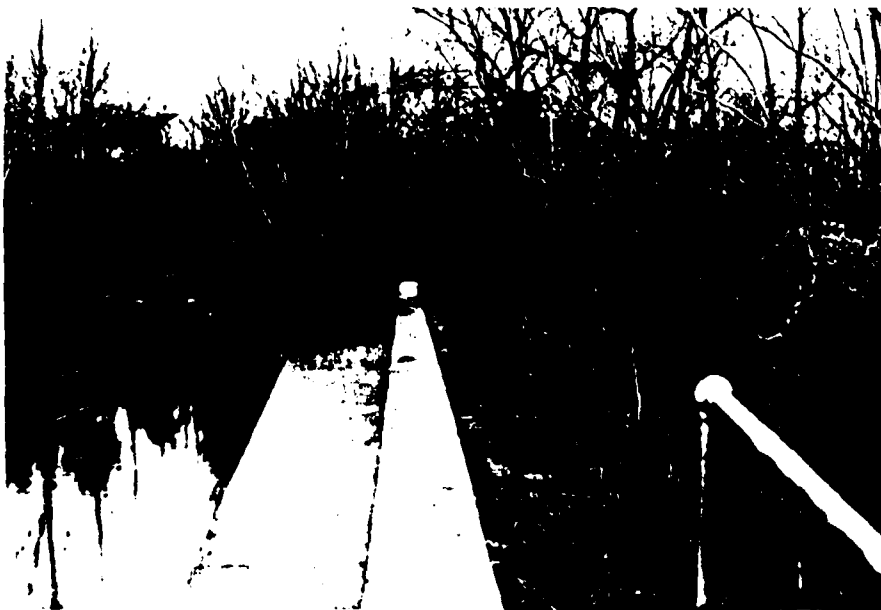
Several transverse hairline cracks were observed in the concrete apron and 2-foot thick core wall on right side. Four transverse cracks, one badly spalled and eroded, were visible on the concrete core wall, left of the spillway.

View along corewall toward left abutment.

(7) Design and oversee repairs to the cracked concrete core walls and upstream concrete walls.
