# GRUENDYKE MILL DAM

## NJ 00793

### PHASE 1 INSPECTION REPORT NATIONAL DAM SAFETY PROGRAM

REPT. No: DAEN/NAP-53842/NJ00793-81/08  
AUGUST 1981

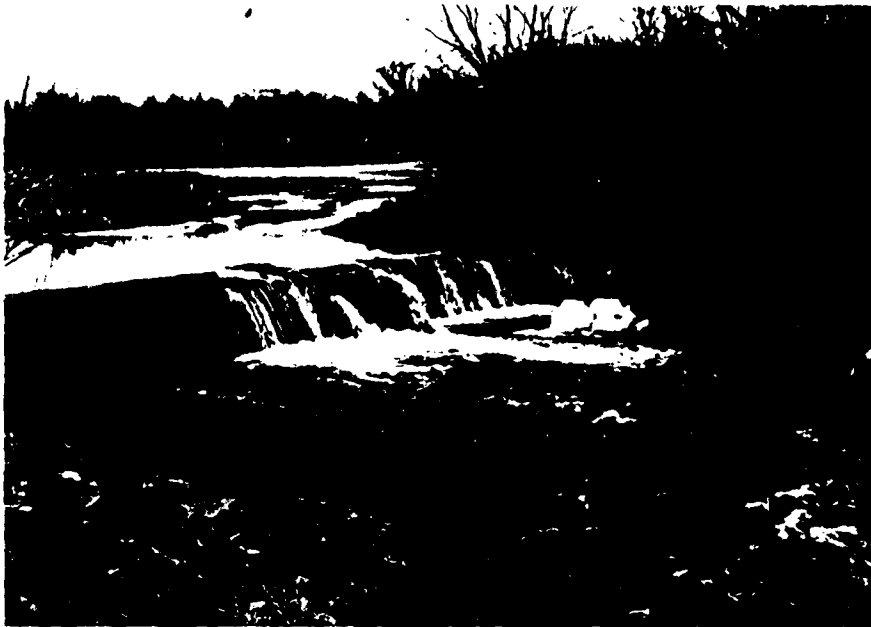
February 19, 1981

The erosion and seepage at the foundation of the former raceway structures could contribute to future stability problems for these structures, if allowed to continue.

Right bank looking u/s at old mill structure foundation

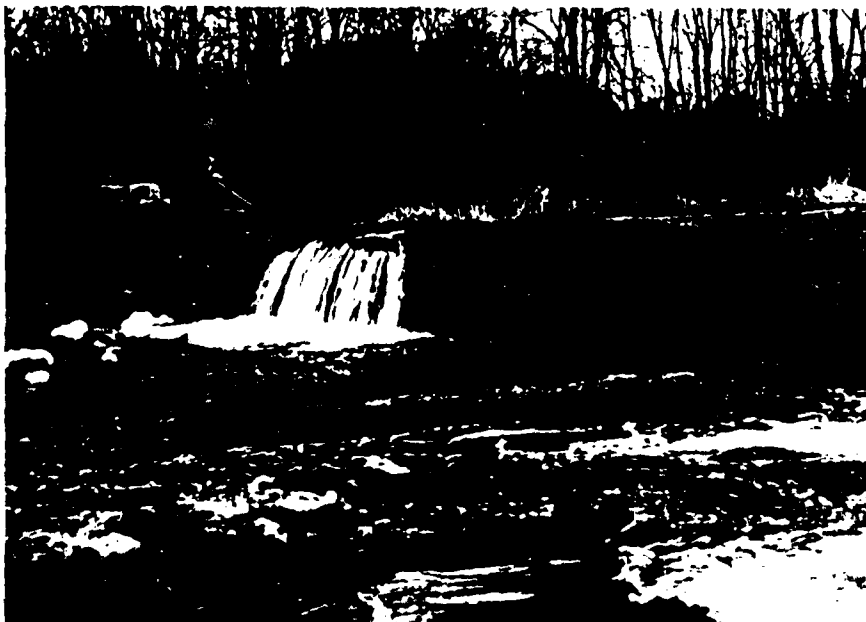
February 19, 1981

View of d/s left bank looking u/s

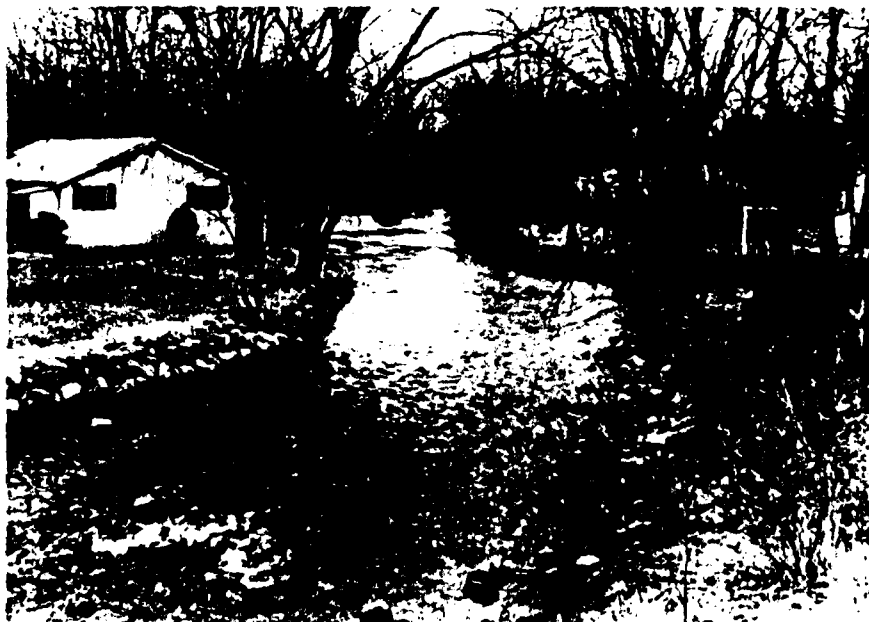
February 19, 1981

Looking d/s from d/s side of Rte 46 bridge at d/s channel
