| 18 REPORT DOCUMENTATION PAGE | | READ INSTRUCTIONS<br>BEFORE COMPLETING FORM |
|---|---|---|
| 4. TITLE (and Subtitle)<br>Phase I Inspection Report<br>National Dam Safety Program<br>Overpeck Tidal Dam<br>Bergen County, New Jersey | 5. TYPE OF REPORT & PERIOD COVERED<br>9 FINAL + rept. 4 | |

OVERPECK TIDAL DAM (NJ00799)

PHASE I INSPECTION REPORT  
NATIONAL DAM SAFETY PROGRAM

### PHASE I INSPECTION REPORT NATIONAL DAM SAFETY REPORT

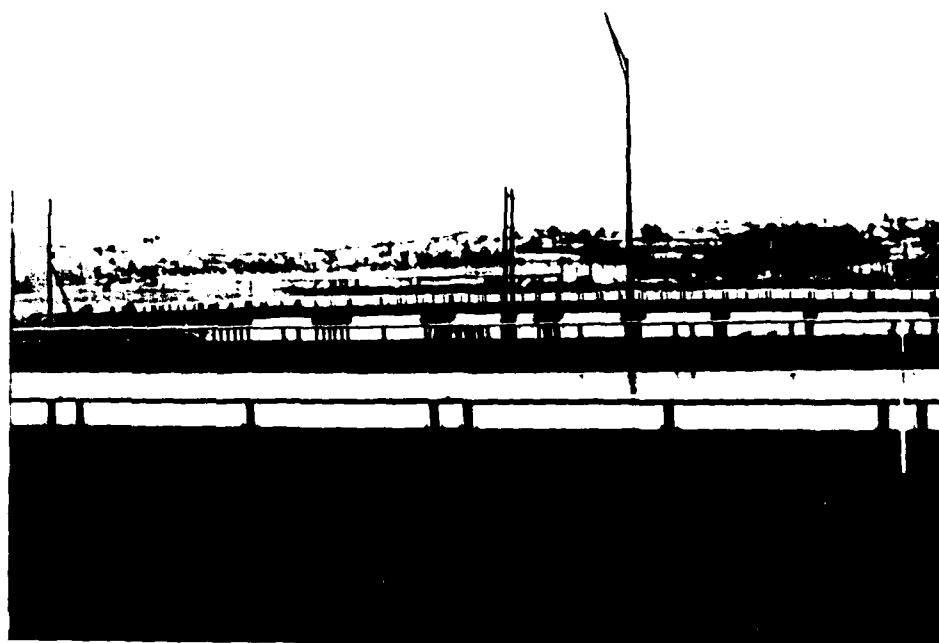
Looking upstream from New Jersey Turnpike, near center of dam.
