LAKE TISHOMINGO DAM
JEFFERSON COUNTY, MISSOURI
MISSOURI INVENTORY NO. 30039

PHASE I INSPECTION REPORT
NATIONAL DAM SAFETY PROGRAM

PREPARED BY: ST. LOUIS DISTRICT CORPS OF ENGINEERS
FOR: GOVERNOR OF MISSOURI

JANUARY 1978

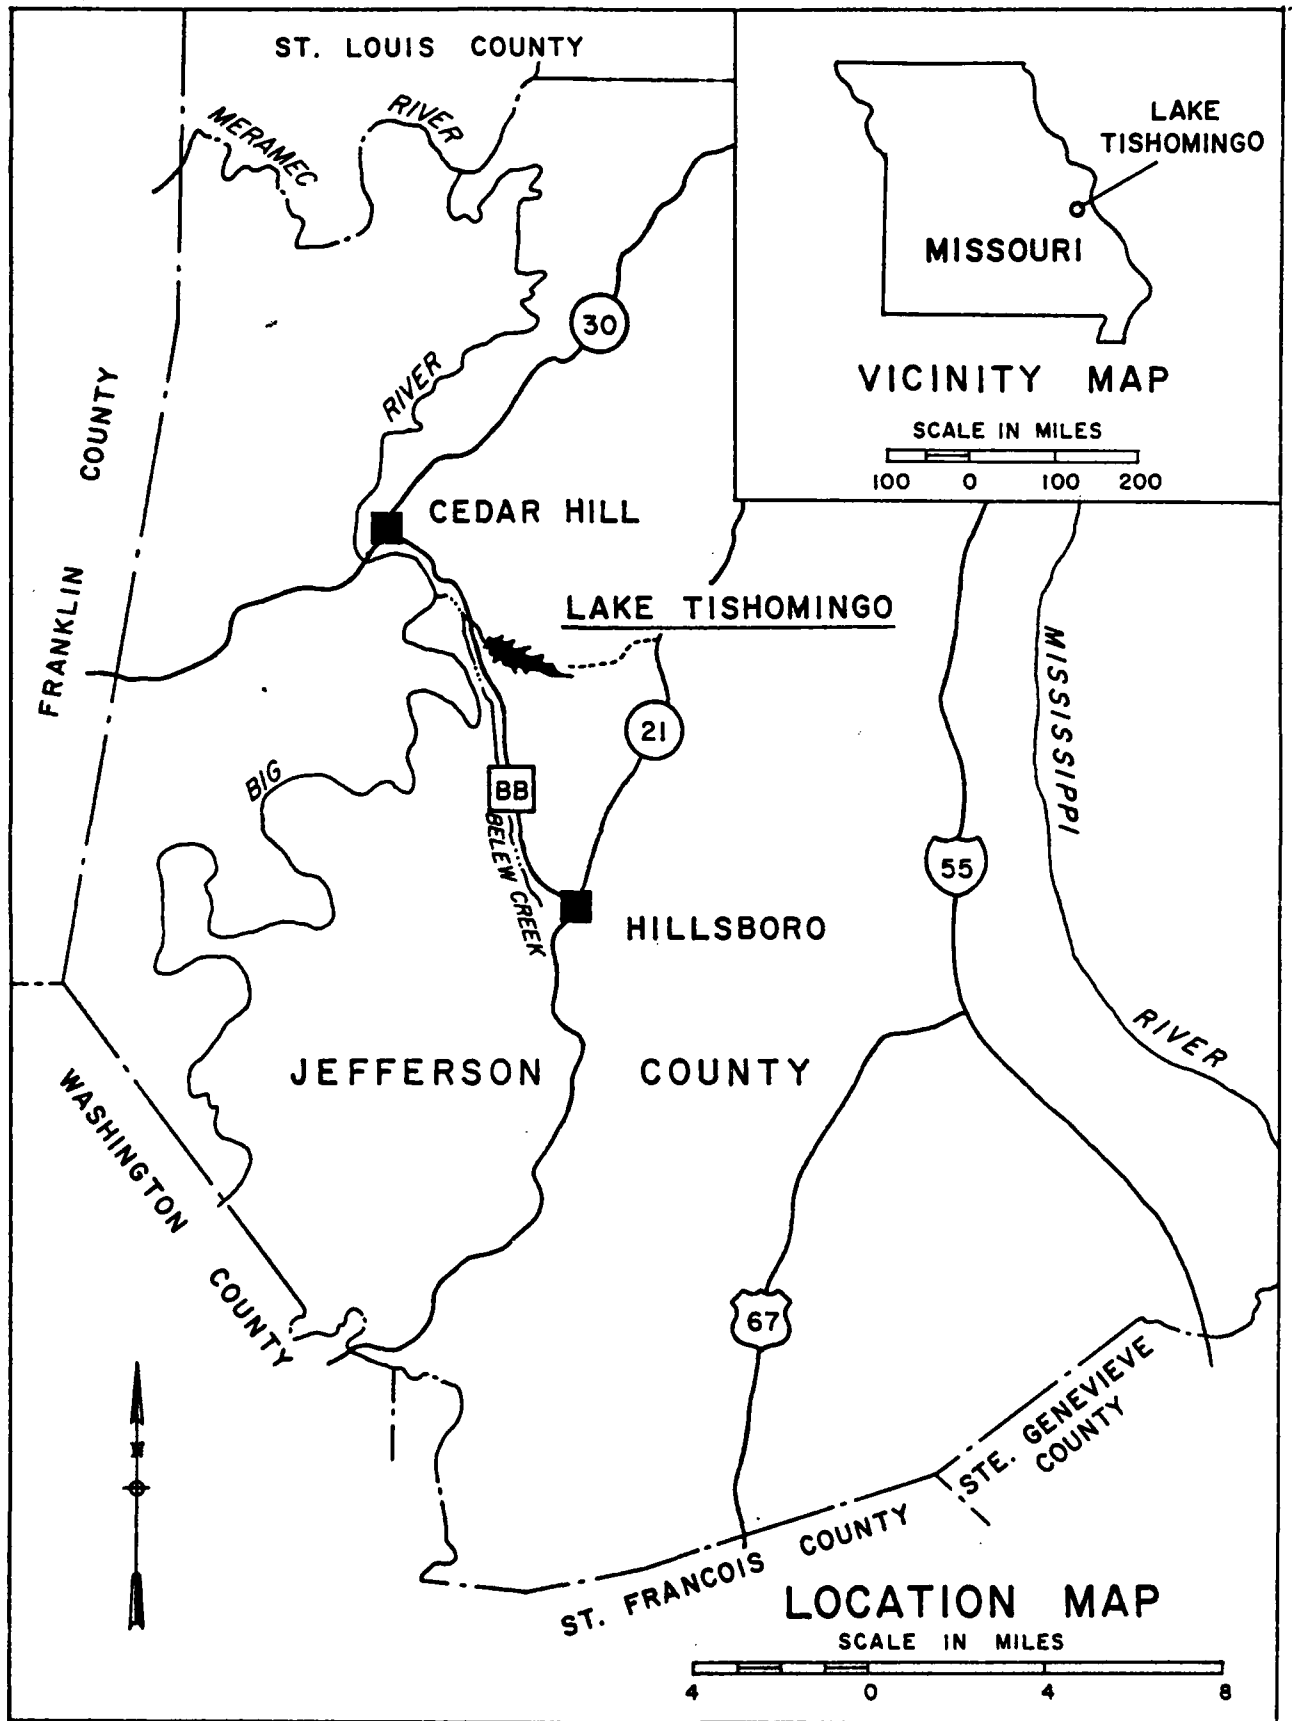
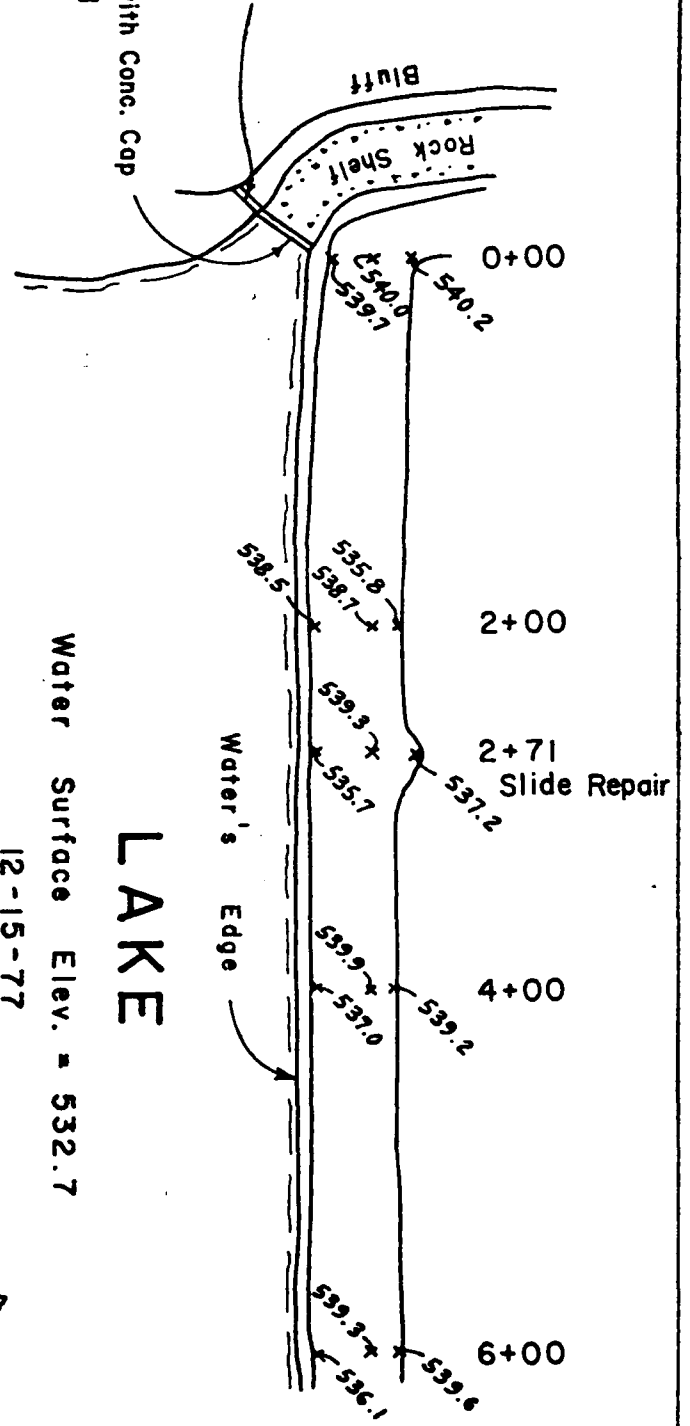
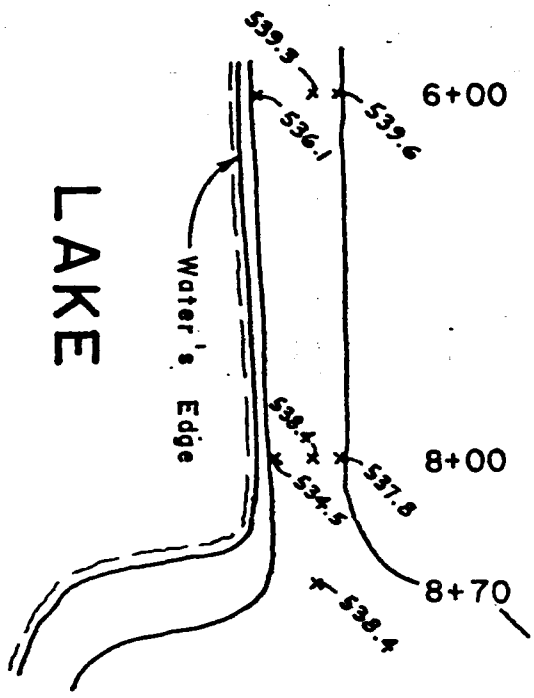
LAKE TISHOMINGO
 TOP OF DAM
 ELEVATIONS
 PL 1 : 3

20'± Rock Spillway with 4'± Clay Plug
 30' Rock Spillway with Conc. Cap
 Crest Elev. = 532.1

Water Surface Elev. = 532.7
