RADC-TR-81-180

**RADC-TR-81-180**  
Final Technical Report  
July 1981

## **FAILURE MECHANISM STUDY OF GaAs TECHNOLOGY**

**Hughes Aircraft Company**

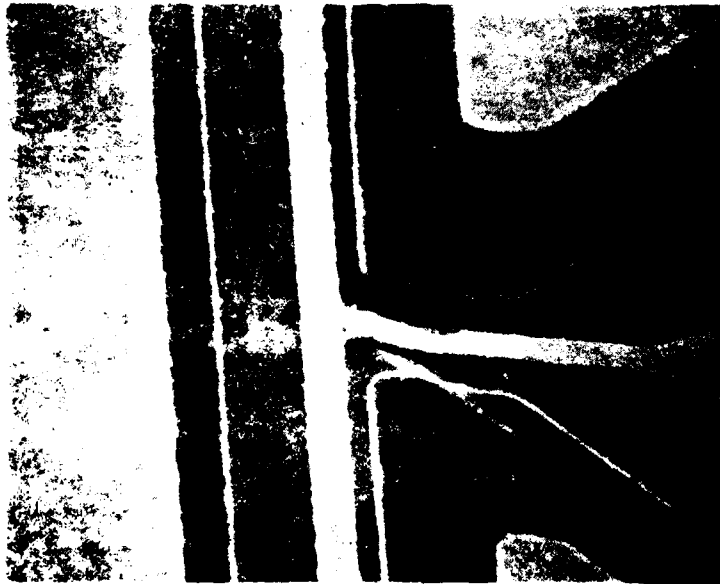
Figure 2-2 FET D-60/8. (a) SEM photograph, overall view, 168 X. (b) Gate connector, showing glass missing in some areas. S-D spacing is 4.7  $\mu\text{m}$ . 4500X mag.

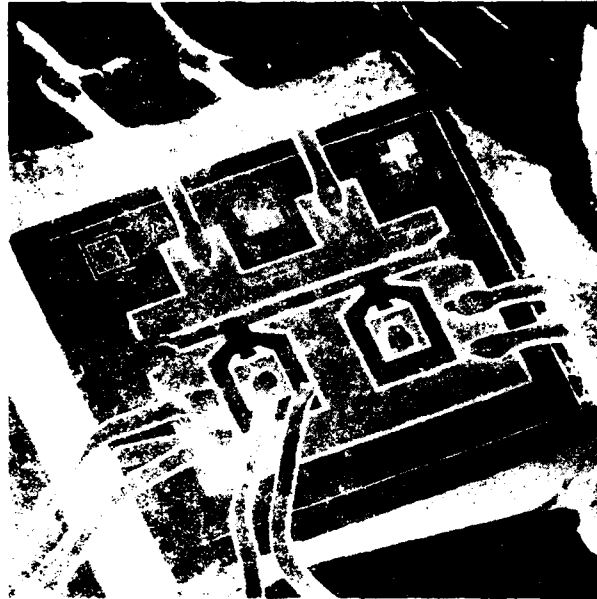
Figure 3-21 (a) SEM photograph of failed Type N-3, No. 8 FET at 160X; (b) Nodules on the gate stripe. 12,000X.

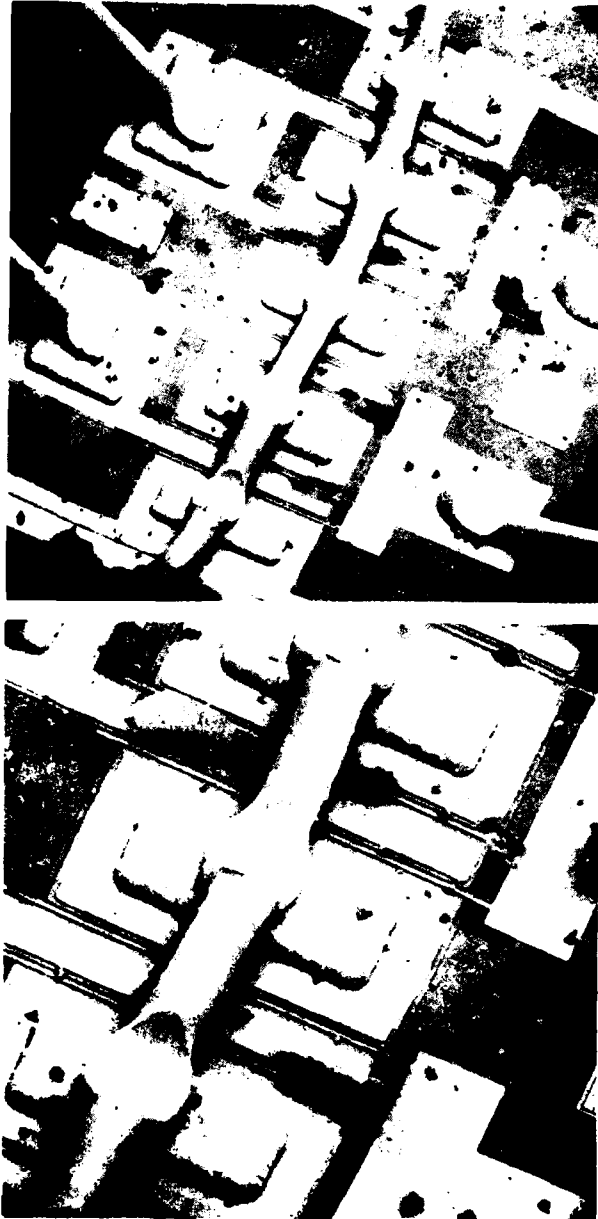
Figure 4-2 Type T-500/8, #2, after  
maximum  $V_{DS}$ ,  $V_G = 0$ ;  
electrical stress test.  
SEM at 200X, 400X.

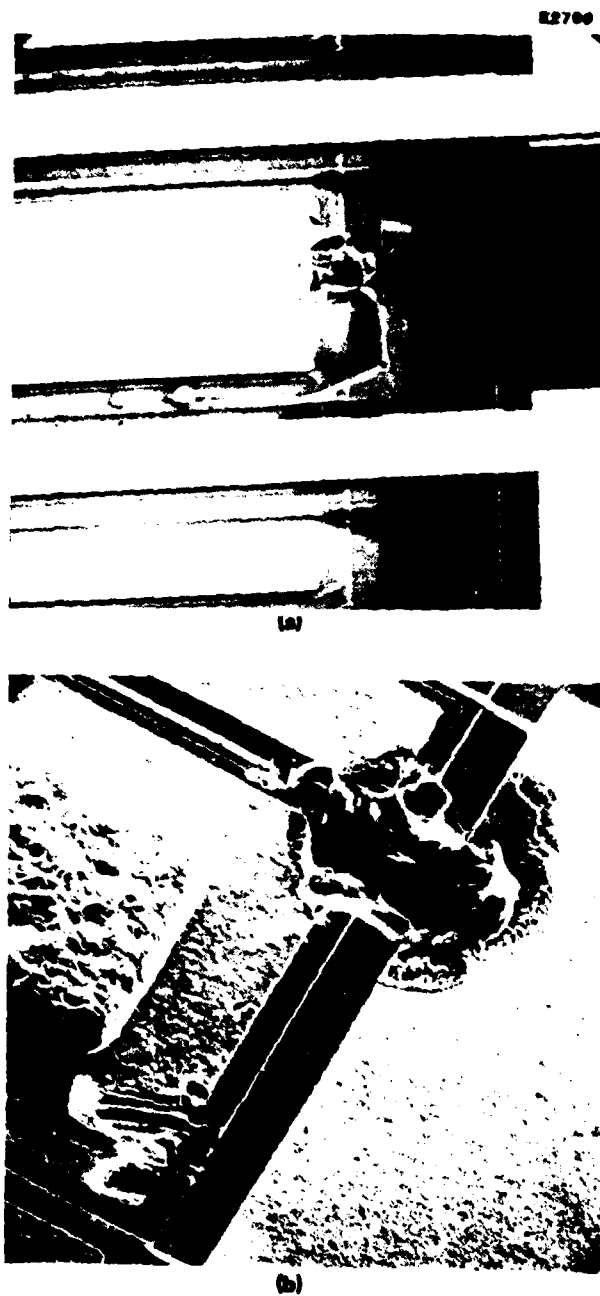
Figure 4-8 (a) Type N-250/11-P, #25, Test D, 200X. (b) Type T-500/8, #4, Test D, 1000X.

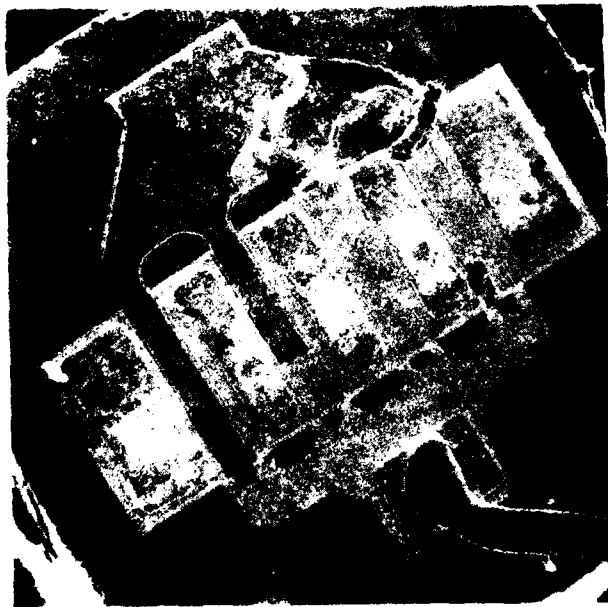
Figure A-22 Test A failures. (a) Type D-250/6 No. 51 FFT at 156X.  
(b) Type M-400/6 No. 17J FET at 214X.

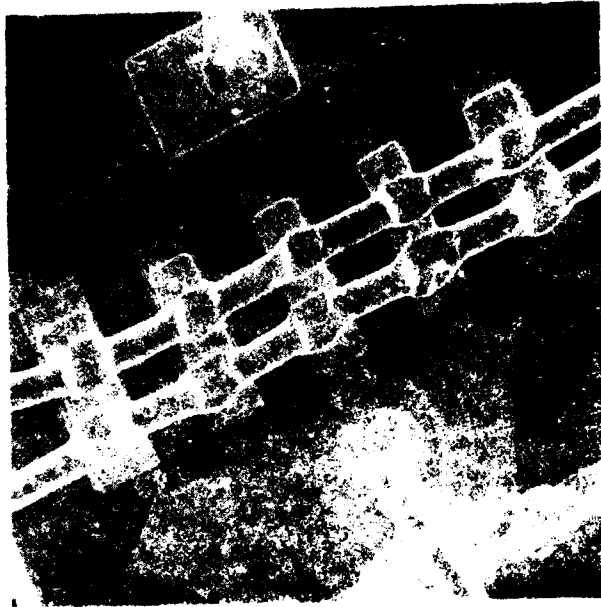
Figure A-27 Test D failure of Type T-LAB  
No. 3 FET at 180X.
