MONROE CITY SOUTH LAKE DAM
MONROE COUNTY, MISSOURI
MO. 10538

PHASE I INSPECTION REPORT
NATIONAL DAM SAFETY PROGRAM

NOVEMBER 1979

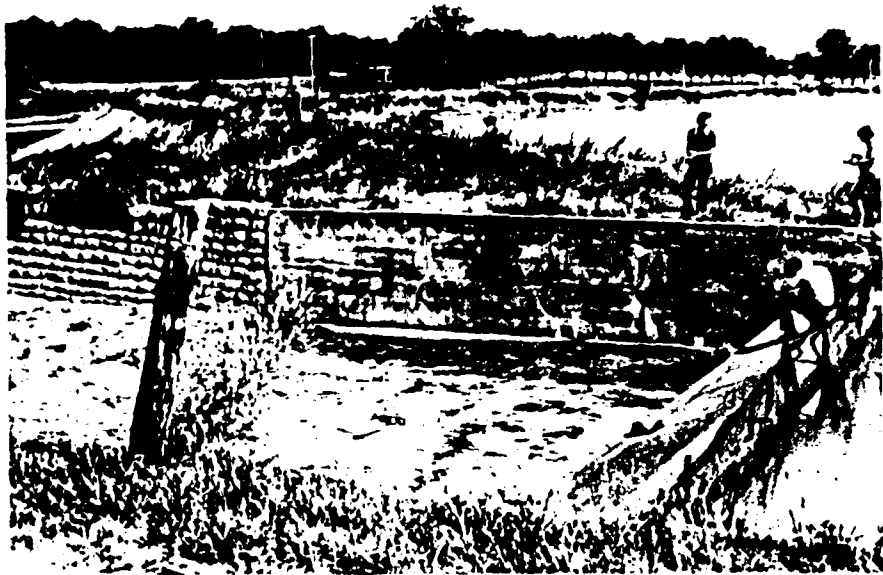
Photo 5

The spillway has apparently had a concrete cap added to it as evidenced by the condition of the concrete relative to the rest of the spillway. This accounts for the difference between what is shown on the available drawings and field measurements made by the inspection team. The concrete on the downstream side of the weir, immediately below the cap, has undergone severe spalling. Reinforcement is exposed on the right side of the spillway (as viewed looking downstream). Standing water was also observed in this location. Immediately downstream of the weir, on the right wingwall, leaching deposits were observed. Some minor temperature cracks were observed in the spillway cap along with a small amount of spalling on the upstream side. No displacement was observed in construction joints. The concrete wingwalls appeared to be in good condition. The discharge apron has deteriorated severely as a result of cracking and spalling.

- Photo 4. - View of the approach to the spillway.
- Photo 5. - View of the spillway and the discharge channel. Note leaching of retaining walls and spalling of concrete in the discharge channel.

1. Deteriorated concrete should be removed from the spillway and discharge apron and repairs made to the damaged areas.
2. All brush should be cleared from the upstream slope.
3. The erosion along the upstream crest should be repaired and the area should be protected with proper riprap to prevent future erosion.
